**From:** Hansen, Edward J., EMNRD  
**Sent:** Wednesday, May 09, 2012 9:03 AM  
**To:** Hack Conder (hconder@riceswd.com)  
**Cc:** Leking, Geoffrey R, EMNRD; Katie Jones <kjones@riceswd.com> (kjones@riceswd.com); Laura Pena (lpena@riceswd.com); Scott Curtis (scurtis@riceswd.com)  
**Subject:** Remediation Plan (1R425-20) Termination - ROC Vacuum Phillips 'B' Santa Fe EOL Site

RE: Termination Request  
Vacuum Phillips 'B' Santa Fe EOL (1R425-20): UL/O, Sec. 30, T17S, R35E  
RICE Operating Company – Vacuum SWD System

**RICE OPERATING COMPANY  
JUNCTION BOX FINAL REPORT**

# Vacuum Phillips 'B' Santa Fe EOL

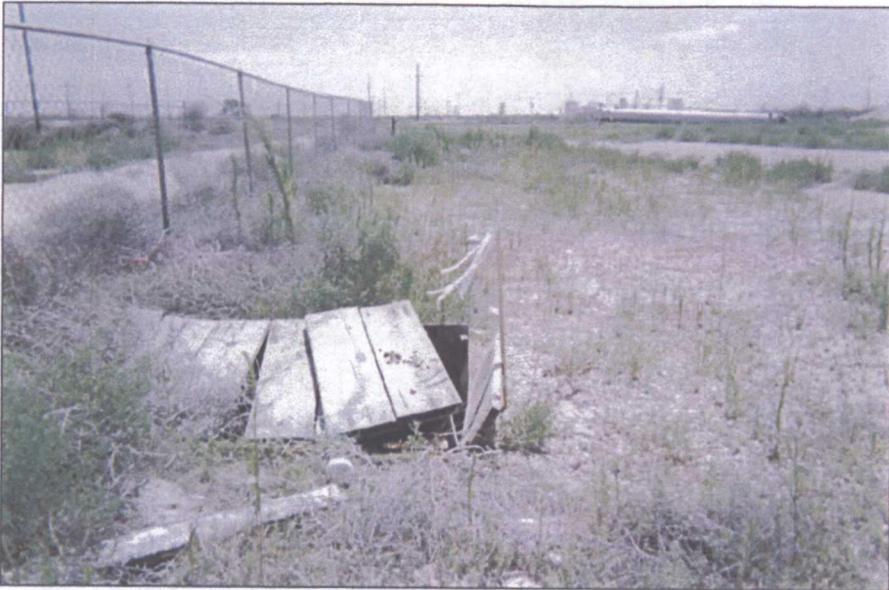
7/11/2005

undisturbed junction box

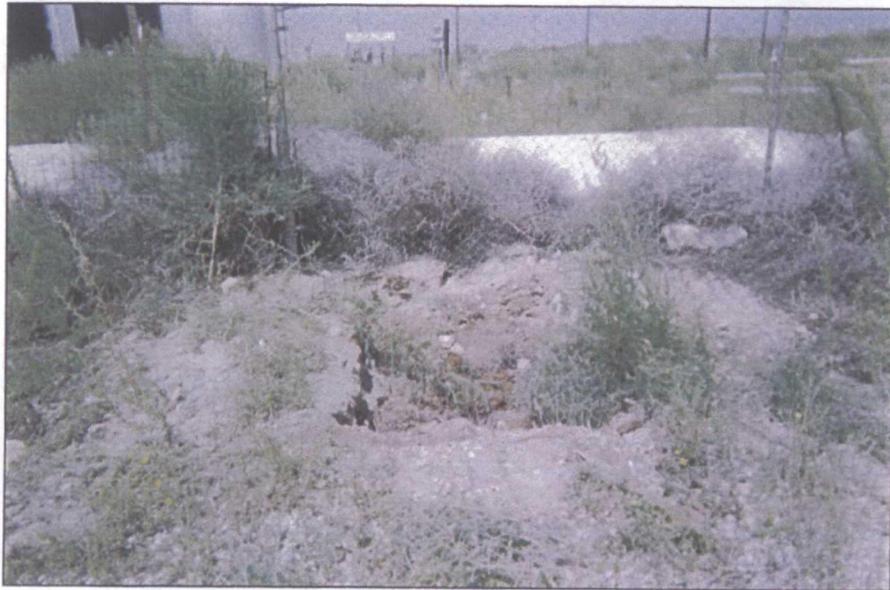
9/2/2005

junction box removed

as part of the Vacuum SWD System Abandonment. After the box materials were removed, a delineation trench was made at the junction using a backhoe while soil samples were collected every ft of depth to 6 ft BGS. Chloride field tests conducted on the samples yielded low concentrations that exhibited a conclusive trend of decline with depth, indicative of unsaturated historical vadose conditions. PID screenings were also performed on the samples and yielded no VOC readings, all 0.0 ppm. The laboratory analysis of the deepest sample (6 ft) confirmed the field tests and TPH concentrations were not present within the lab's detection limits (<10.0 ppm), meeting NMOCD guidelines. The excavated soil was blended on site and then backfilled into the trench and contoured to the surrounding terrain. The disturbed surface was seeded with a blend of native vegetation and is expected to return to productive capacity at a normal rate. Since the SWD System is no longer active, a replacement box is not required at this site.

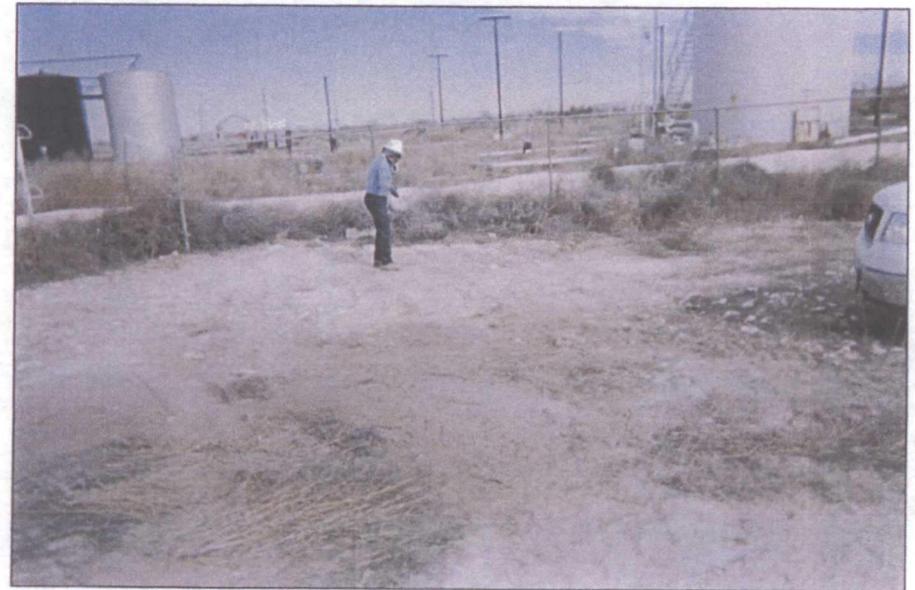
12/23/2005

seeding backfilled site
