From: Hansen, Edward J., EMNRD
Sent: Thursday, May 24, 2012 2:47 PM
To: Hack Conder (hconder@riceswd.com)
Cc: Leking, Geoffrey R, EMNRD; Katie Jones <kjones@riceswd.com> (kjones@riceswd.com); Laura Pena (lpena@riceswd.com); Scott Curtis (scurtis@riceswd.com)
Subject: Remediation Plan (1R425-54) Termination - ROC Vacuum Jct I-34 Site

RE: Termination Request
Vacuum Jct. I-34 (1R425-54): UL/I, Sec. 34, T17S, R35E
RICE Operating Company – Vacuum SWD System

**RICE OPERATING COMPANY
JUNCTION BOX FINAL REPORT**

Vacuum Jct. I-34

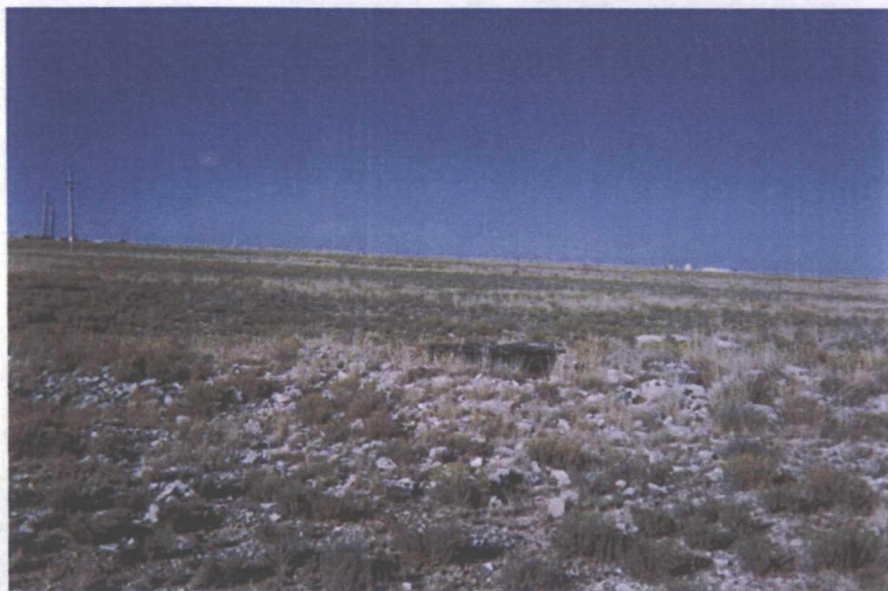
11/15/2005

undisturbed junction box, facing north

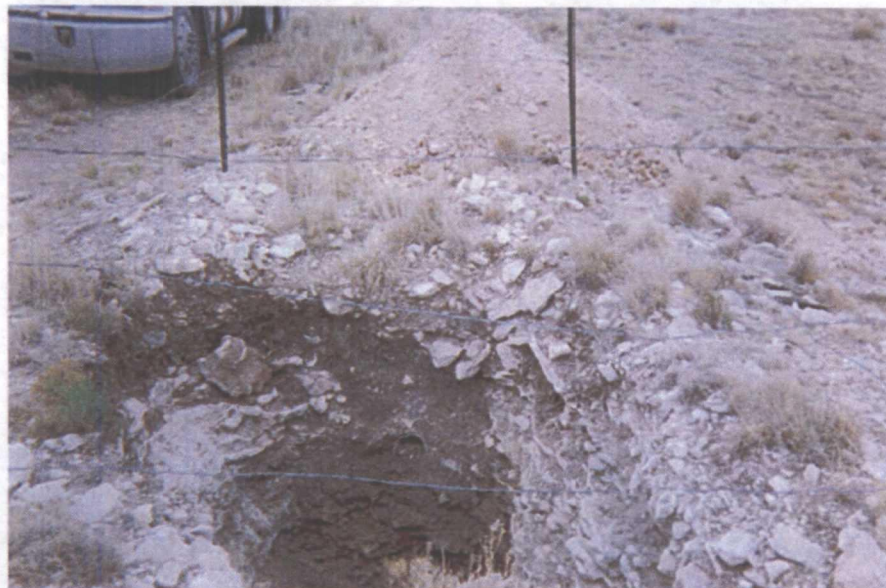
4/30/2008

delineation trench at former junction site

General Description of Remedial Action: This junction was addressed under the Vacuum SWD System abandonment. After this junction was removed, an investigation was conducted using a backhoe to collect soil samples at regular intervals producing a 5x3x12-ft-deep hole. Chloride field tests were performed on each sample, which yielded low concentrations. Organic vapors were measured using a PID, which also yielded low concentrations. The deepest sample, 12 ft BGS, was sent to a commercial laboratory for analysis of chloride and TPH, which confirmed low concentrations. The excavated soil was returned to the excavation and clean, imported soil was used to top cap and to contour to the surrounding area. On 5/20/2008, the site was seeded with a blend of native vegetation and is expected to return to a productive capacity at a normal rate.

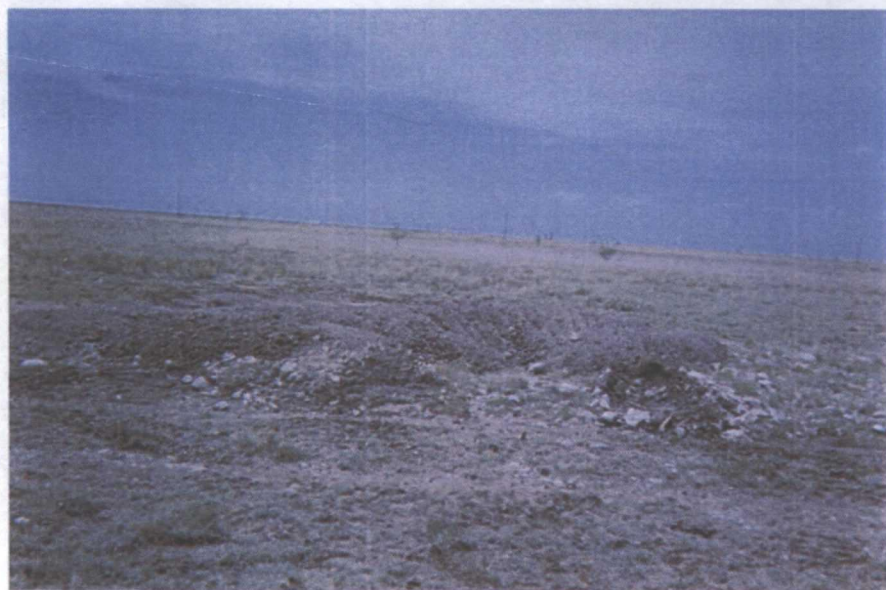
5/15/2008

spreading clean, imported topsoil on site

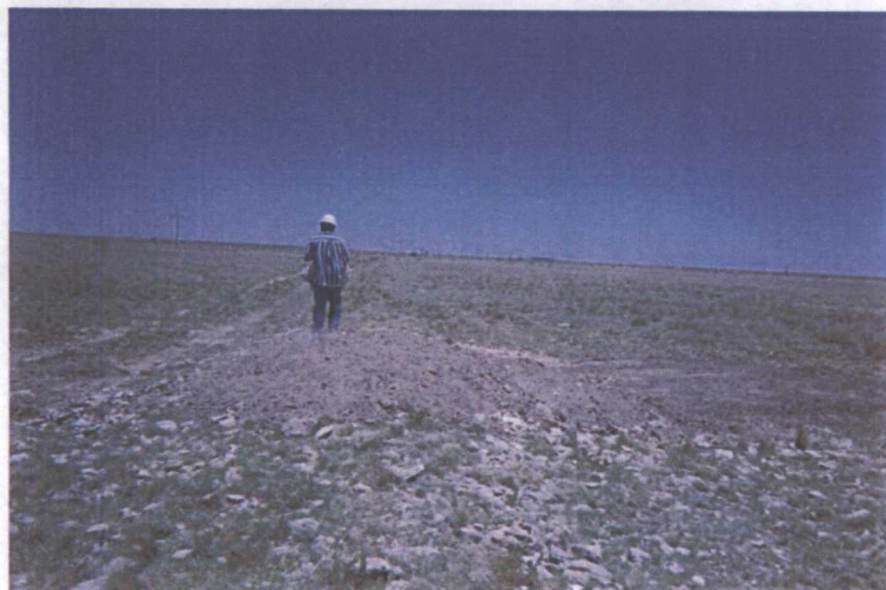
5/20/2008

seeding backfilled site
