**RE: Termination Request  
for the Rice Operating Company's  
Vacuum Jct C-27 Site  
Unit Letter C, Section 27, T17S, R35E, NMPM, Lea County, New Mexico  
Remediation Plan (1R425-96) Termination**

RE: Termination Request  
Vacuum Jct. C-27 (1R425-96): UL/C, Sec. 27, T17S, R35E  
RICE Operating Company – Vacuum SWD System

## Vacuum Jct. C-27

Unit C, Section 27, T17S, R35E

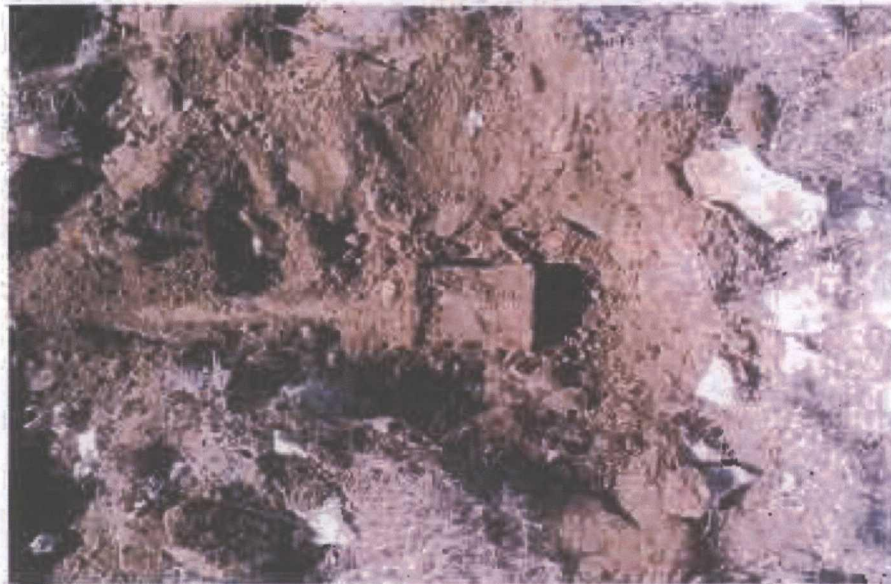
Site prior to delineation

3/19/2010

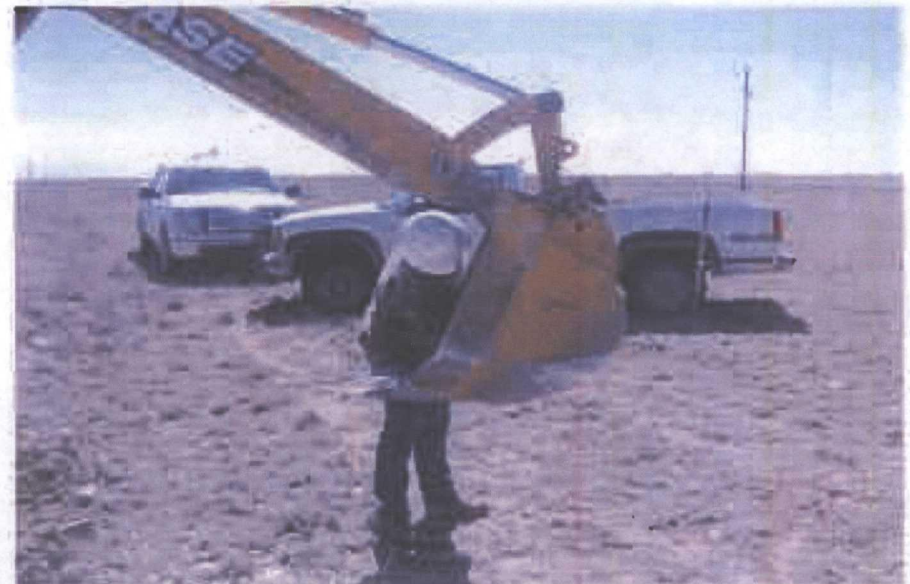
Collecting sample

3/19/2010

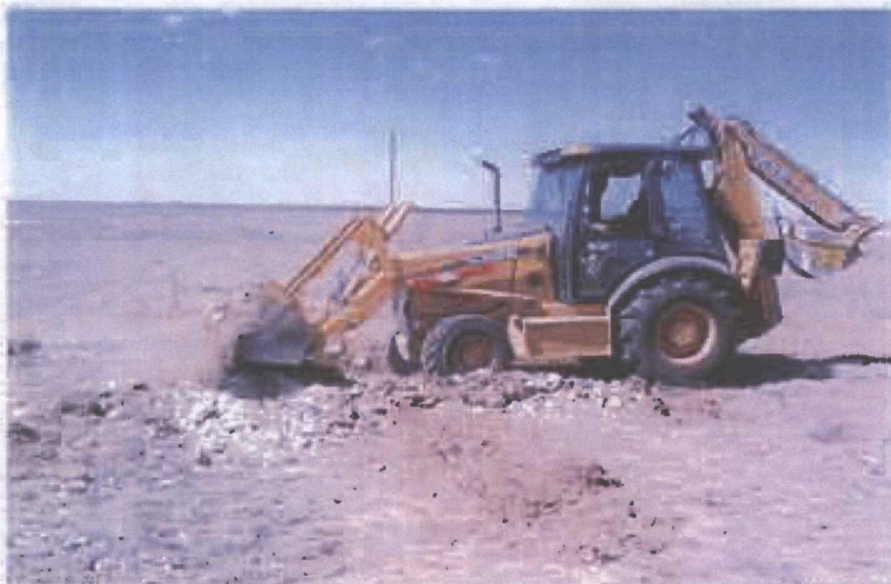
Backfilling excavation

3/19/2010

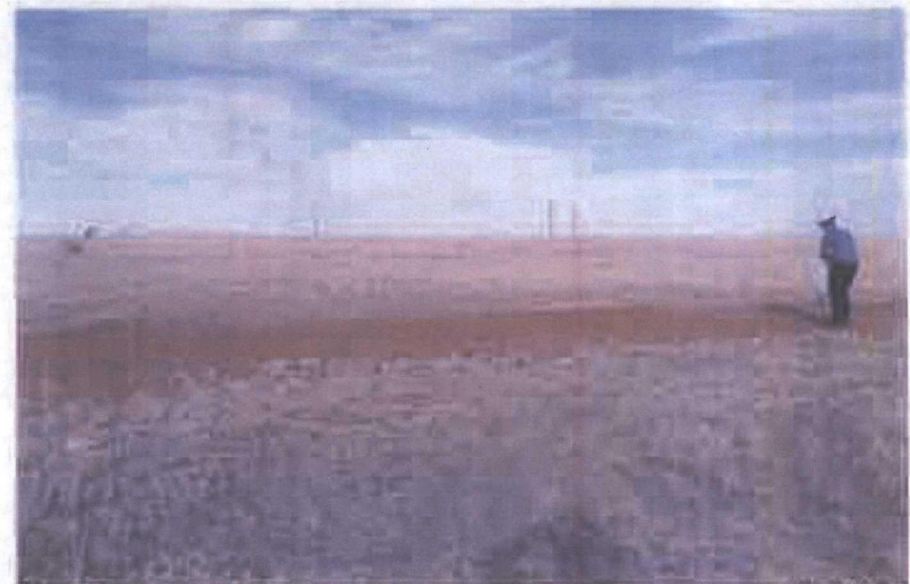
Seeding excavation

3/03/2011
