**RE: Termination Request
for the Rice Operating Company's
Vacuum M-31 EOL Site
Unit Letter M, Section 31, T17S, R35E, NMPM, Lea County, New Mexico
Remediation Plan (1R425-100) Termination**

RE: Termination Request
Vacuum M-31 EOL (1R425-100): UL/M, Sec. 31, T17S, R35E
RICE Operating Company – Vacuum SWD System

RICE OPERATING COMPANY
JUNCTION BOX FINAL REPORT

Vacuum M-31 EOL

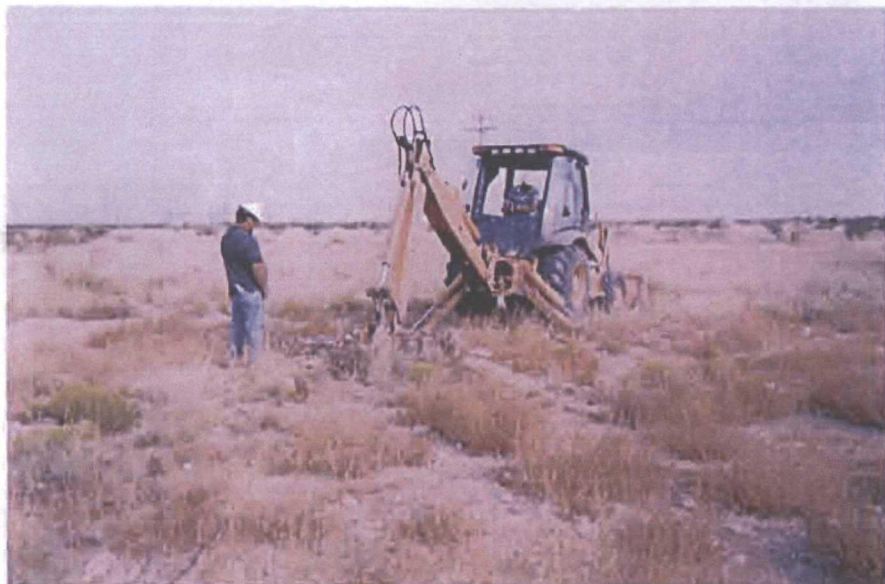
10/18/2010

Digging initial vertical delineation trench

General Description of Remedial Action: This junction box was addressed during the Vacuum SWD System abandonment. After the former junction box was removed an investigation was conducted using a backhoe to collect soil sample at regular intervals creating a 5x2x5-ft deep excavation. Each sample was field tested for chlorides and organic vapors which yielded low concentrations similar to that of the background sample.

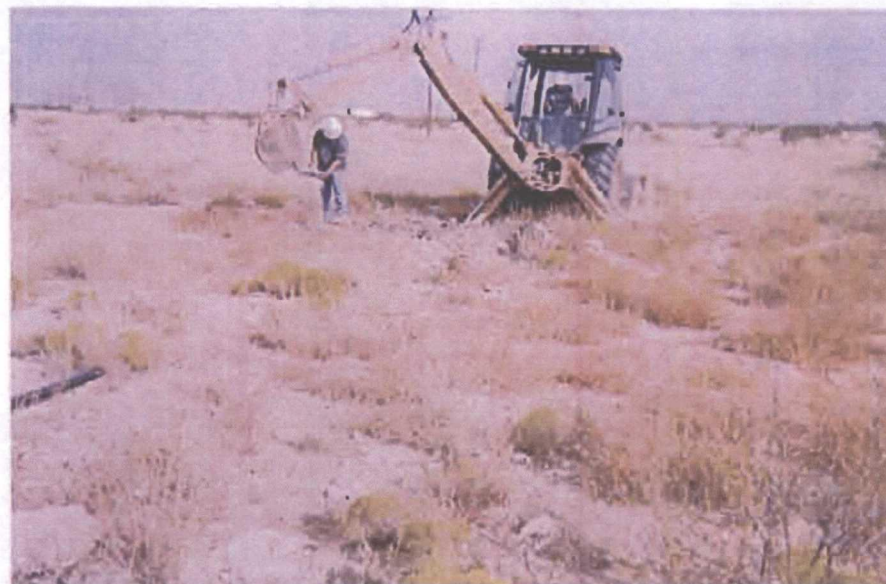
10/18/2010

Collecting Sample

The deepest sample, 5 ft BGS, was sent to a commercial laboratory for analysis of chloride and TPH which confirmed low concentrations.

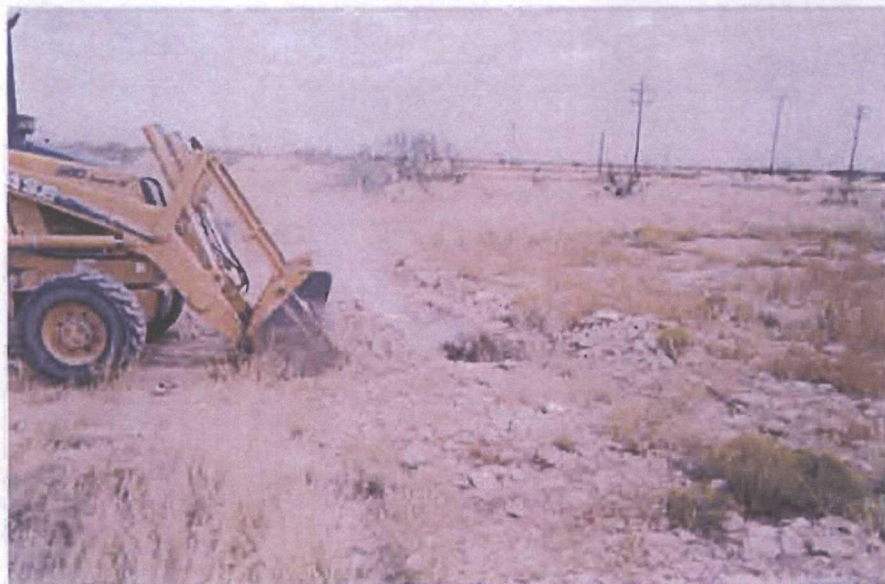
10/25/2010

Backfilling site

The excavated soil was returned to the excavation to ground surface and contoured to the surrounding area. On 10/25/10, the site was seeded with a blend of native vegetation and is expected to return to a productive capacity at a normal rate.

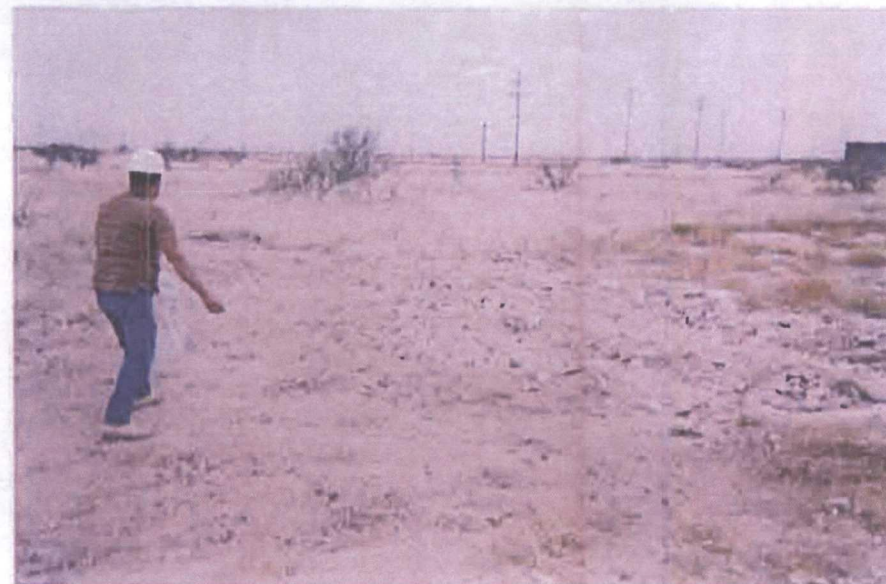
10/25/2010

Seeding site
