From: Gregston, Terry G <tgregsto@blm.gov>
Sent: Friday, September 07, 2012 3:44 PM
To: tainsworth@cimarex.com; tstathem@cimarex.com
Cc: Bratcher, Mike, EMNRD
Subject: Undesirable Event: NU12193TG, CK 7 Federal 1: Archeological clearance; notification of cave/karst and groundwater concerns
Attachments: CK 7 Federal 1 and 2-090212 spill-090512- 025.jpg; CK 7 Federal 1-090212 spill map-090512.jpg; CK 7 Federal 1-storage tank APD COAs-090712.pdf

Event Number: NU12193TG
Event Date: 9/2/2012
Event Name: CK 7 Federal 1
Legals: T24S/R26E, sec. 7, SWNE

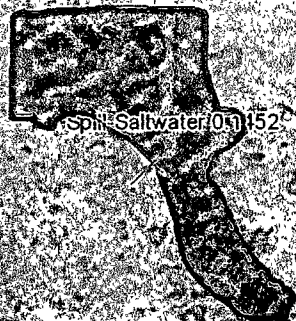
Spill Saltwater 01152

C/K-7 FEDERAL #001 C/K-7 FEDERAL #001

C/K-7 FEDERAL #002 C/K-7 FEDERAL #002

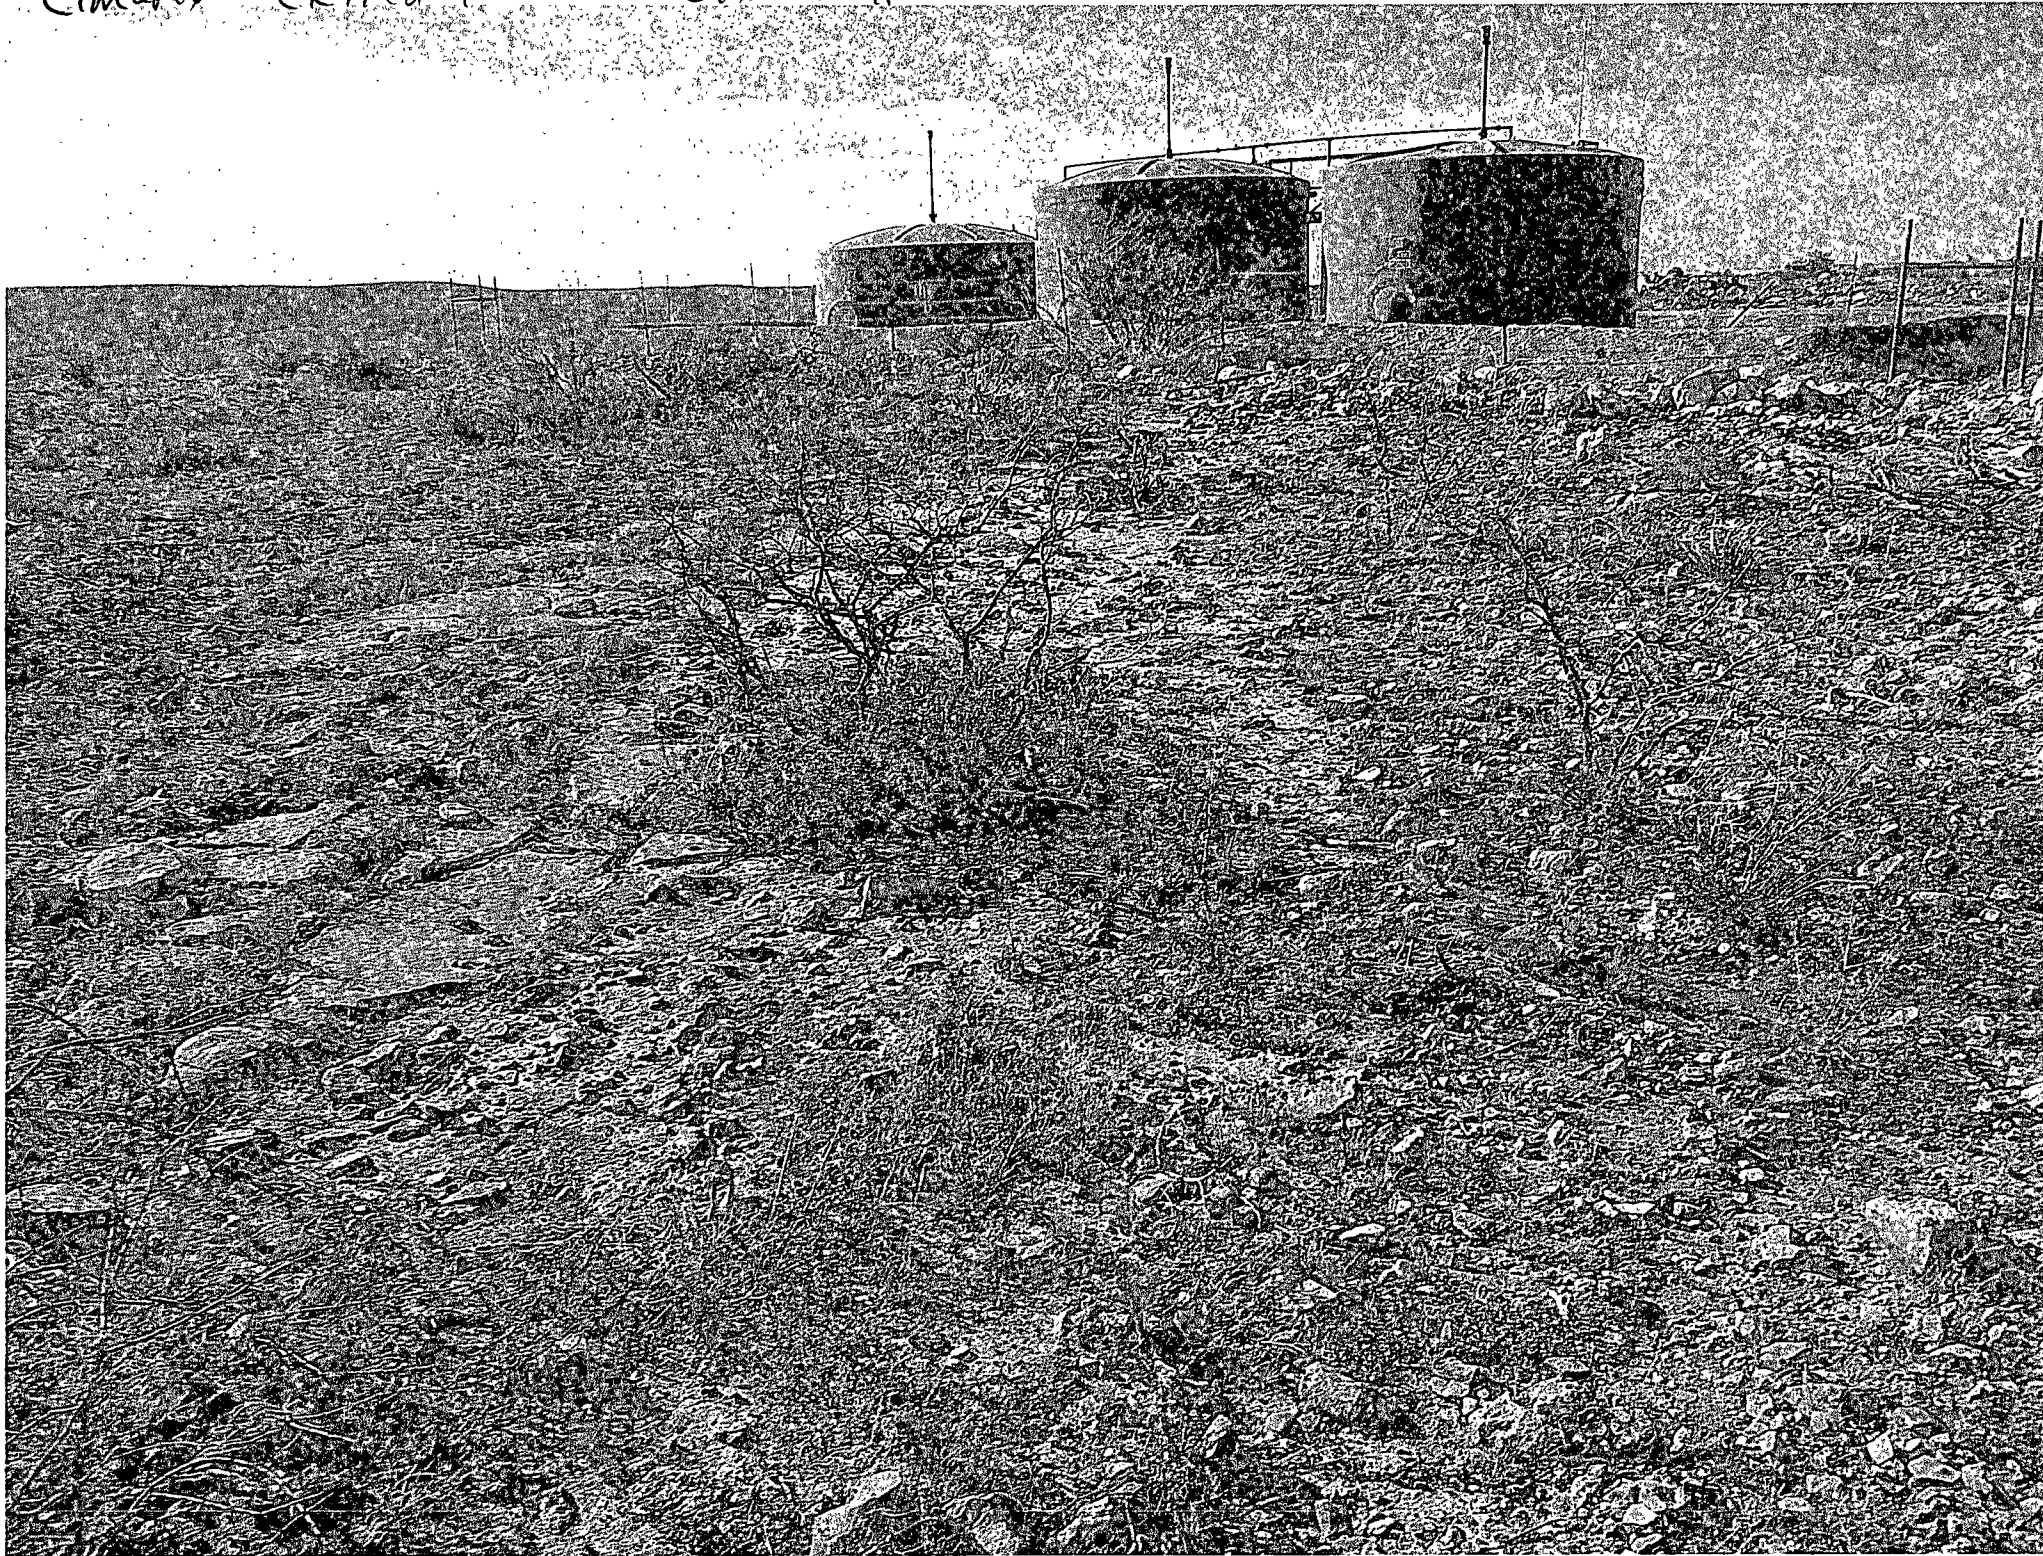
Cimarron CK7Fed#1

This spill event is in a cave and karst area ranked as "critical" due to its proximity to known cave and karst features that are connected with the recharge of the Capitan Reef aquifer. A known cave system downslope of the spill has direct access to the Capitan Reef. While the spill itself did not enter the cave feature, runoff from the spill event and any spillage that entered into rock cracks or karst features beneath the battery have a high potential of finding an egress route into both the cave system and the Capitan Reef aquifer that is associated with that cave system.

During the onsite inspection of this spill event, it was found that the tank battery on this location was not built according to APD COAs. The conditions of approval on the drilling permit for this well stated that the tank battery should have a "permanent liner" installed as well as a leak detection system. The tank battery on this location was built without a liner or leak detection and the containment berms were constructed of highly porous gravel. As a result, the spill permeated the battery containment berms and soaked into bedrock cracks and cave/karst features very rapidly.

The spill impacts on this location need to be address as soon as possible. Cleanup crews should take special care to ensure that bermed containment with a plastic liner (that goes up and over the berms, rather than lying flat on the ground) should be used to stockpile contaminated materials during spill cleanup and contaminated soil removal operations. The tank battery needs to be built according the APD Conditions of Approval for this location. All contaminants on this location, whether associated with wellheads, tank battery, compressors, chemical barrels, or load lines should be picked up and removed as soon as possible. Ensure that cleanup crews clean up these contaminated areas to the greatest extent possible.
