Release Notification and Corrective Action

Name of Company Apache Corporation	Contact Natalie Gladden
Address PO Box 1849 Eunice, NM 88231	Telephone No. 575-390-4186
Facility Name DC Hardy Battery (nearest well #4)	Facility Type Production Facility
Surface Owner Sims	Mineral Owner NMOCD
API No. 30-025-06691

**APACHE DC
HARDY TANK
BATTERY NO. 1 AD**
 LEGALS: UL O & P sec. 20
 T-21-S R-37-E
 LEA COUNTY, NM

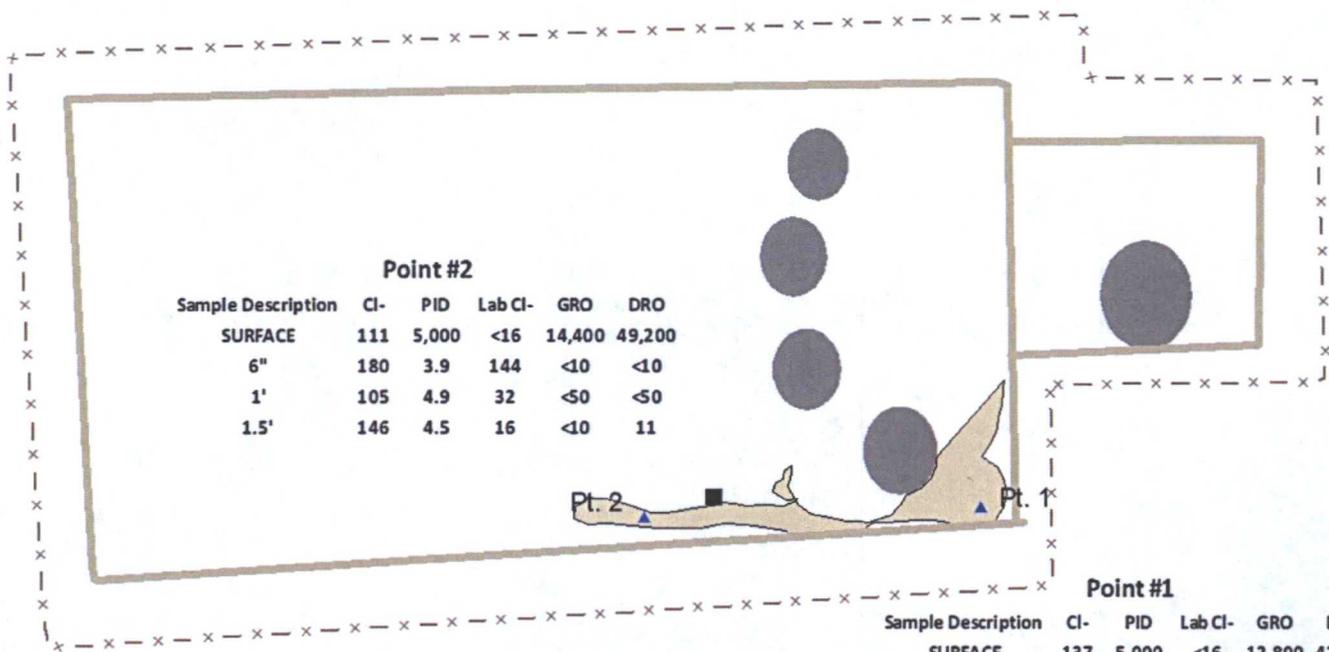
Point #1					
Sample Description	Cl-	PID	Lab Cl-	GRO	DRO
SURFACE	137	5,000	<16	12,800	42,200
6"	133	5.3	96	<10	54.6
1'	171	5.5	96	<10	<10
1.5'	168	5.8	80	<10	<10

- ▲ SAMPLE POINTS
- ELECTRICAL CONTROL
- BERM
- x - x - FENCE LINE
- STAIN (287 sq ft)
- TANKS
