Release Notification and Corrective Action

Name of Company	Paladin Energy Corp.	Contact	Michael Horn
Address	4006 Dunkirk, Midland, TX, 79707	Telephone No.	432-634-6599
Facility Name	State C #003	Facility Type	Salt Water Disposal
Surface Owner	James Reed McCrory	Mineral Owner	Unknown
		Lease No.	30-025-34239

## PALADIN STATE C #3 AD

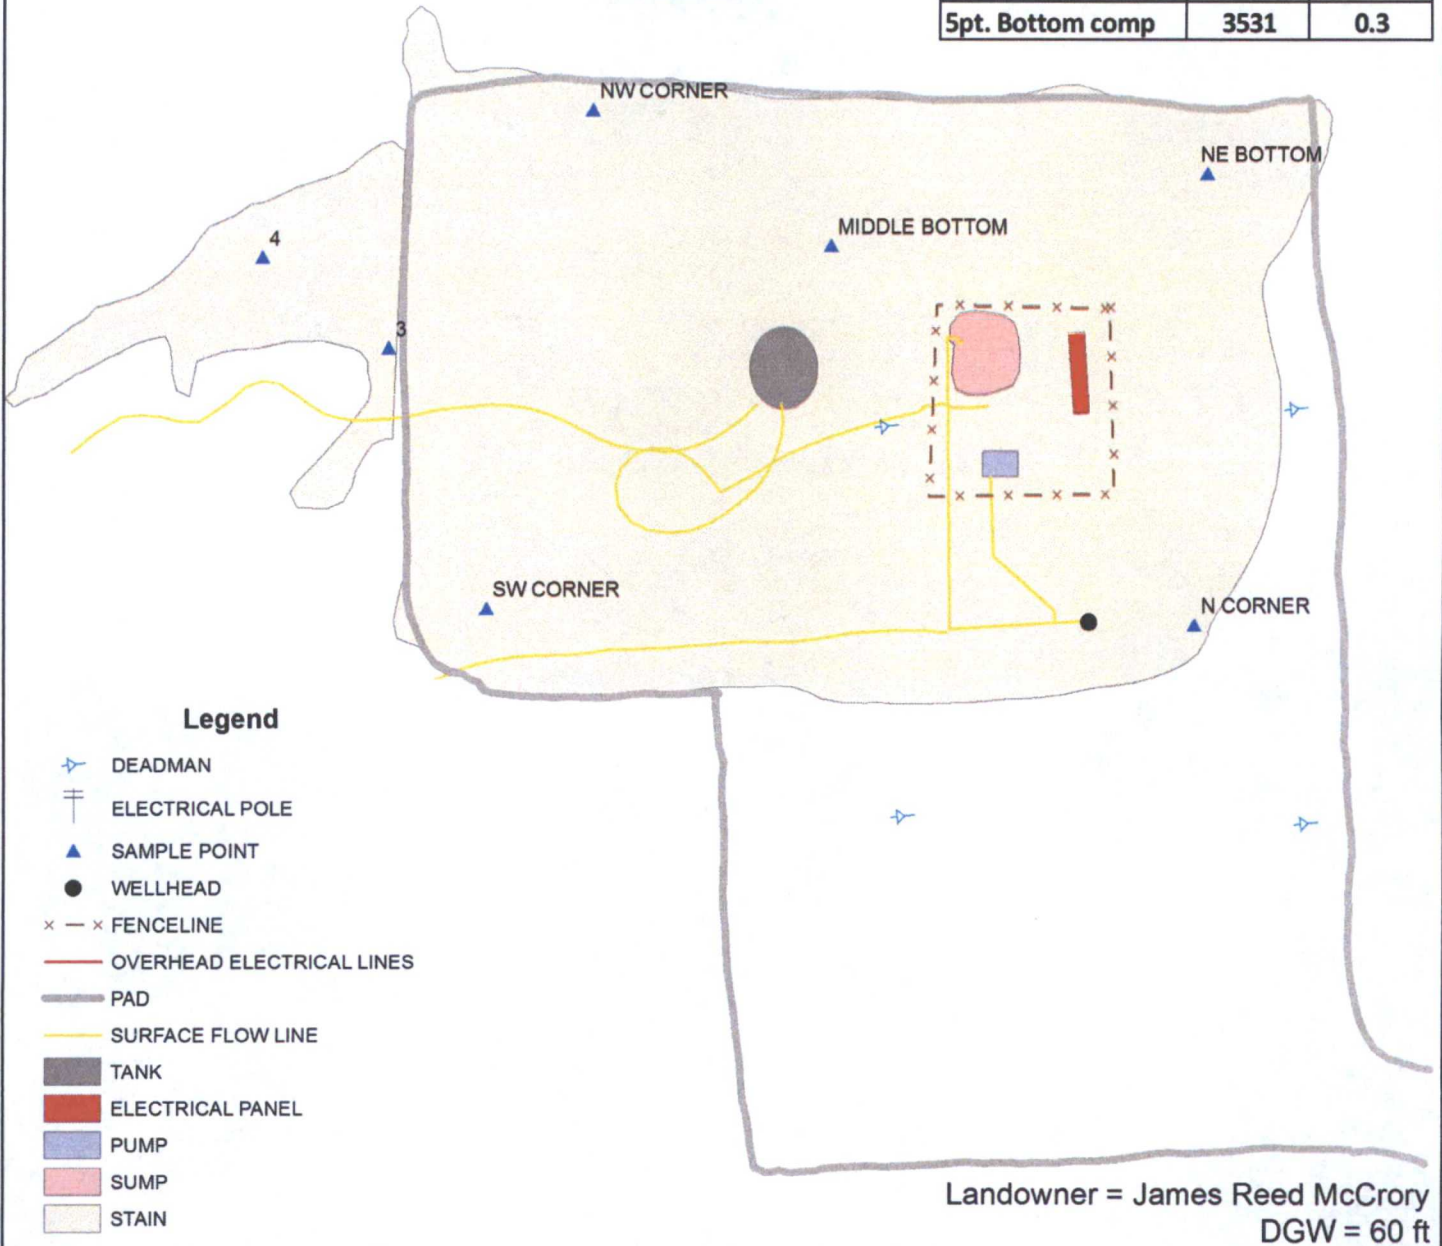
Sample Description	CI-	PID
pt.3	2690	0.3
pt.4	2729	0.3

Sample Description	CI-	PID
northeast bottom	5269	0.3
northwest bottom	637	0.2
southeast bottom	607	0.2
southwest bottom	5289	0
middle bottom	1330	0
5pt. Bottom comp	3531	0.3

UL/ H SECTION 35  
UL/D & E SECTION 36  
T-13-S R-37-E  
LEA COUNTY, NM
