1RP - 2155

Release Notification and Corrective Action

Name of Company	John H. Hendrix Corporation	Contact	Carolyn Doran Haynes
Address	110 N. Marienfeld, Midland, TX 79702	Telephone No.	575-390-9689
Facility Name	Parks West RP - 2155	Facility Type	Production Oil Battery

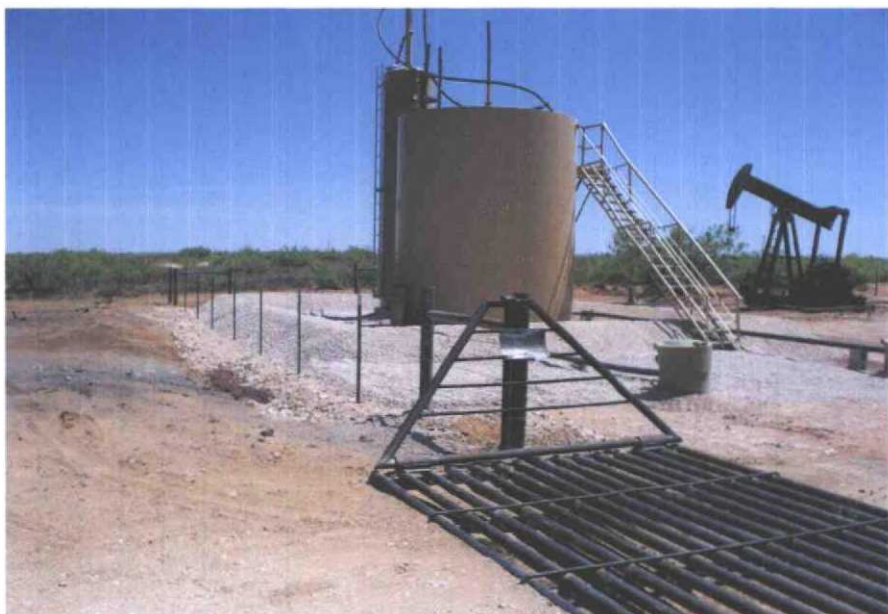
Parks West from SW corner 5-21-09

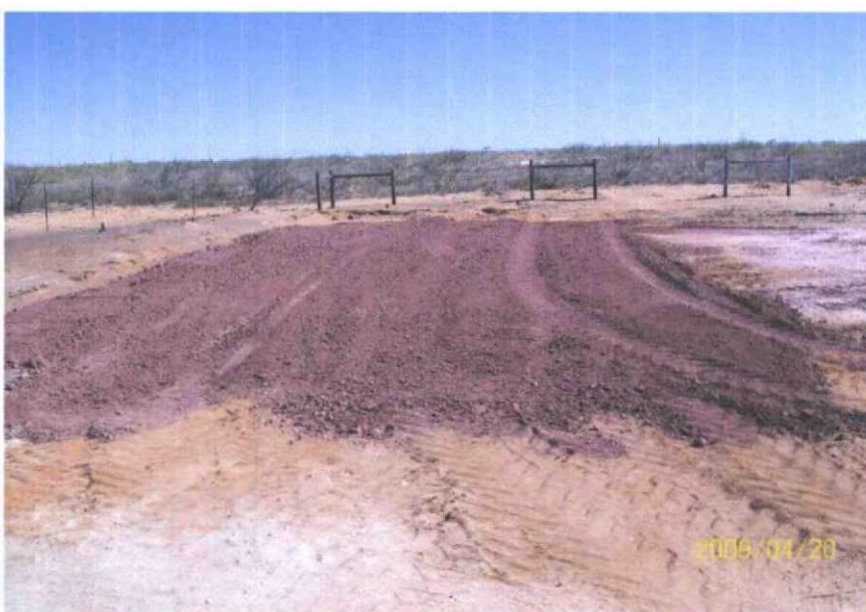
Compacted clay layer underlying new facility - approx 90 cu yds

Drawing and photos are attached. Area affected outside the berm is approximately 34 x 80'. Oily soils were scraped-up and restored with clean caliche material purchased from the landowner. 140 cubic yards of oily dirt was taken to Sundance Disposal. Clay was compacted 1' BGS where the new facility is set. New gun barrel and holding tank has been set. The berm is reconstructed. Ground water is 90-100' BGS at this location (Will Cary monitor wells water levels). Attached are lab results. TPH < 1000 mg/kg and Chloride < 250mg/kg. This site remains an active production facility and will be appropriately abandoned at the end of production.
