# Basin Environmental Service Technologies, LLC

## Environmental Site Summary

Project Name: #4 North Plant Storage (NMOCD IRP#-1457)

### Proposed Soil Boring/Monitor Well Locations:

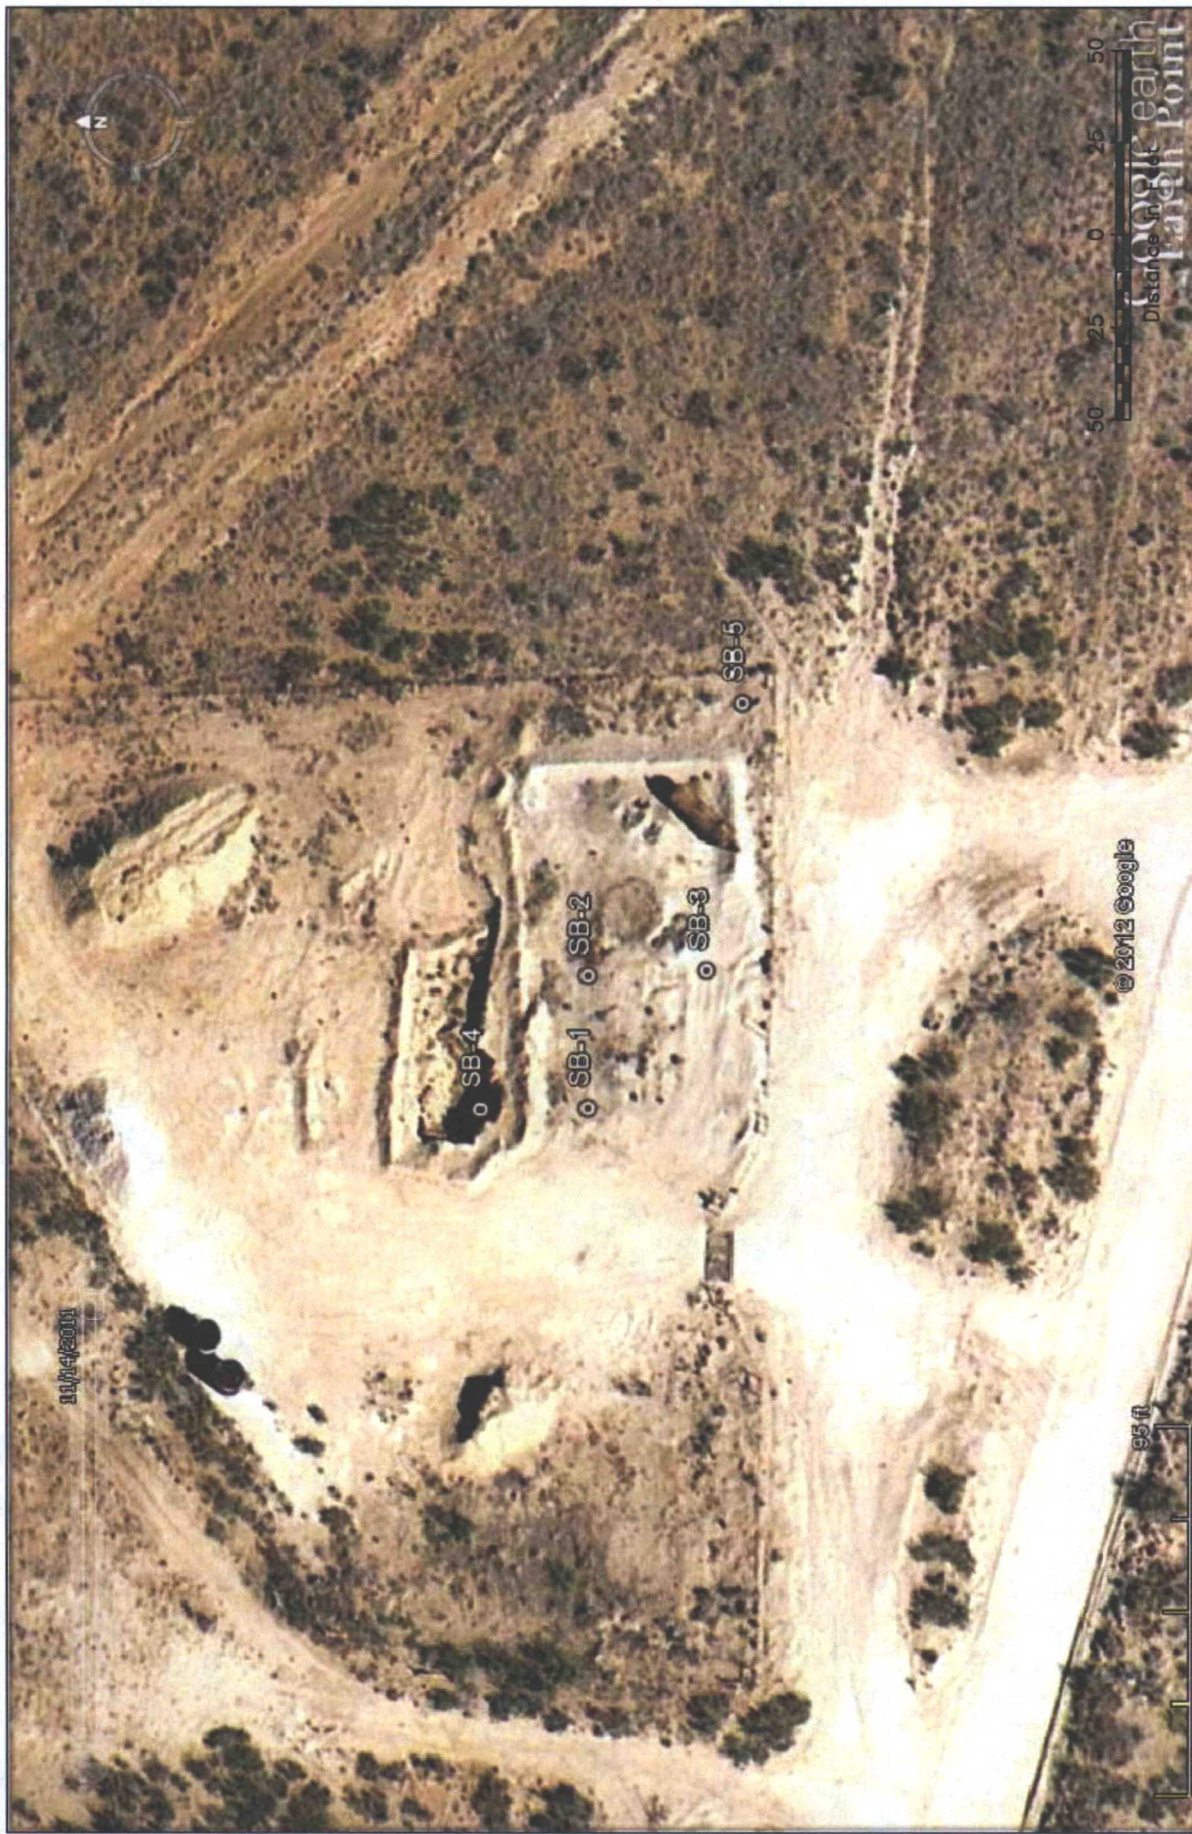
Figure 2  
Proposed Soil Boring Location Map  
Southern Union Gas Services  
#4 North Plant Storage  
NMOCD Ref RP-1457  
Lea County, New Mexico

SB-1 (western portion of primary pooling area)
SB-2 (eastern portion of primary pooling area)
SB-3 (~50' down gradient of primary pooling area)
SB-4 (inferred center of former below grade tank location)
SB-5 (~120' down gradient of primary pooling area)
