BP Pipeline

Simms Gathering Pipeline

**Initial
C-141**

Release Notification and Corrective Action

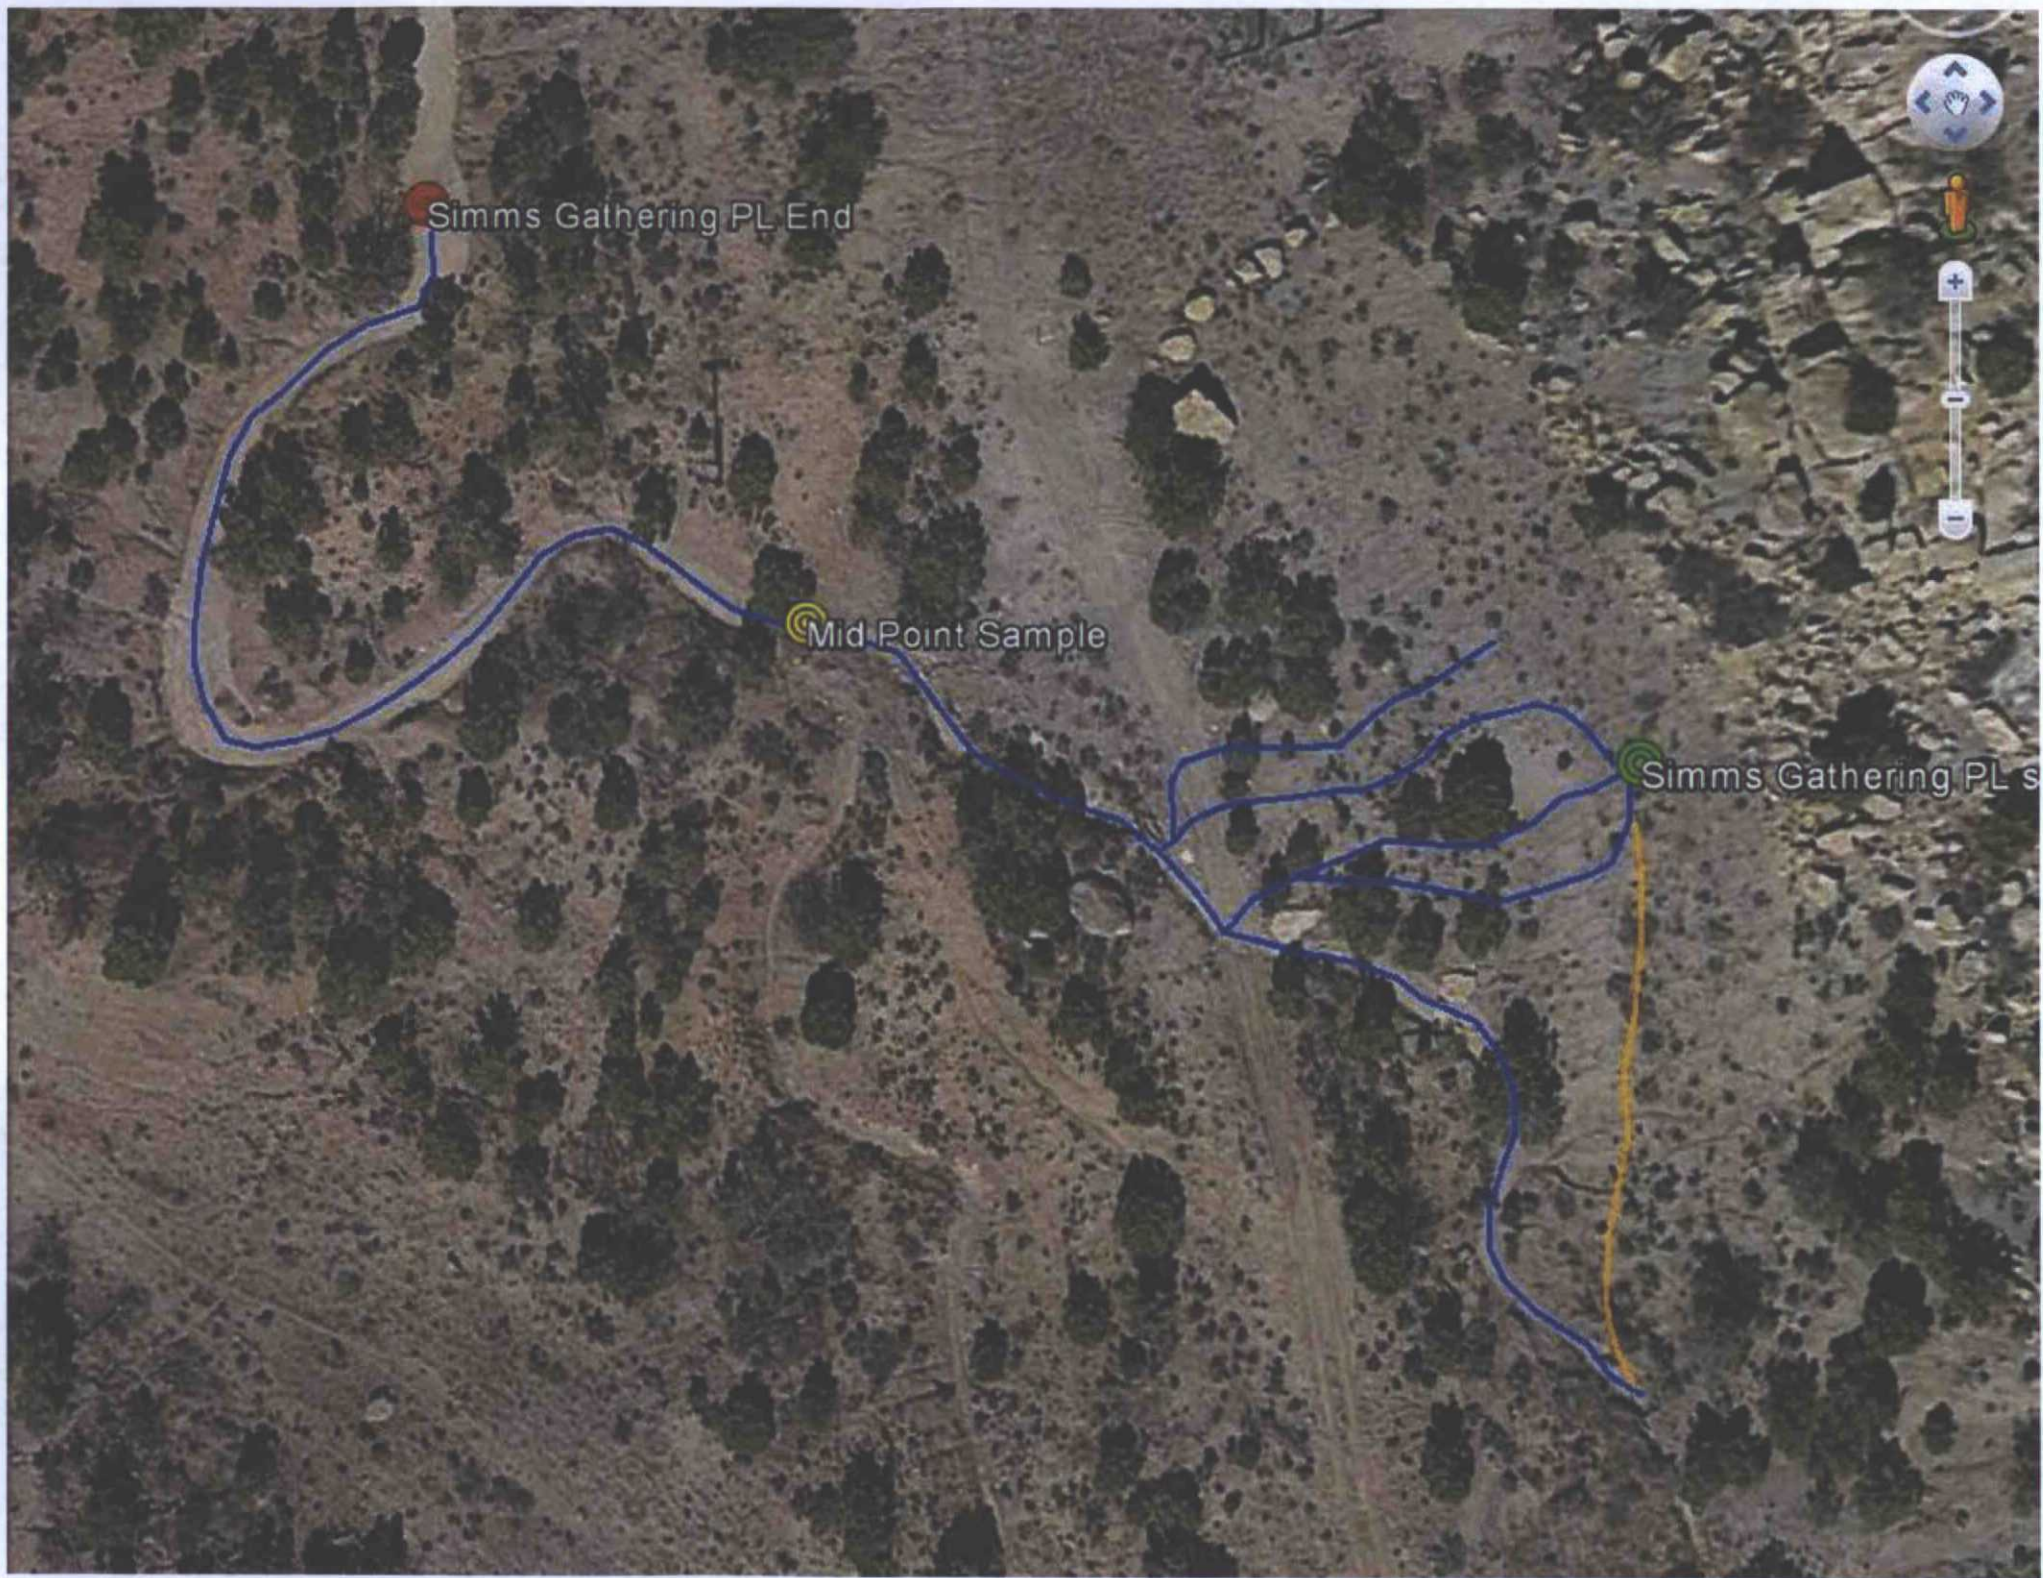
Remedial Actions Taken: The pipeline was isolated and approximately 40 bbls of water were removed from the line at a upstream location. Three, 3-point composite soil samples were collected at the release point (green on attached figure), the approximate mid-point (yellow) and end point (red) of the visible discharge path. The samples were submitted for laboratory analysis for BTEX, TPH and chlorides.

Clean-up actions taken: The area affected remained to the downgradient wash of the release point, as indicated in blue of the attached figure. Subsurface flow of the produced water to the south of the evident pipeline release point allowed the produced water to discharge to the wash slightly upstream of the release point as indicated in orange of the attached figure. Clean up will be determined by the results of the laboratory analysis.
