December 27, 2016

Job No. 16-07-101-17007

Re: Initial C-141 Report, Estimated 10 Barrel Crude Oil Spill, Holly Transportation, LLC Hobbs Station #571, 413 West Arco Road, Hobbs, New Mexico

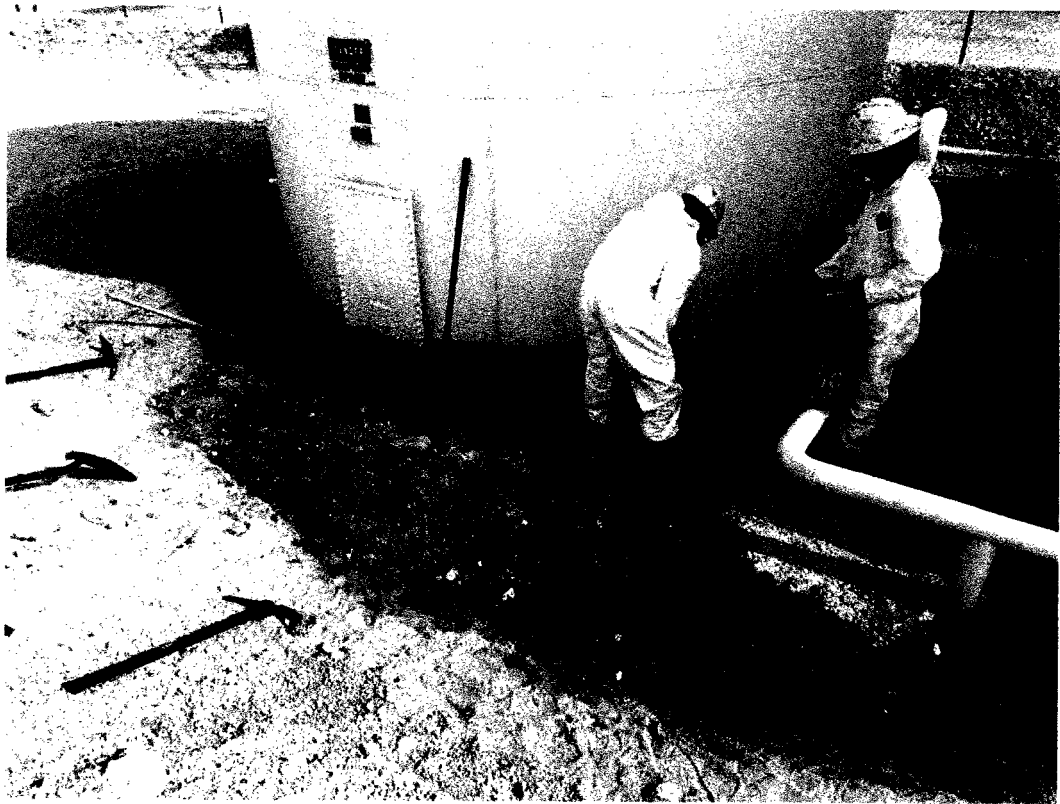
Excavation of the crude impact soil

G1 returned to the Site on December 19, 2016 to resume spill abatement. The outside wall of the overfilled AST was cleaned using a power washer. The crude impacted soil was excavated by hand using shovels, in order to protect the integrity of the containment wall from heavy machinery. The excavated soil is currently stored at the Site in a roll off container, pending disposal. Disposal documentation will be provided to the EMNRD in the final C-141 report.
