Pit, Below-Grade Tank, or
Proposed Alternative Method Permit or Closure Plan Application

BELOW-GRADE TANK CLOSURE PLAN
MANZANARES STRADDLE COMPRESSOR

API No. PLL1263008

Unit Letter L Section 26 T 30N R 08W

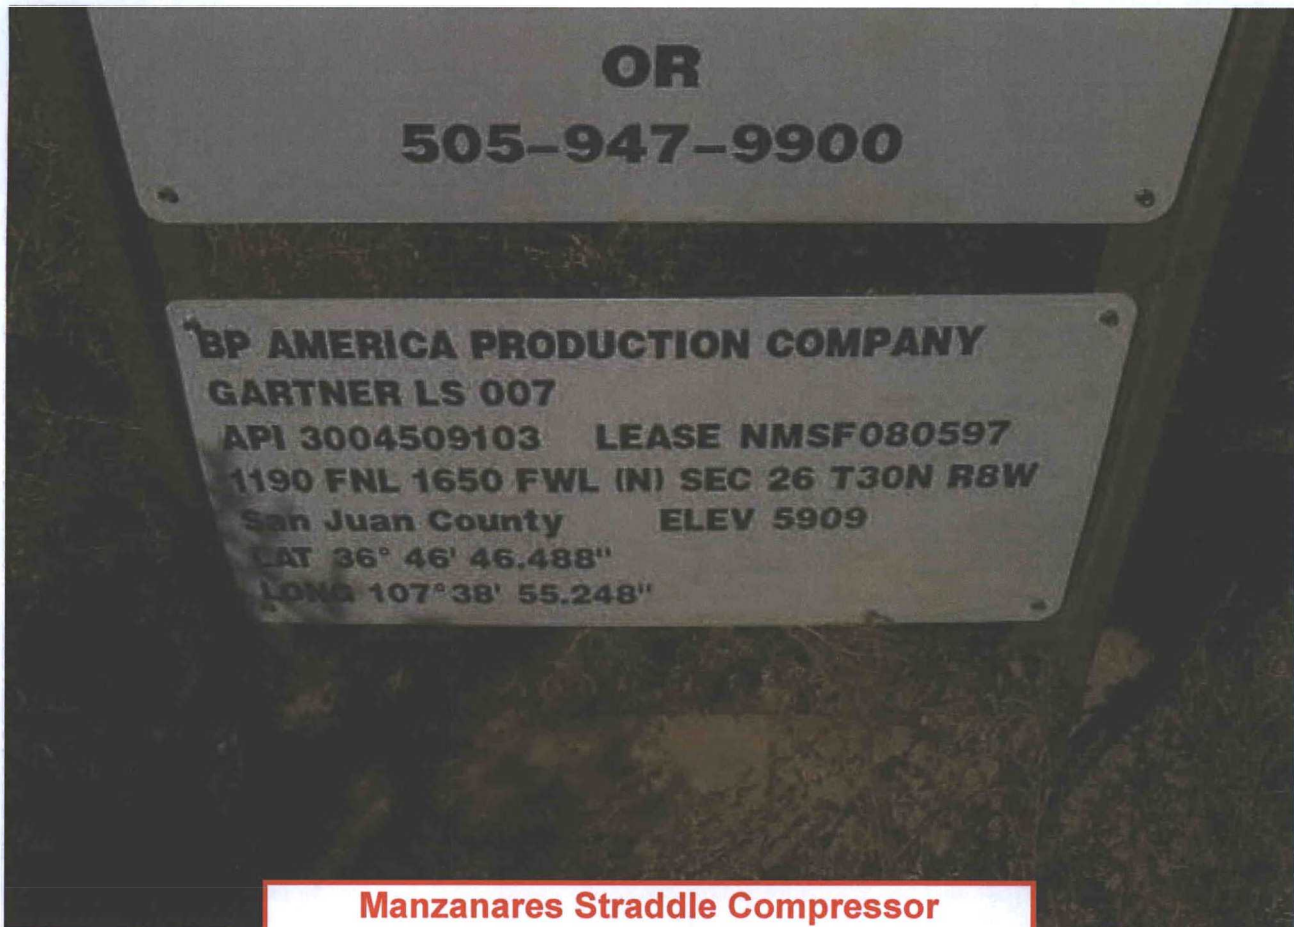
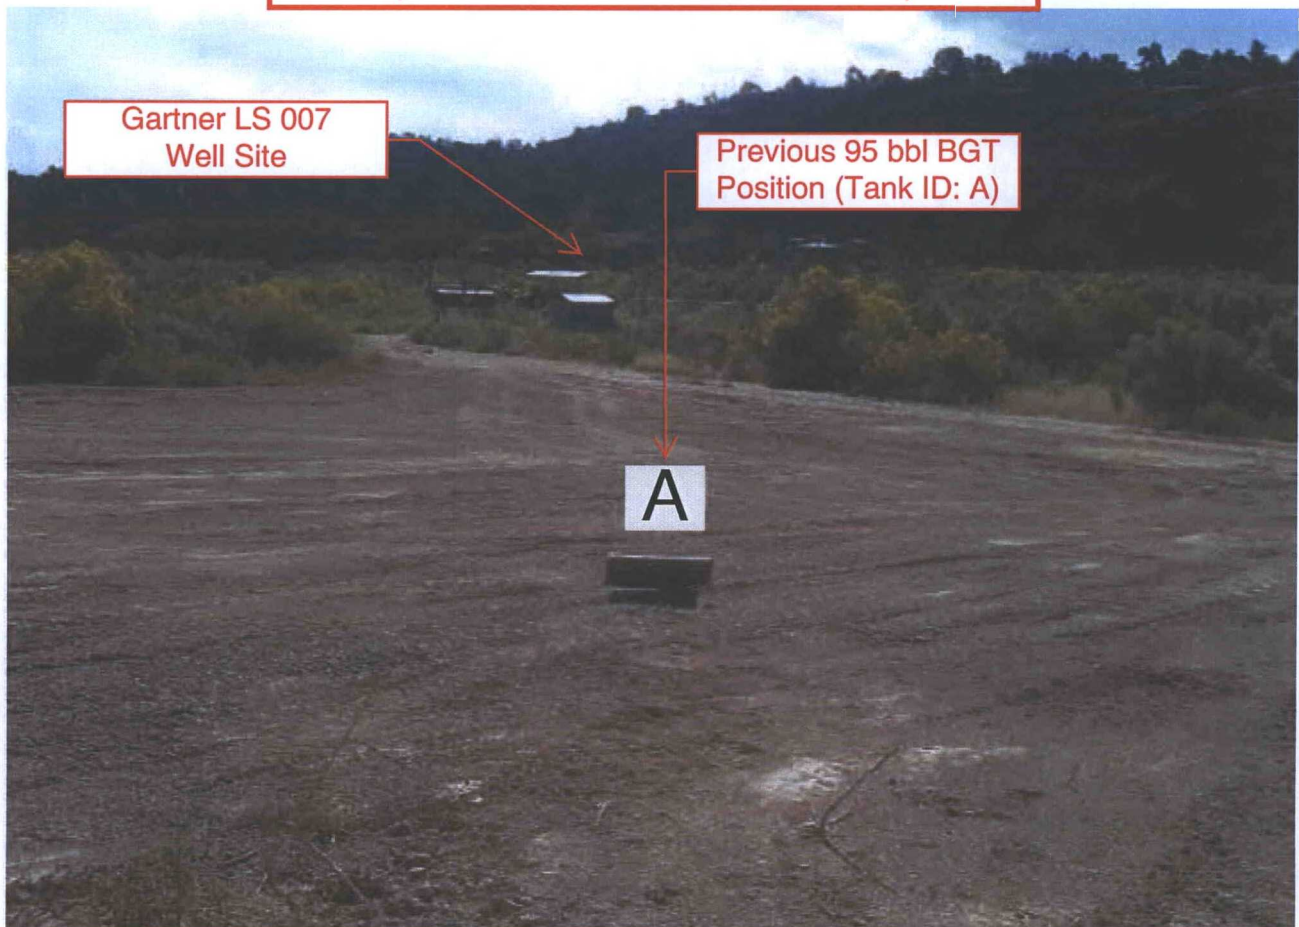
**Manzanares Straddle Compressor
(2017-08-01 BGT Closure Date)**

The area has been backfilled. The location will be reclaimed once the well is plugged and abandoned.
