Release Notification and Corrective Action

Name of Company - Phoenix Hydrocarbons	Contact - Billy Snead	
Address P. O. Box 3638 Midland, TX 79702	Telephone No. 432-686-9869	
Facility Name - LJU Waterflood	Facility Type LJU Injection Well #85	
Surface Owner - Woolworth Estate	Mineral Owner	Lease No. LC-032511

Field Analytical Report Form

Phoenix Hydrocarbons LJU Injection Well #85 Leak

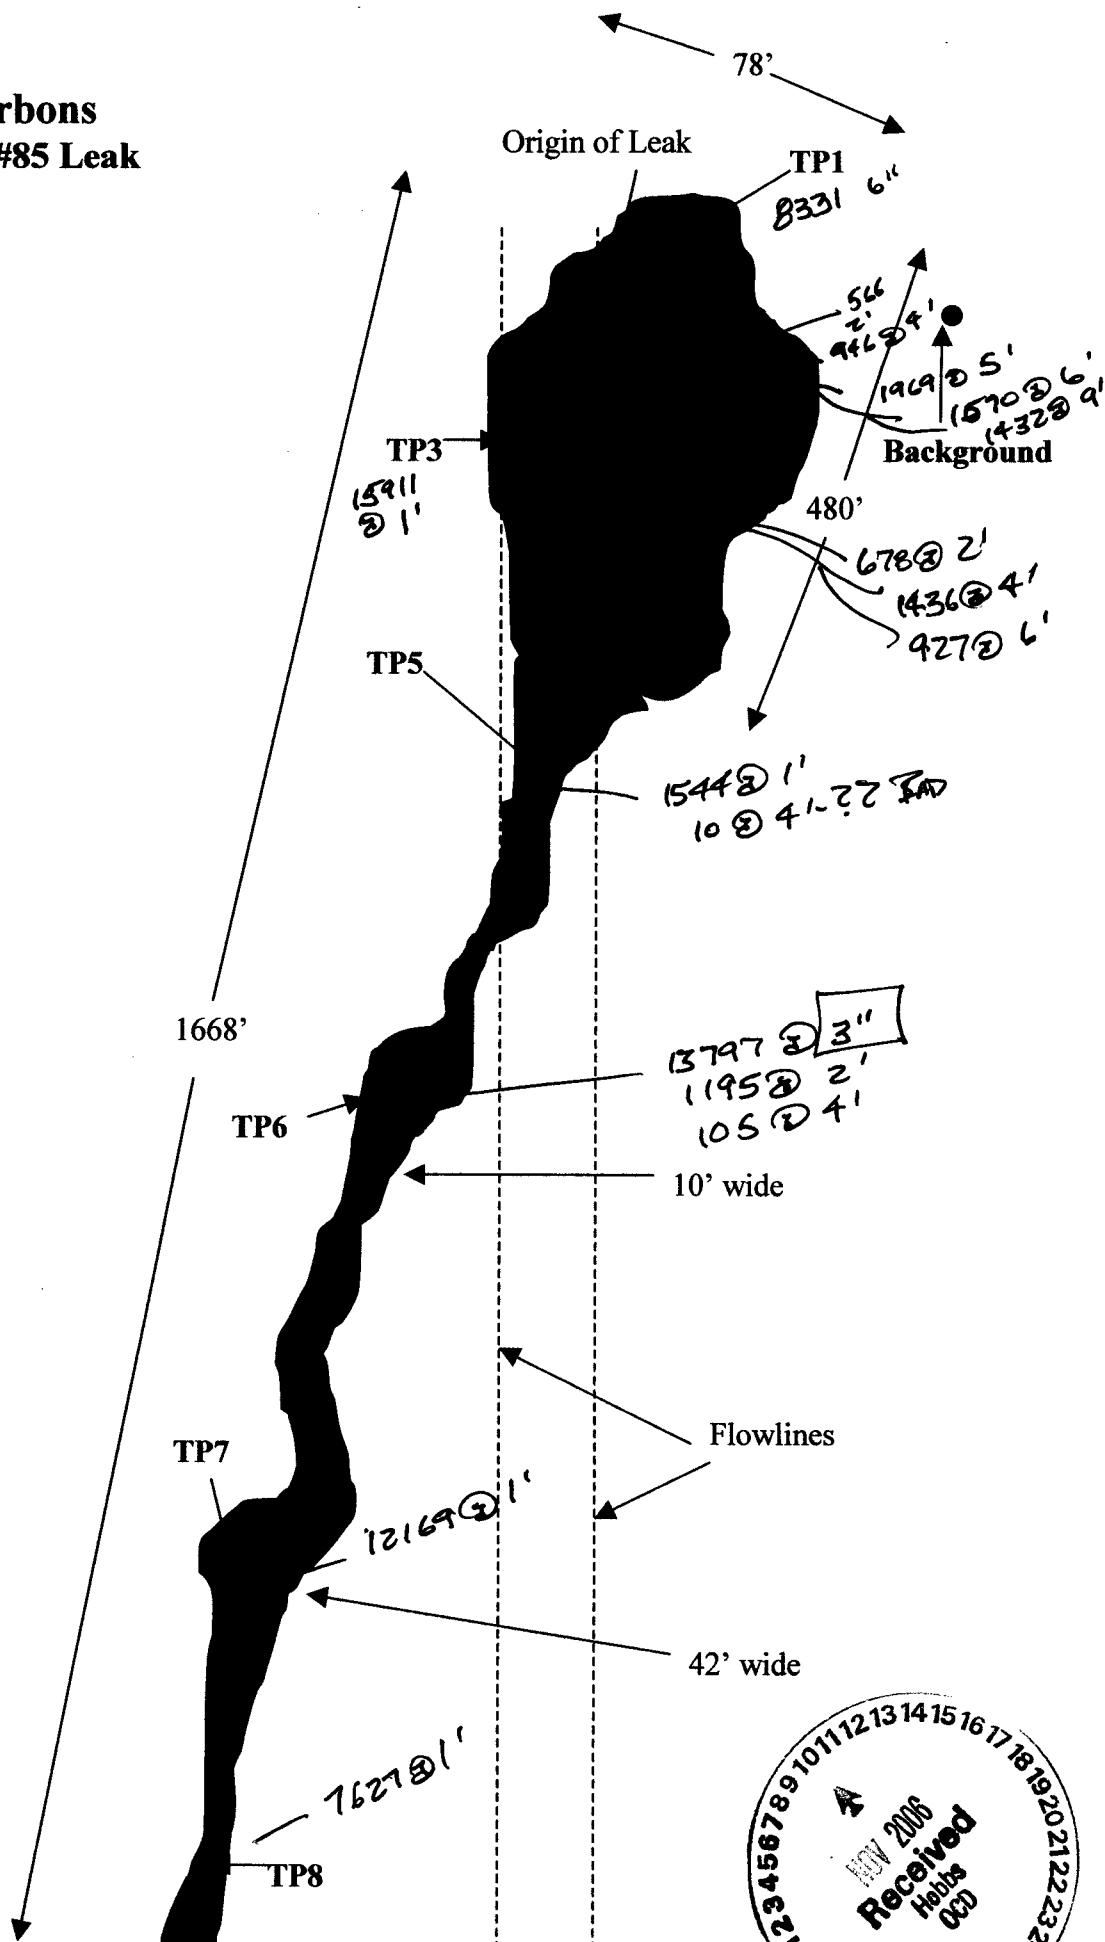
Describe Area Affected and Cleanup Action Taken. * Elke Environmental delineated the site, the plat map and analytical is attached. The top area (Red on plat map) will be excavated 3' deep and hauled to Sundance Disposal then a 20 mil impervious liner will be installed and 3' of fresh top soil will be backfilled. The bottom sloped area on the side of the hill (Blue on plat map) will be excavated 1' deep and hauled to Sundance disposal then backfilled with fresh top soil. A final closure report will be given at the end of the job. NMOCD will be given 48 hrs notice before any samples are taken.
