**TEXLAND PETROLEUM  
SHELTON #1  
UNIT F SECTION 29, TWS. 16 S., RNG. 38 E.**

**FINAL REPORT**

**Prepared By  
Eddie Seay Consulting  
August 2007**

RE: Texland Petroleum  
Shelton #1  
Spill

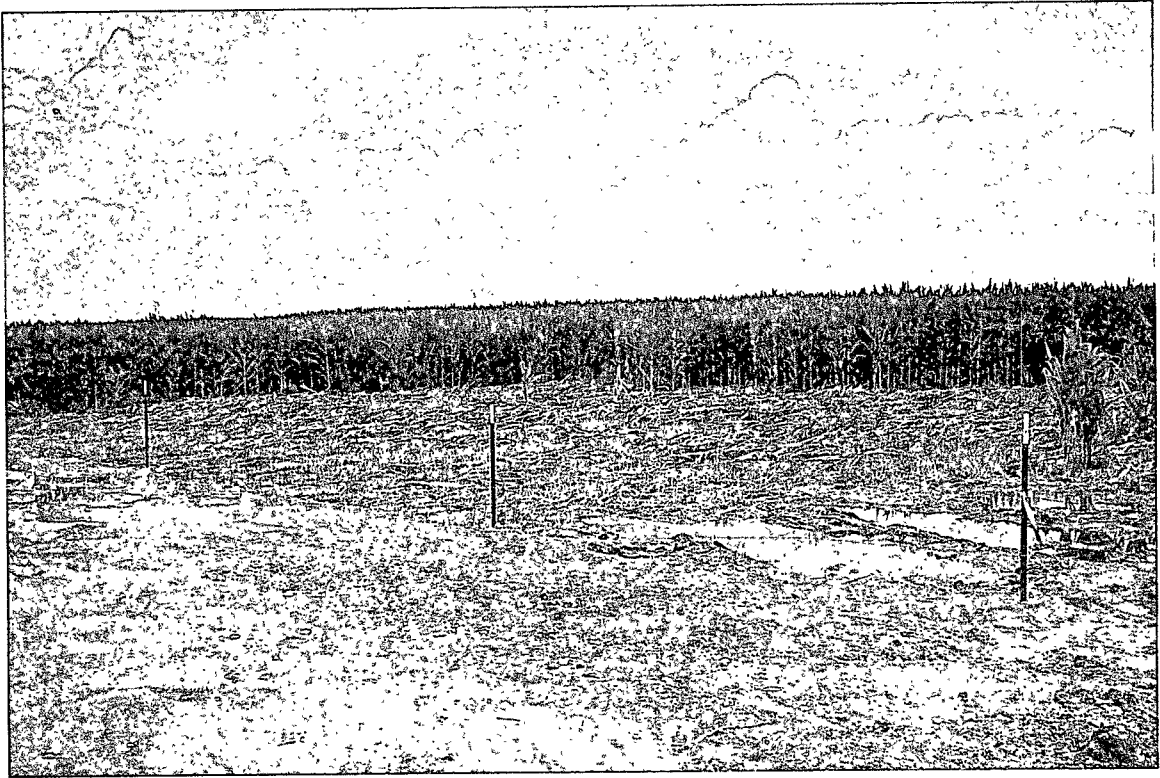
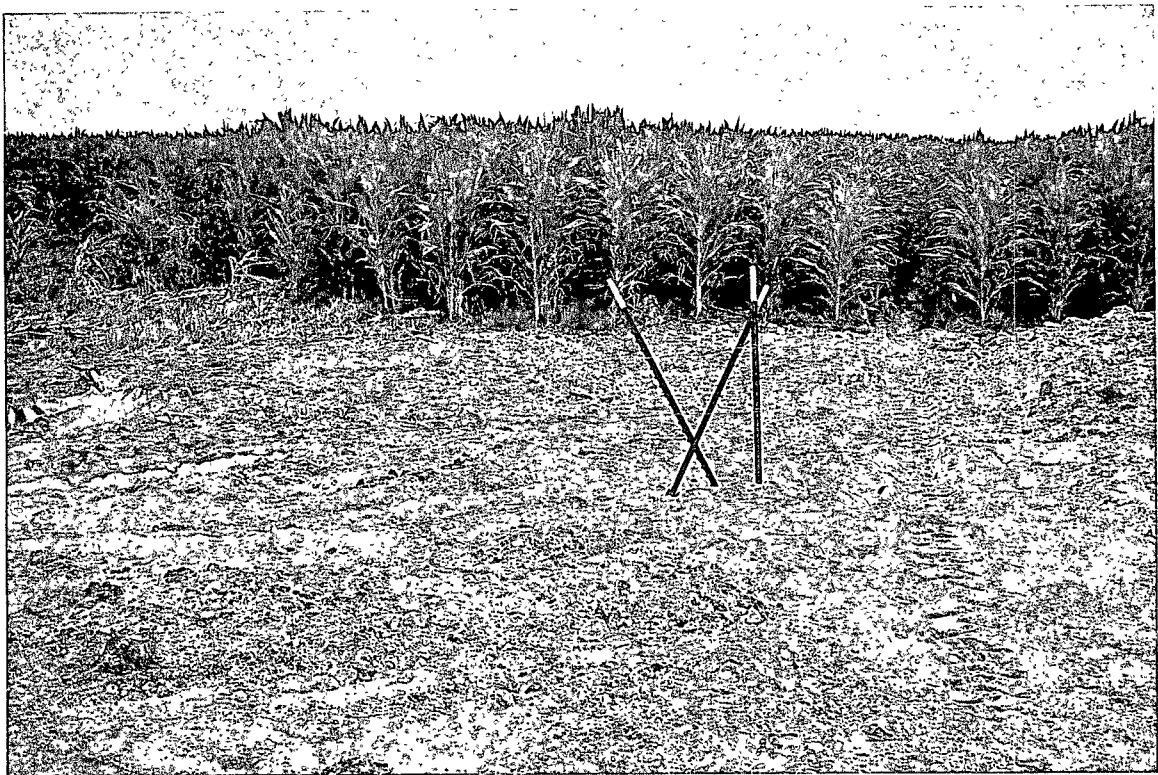
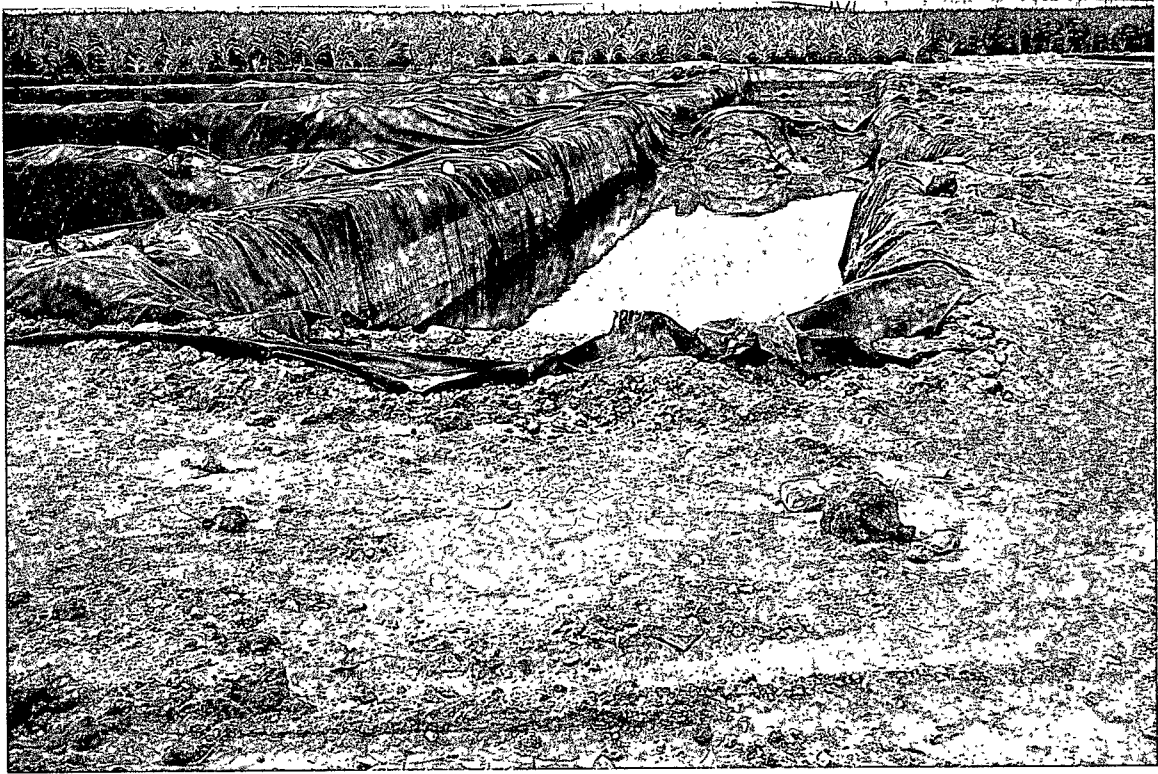
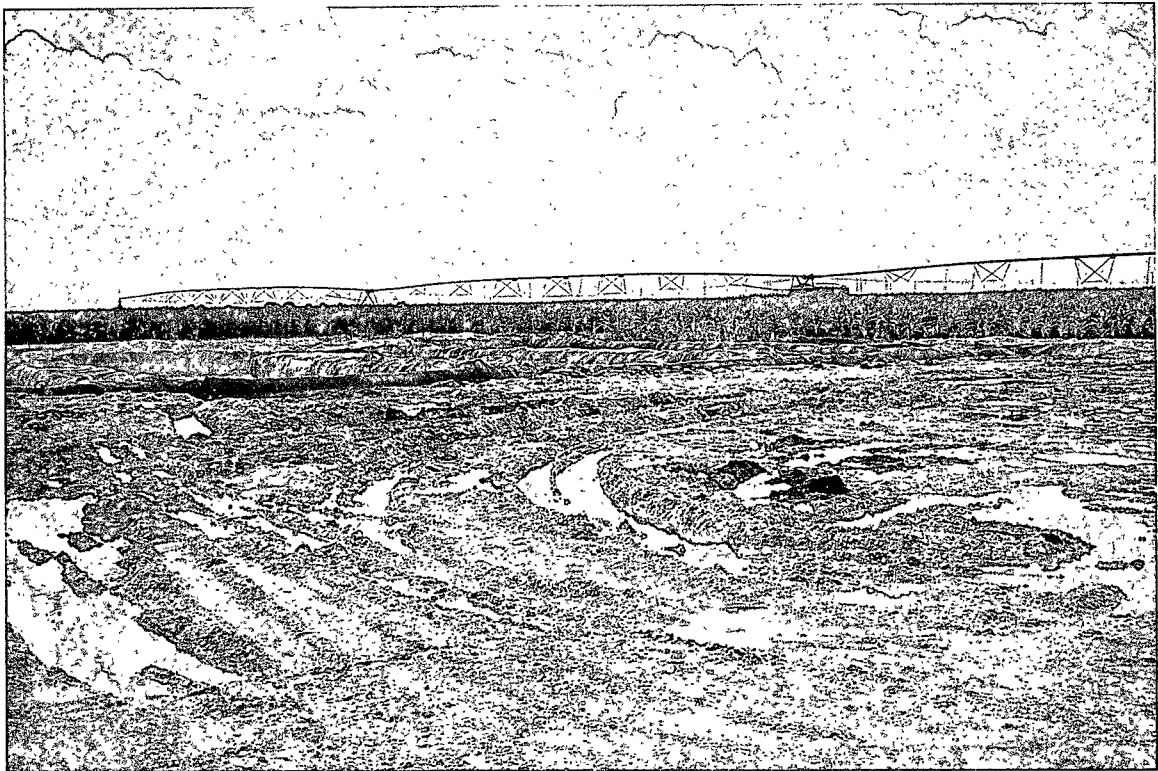
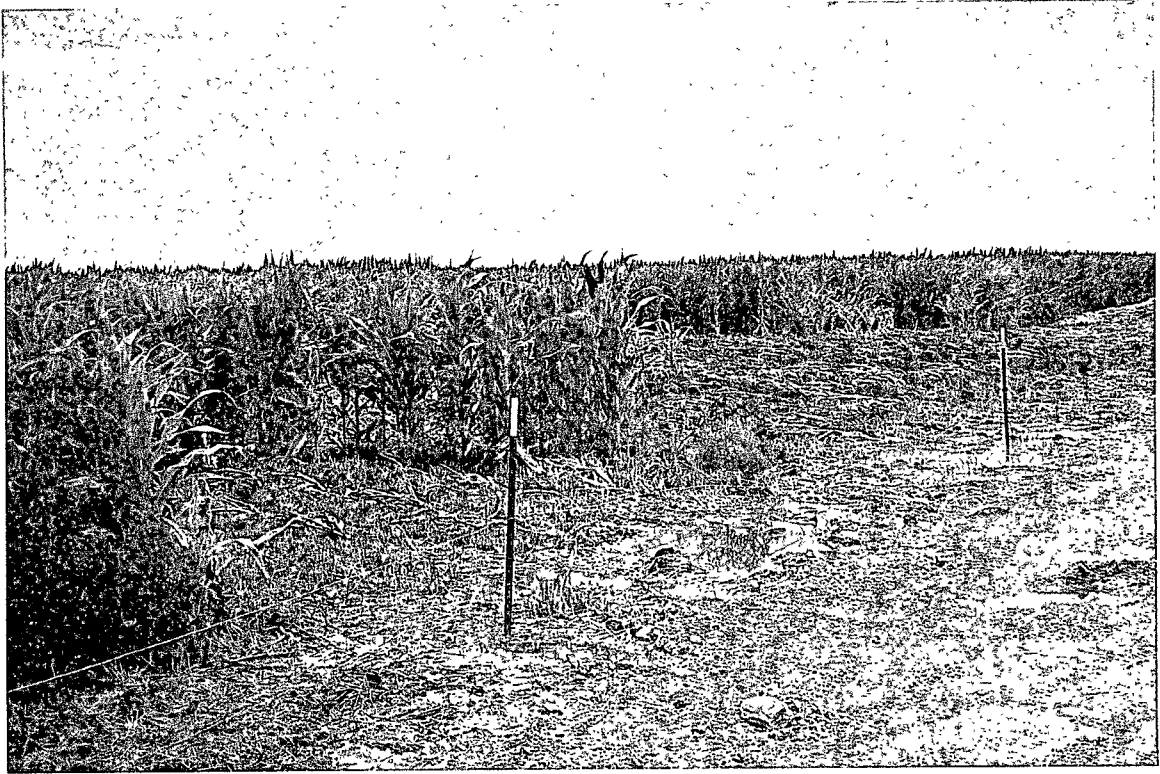
Before

Texland has completed the remediation from the minor spill at its Shelton #1 location. During the drilling of the well, the drilling company allowed the pits to run over into the adjacent pasture. It was estimated that approximately ten barrels of salt water covered an area of 30' x 60'.

Rig crew left centrifugal pump running unmanaged causing the working pit to overflow into surrounding corn field.  
Pump was turned off; water was absorbed by soil and has since dried.  
NOTE: Texland Petroleum-Hobbs was not notified of the incident until 12:00 noon 6/30/07

An Approx 30' half circle of the farmer's corn field was affected, south side of location.  
The top soil will be excavated as soon as possible by a dozer until a soil sample shows the contaminated soil had been removed.

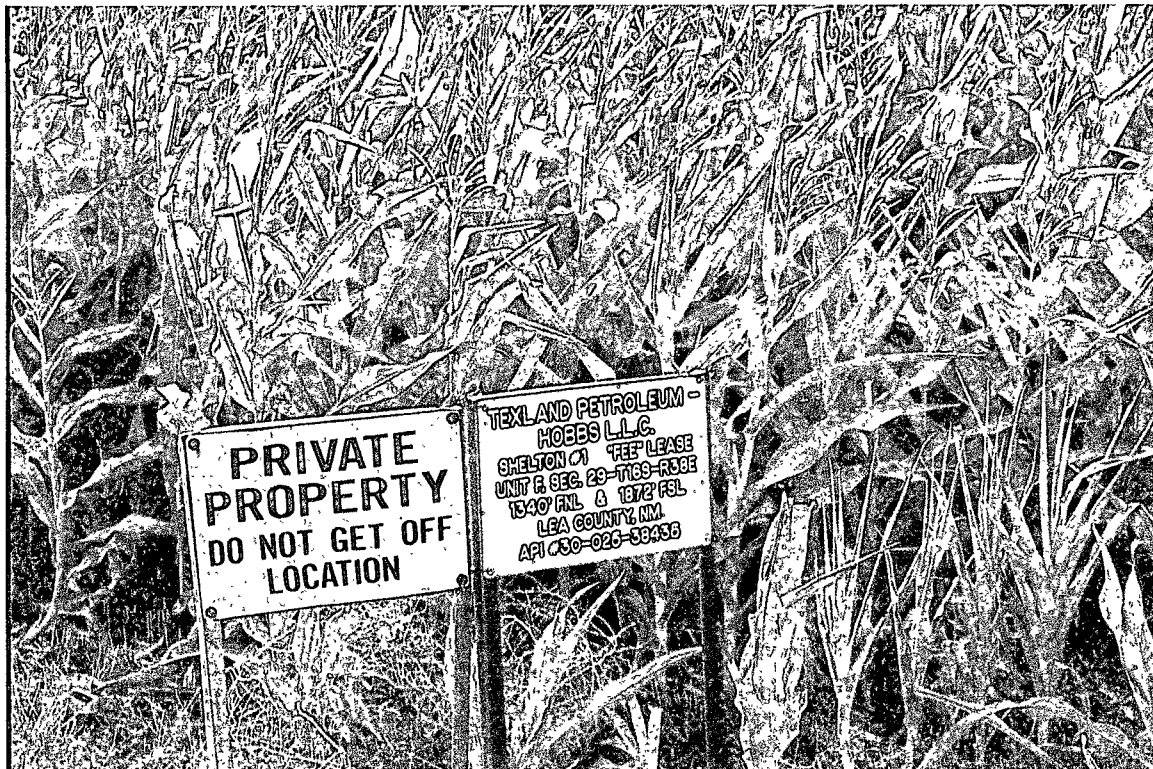
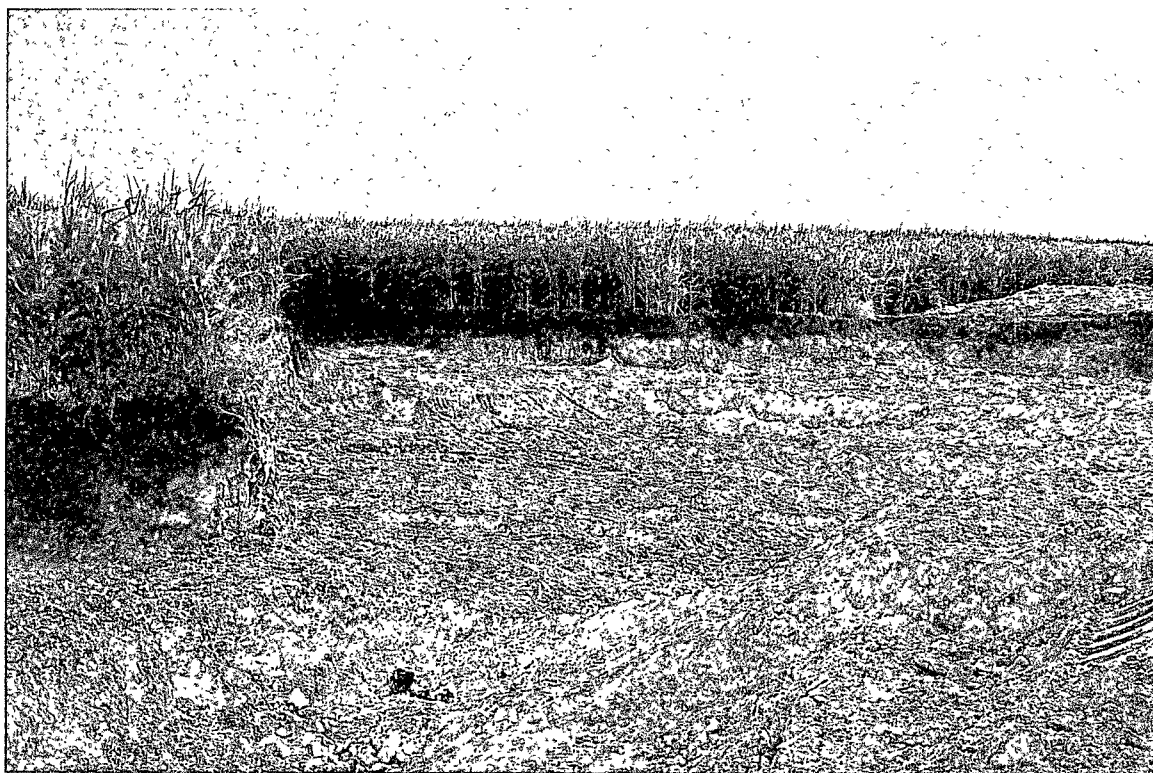
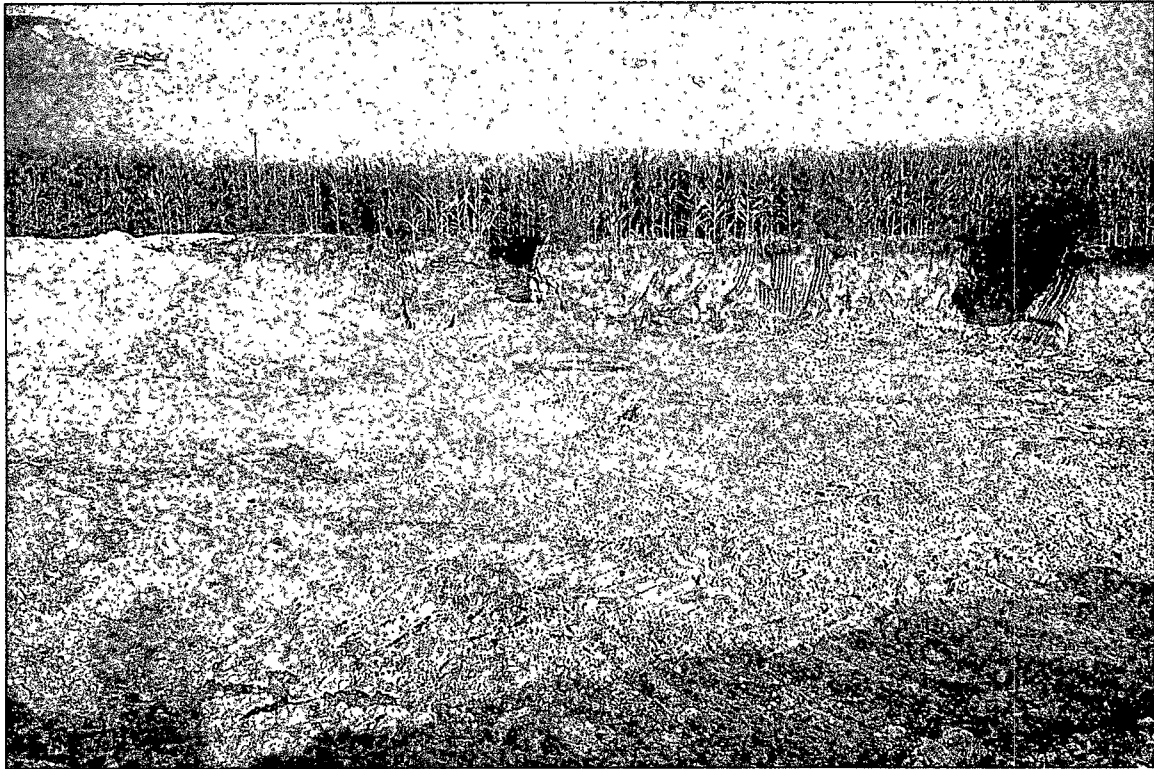
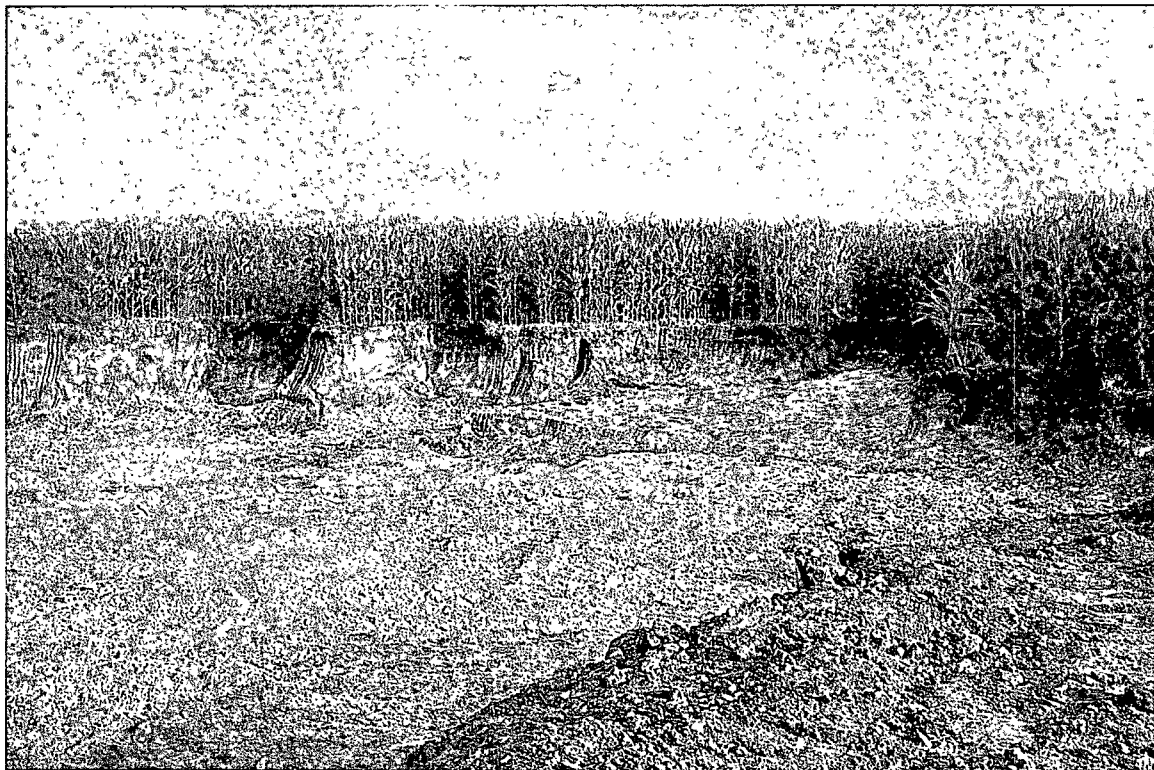
The area was excavated and a total of 1900 cu. yds. was hauled to Sundance Disposal. After sampling and getting analytical approved, the excavation was backfilled and leveled. This concludes the work at this site. A new C-141 is attached with appropriate documentation.

Describe Area Affected and Cleanup Action Taken.\*  
area 30x60 was excavated + hauled to Sundance, bottoms + sides  
were sampled and approved. The excavated area was backfilled with soil  
from Hughes property.
