BD Jct K-7-3

CLOSURE

RICE OPERATING COMPANY
JUNCTION BOX FINAL REPORT

BD jct. K-7-3

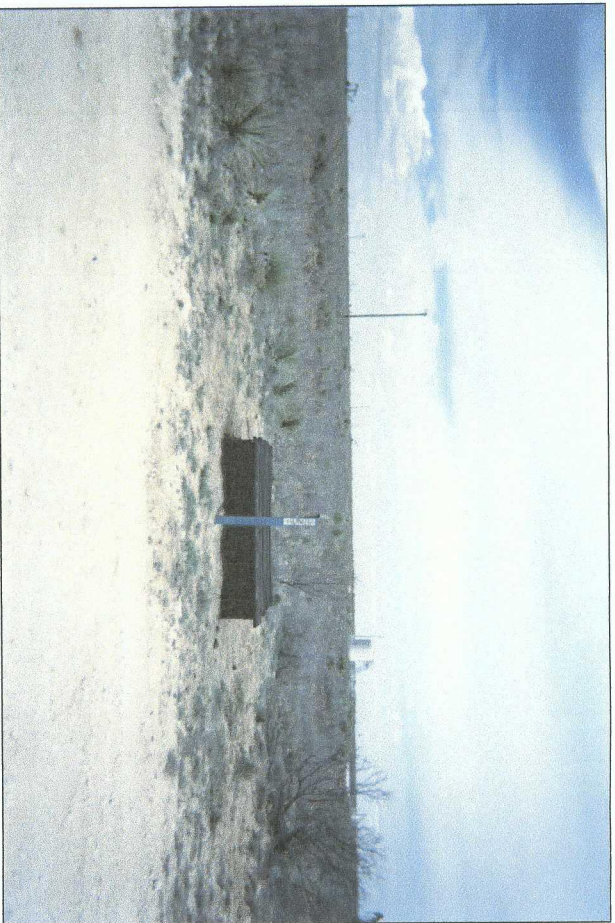
4/2/2004

undisturbed junction box

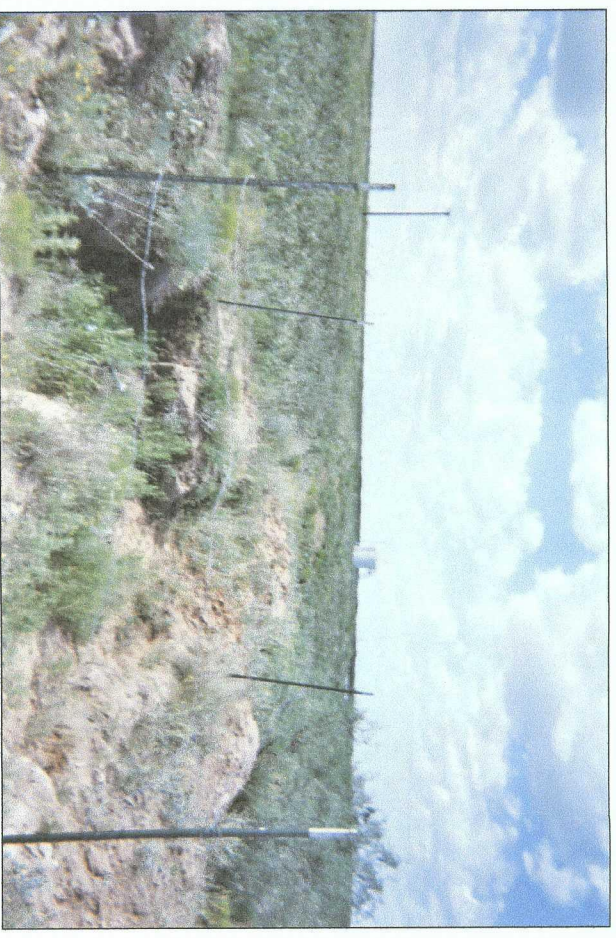
6/21/2007

former junction box site

Once the box lumber was removed from the former site, the location was inspected for chloride and hydrocarbon impact. The soils at and around the site were of a brown sand type and did not exhibit any staining or other signs of adverse impact. The surrounding surface has a healthy vegetation cover and does not appear to be stressed. Field tests on the soil samples confirmed that chloride were very low, similar to those of background. Confirmation samples were analyzed at a certified laboratory. The 4 x 4 x 3-ft hole was backfilled and the disturbed surface area was seeded with a blend of native vegetation on 7/13/2007 and is expected to return to productive capacity at a normal rate.

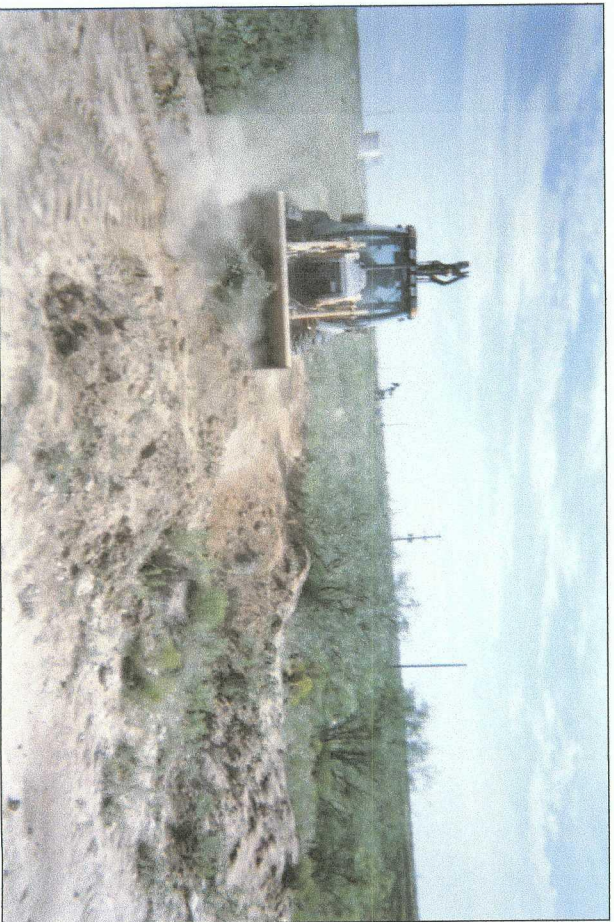
7/13/2007

backfilling hole

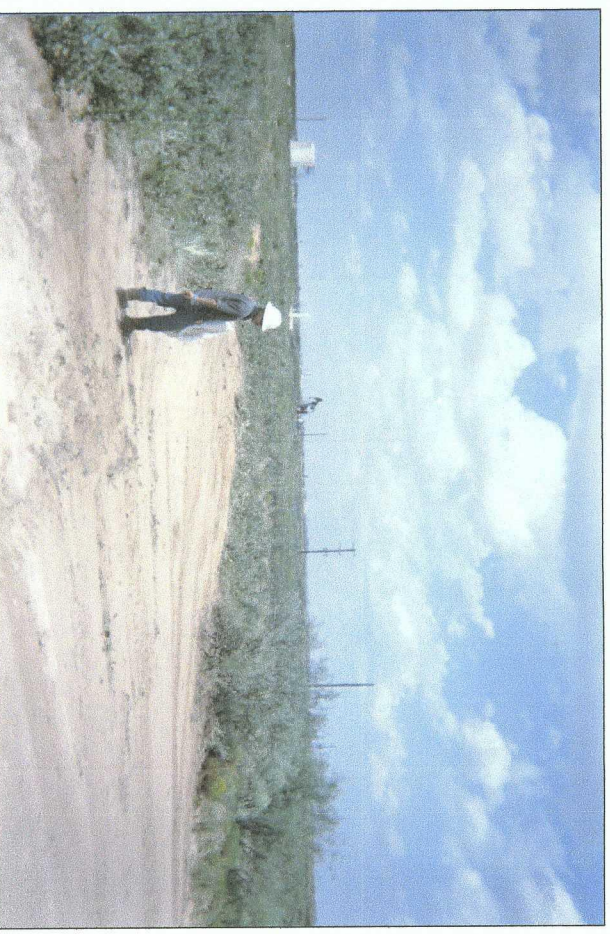
7/13/2007

seeding disturbed area of backfilled site
