BD Jct G-3-1

**RICE OPERATING COMPANY  
JUNCTION BOX DISCLOSURE\* REPORT**

## BD Jct. G-3-1

Unit G, Section 3, T22S, R37E

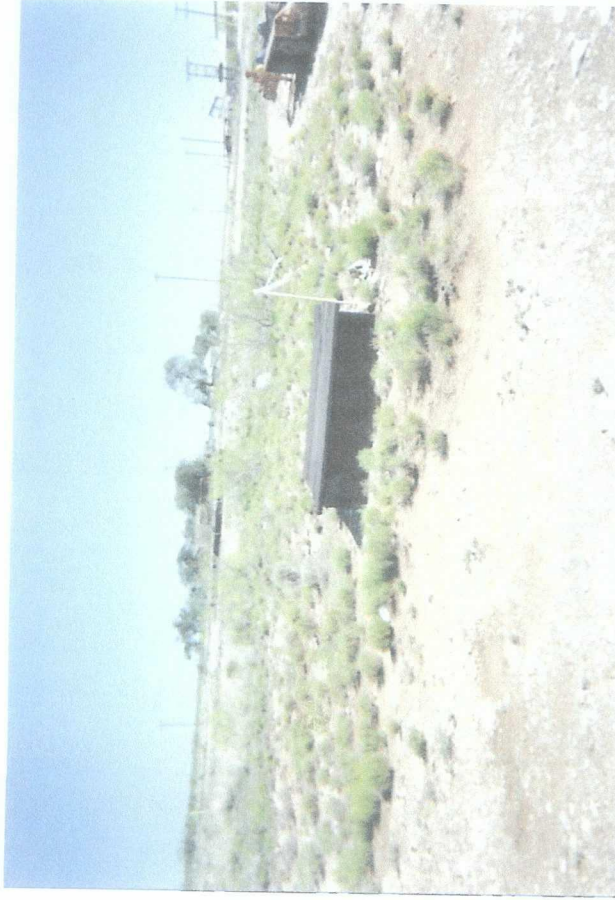
5/3/2007

undisturbed junction box, facing north

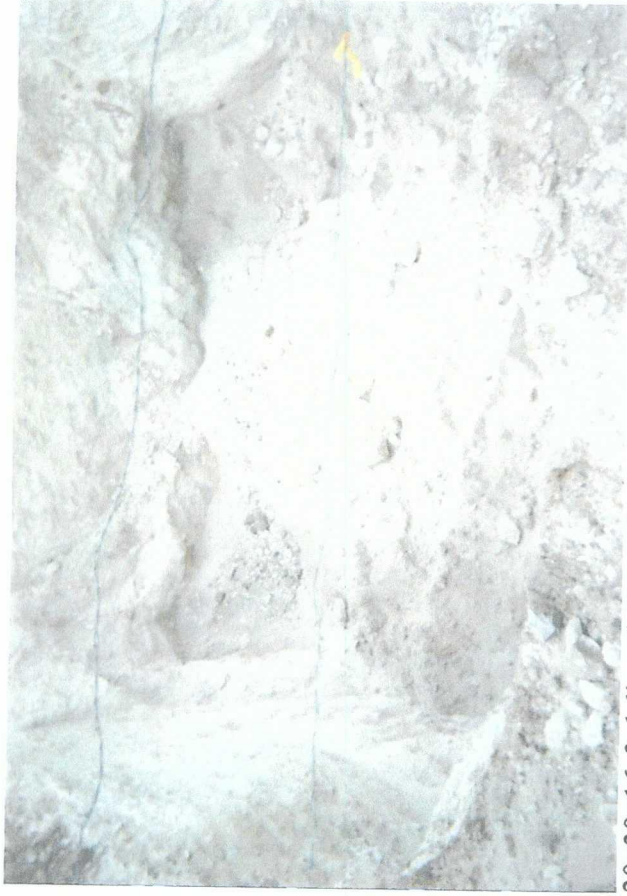
6/7/2007

30x30x16-ft delineation trench

**General Description of Remedial Action:** This junction box was eliminated under the pipeline replacement/upgrade program. After the former box was removed, an investigation was conducted using a backhoe to collect soil samples at regular intervals producing a 30x30x16-ft-deep hole. Chloride field tests were performed on each sample, which yielded chloride concentrations that did not sufficiently relent with depth. Organic vapors were measured using a PID, which also yielded elevated concentrations. Representative composite samples were sent to a commercial laboratory for analysis of chloride, TPH, and BTEX. The excavated soil was blended on-site, returned to the excavation, and contoured to the surrounding area. On 6/18/2007, the site was seeded with a blend of native vegetation and is expected to return to a productive capacity at a normal rate. NMOCD was notified of potential groundwater impact on 10/22/2008.

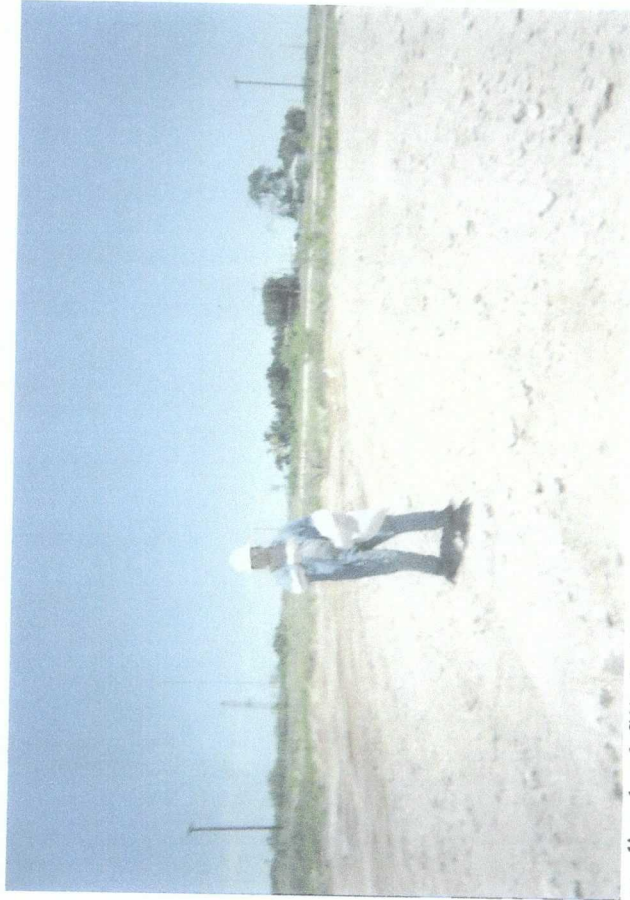
6/18/2007

seeding backfilled site

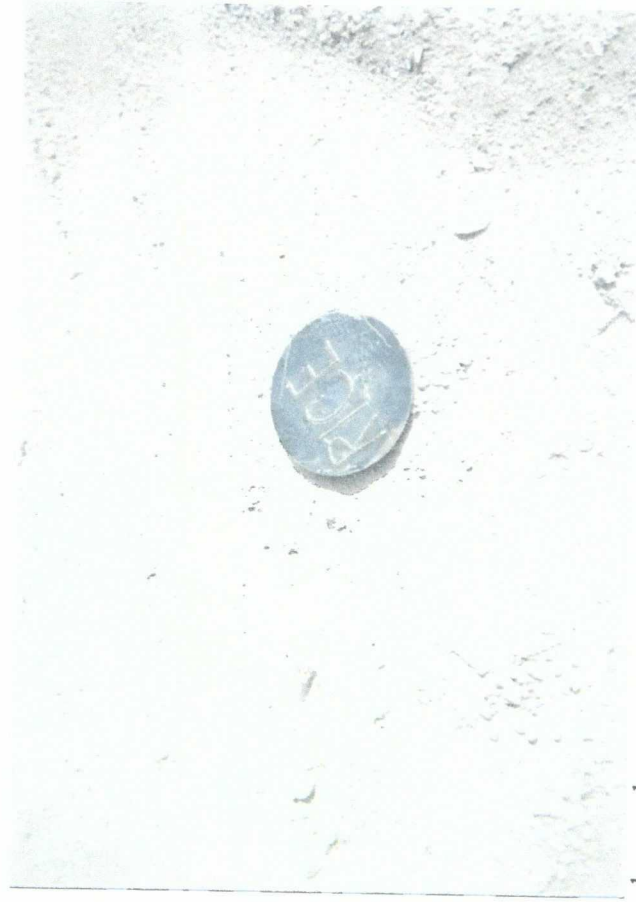
6/25/2007

clay marker
