Release Notification and Corrective Action

Name of Company: Targa Midstream Services L P	Contact: James Lingnau 575.394.2534, Chuck Tolsma 575.631.6026
Address: PO Box 1909 Eunice, NM 88231	Telephone No. (575) 394-2534
Facility Name: Eunice Gas Plant	Facility Type: Natural Gas Gathering System

J. D. MARTIN 20"

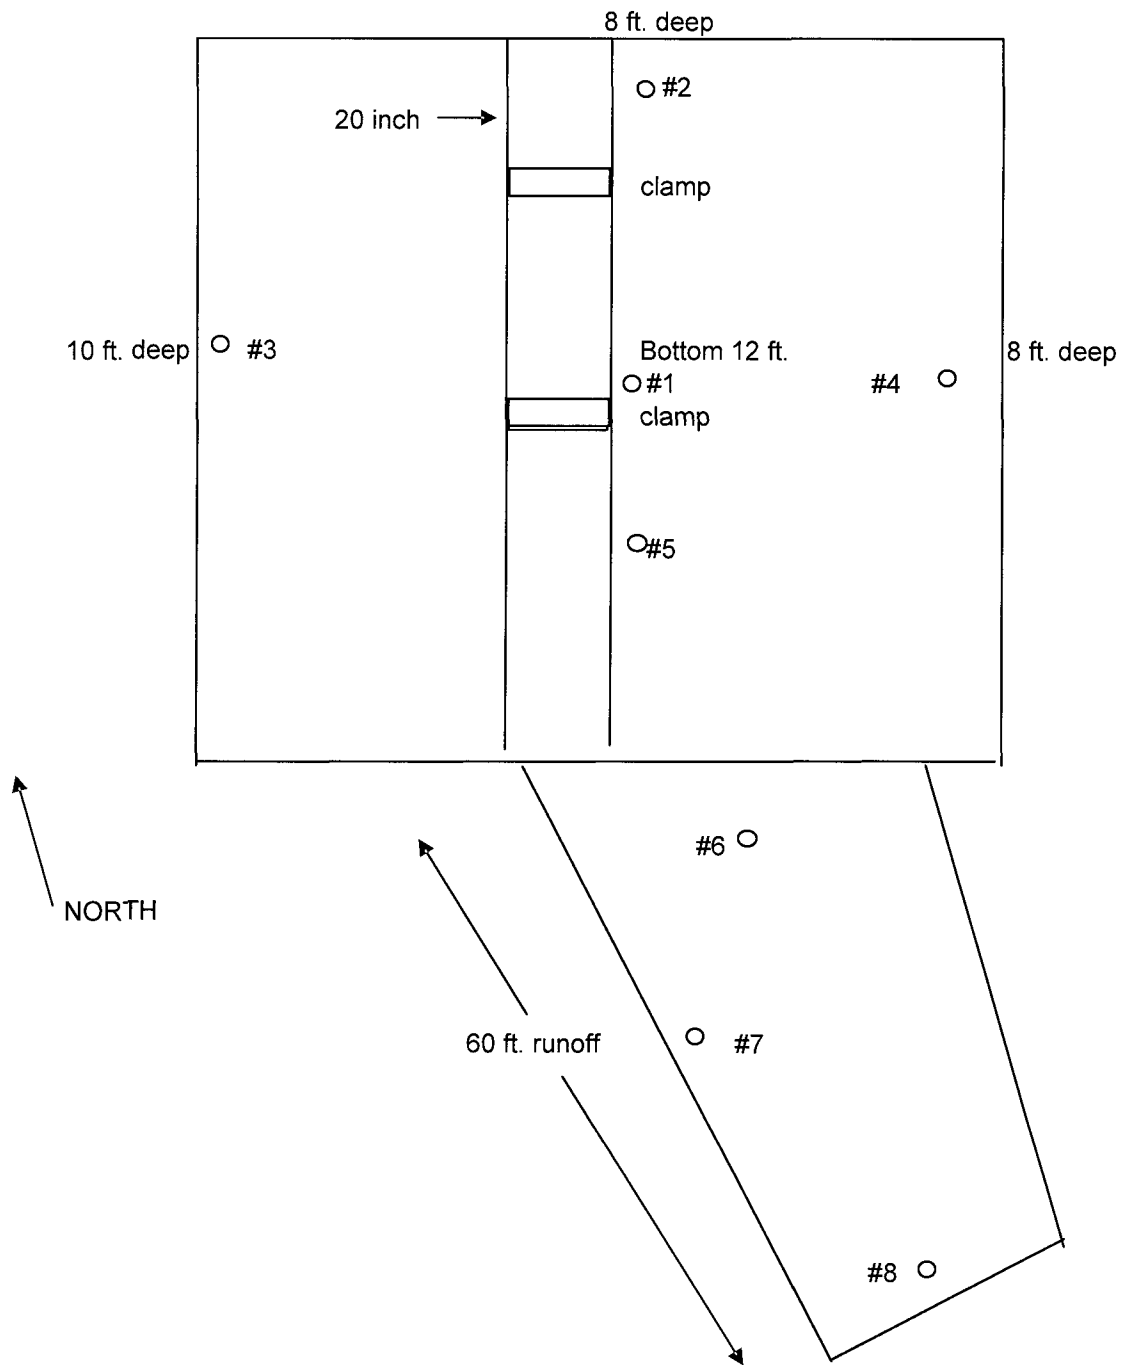
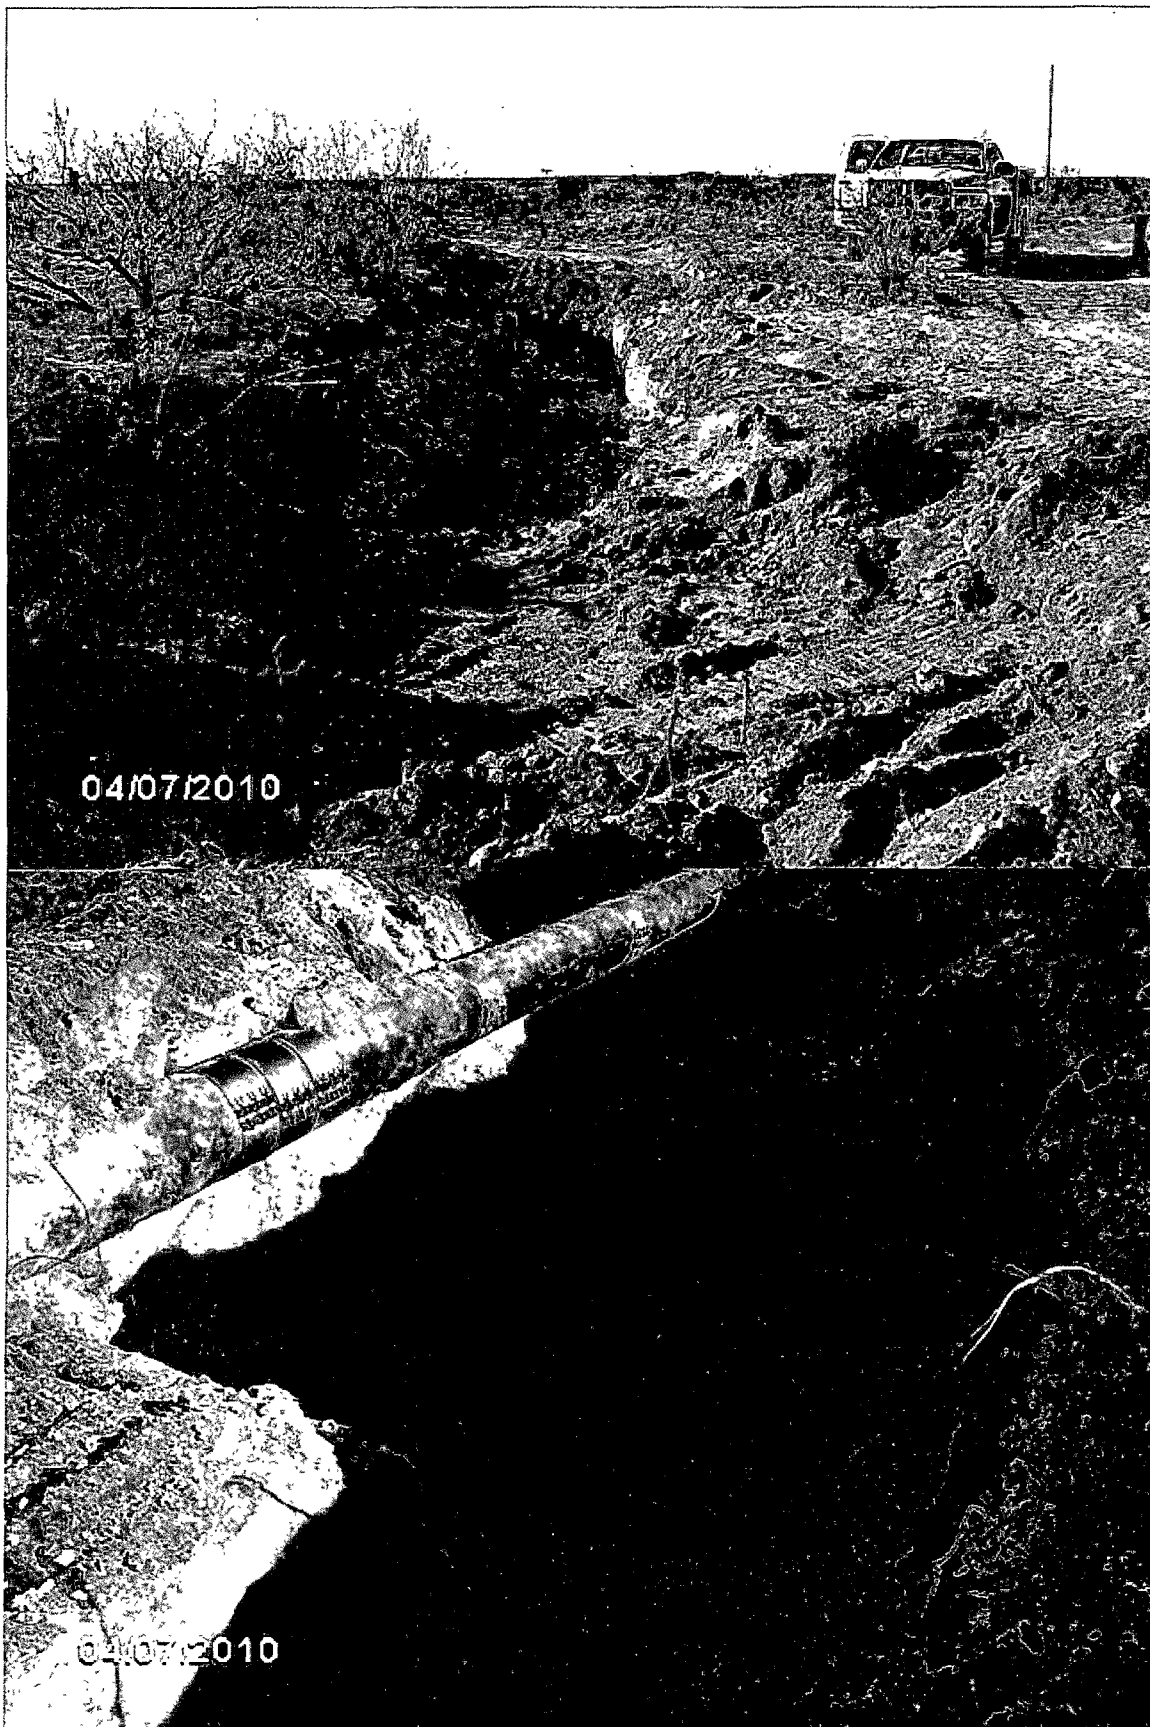
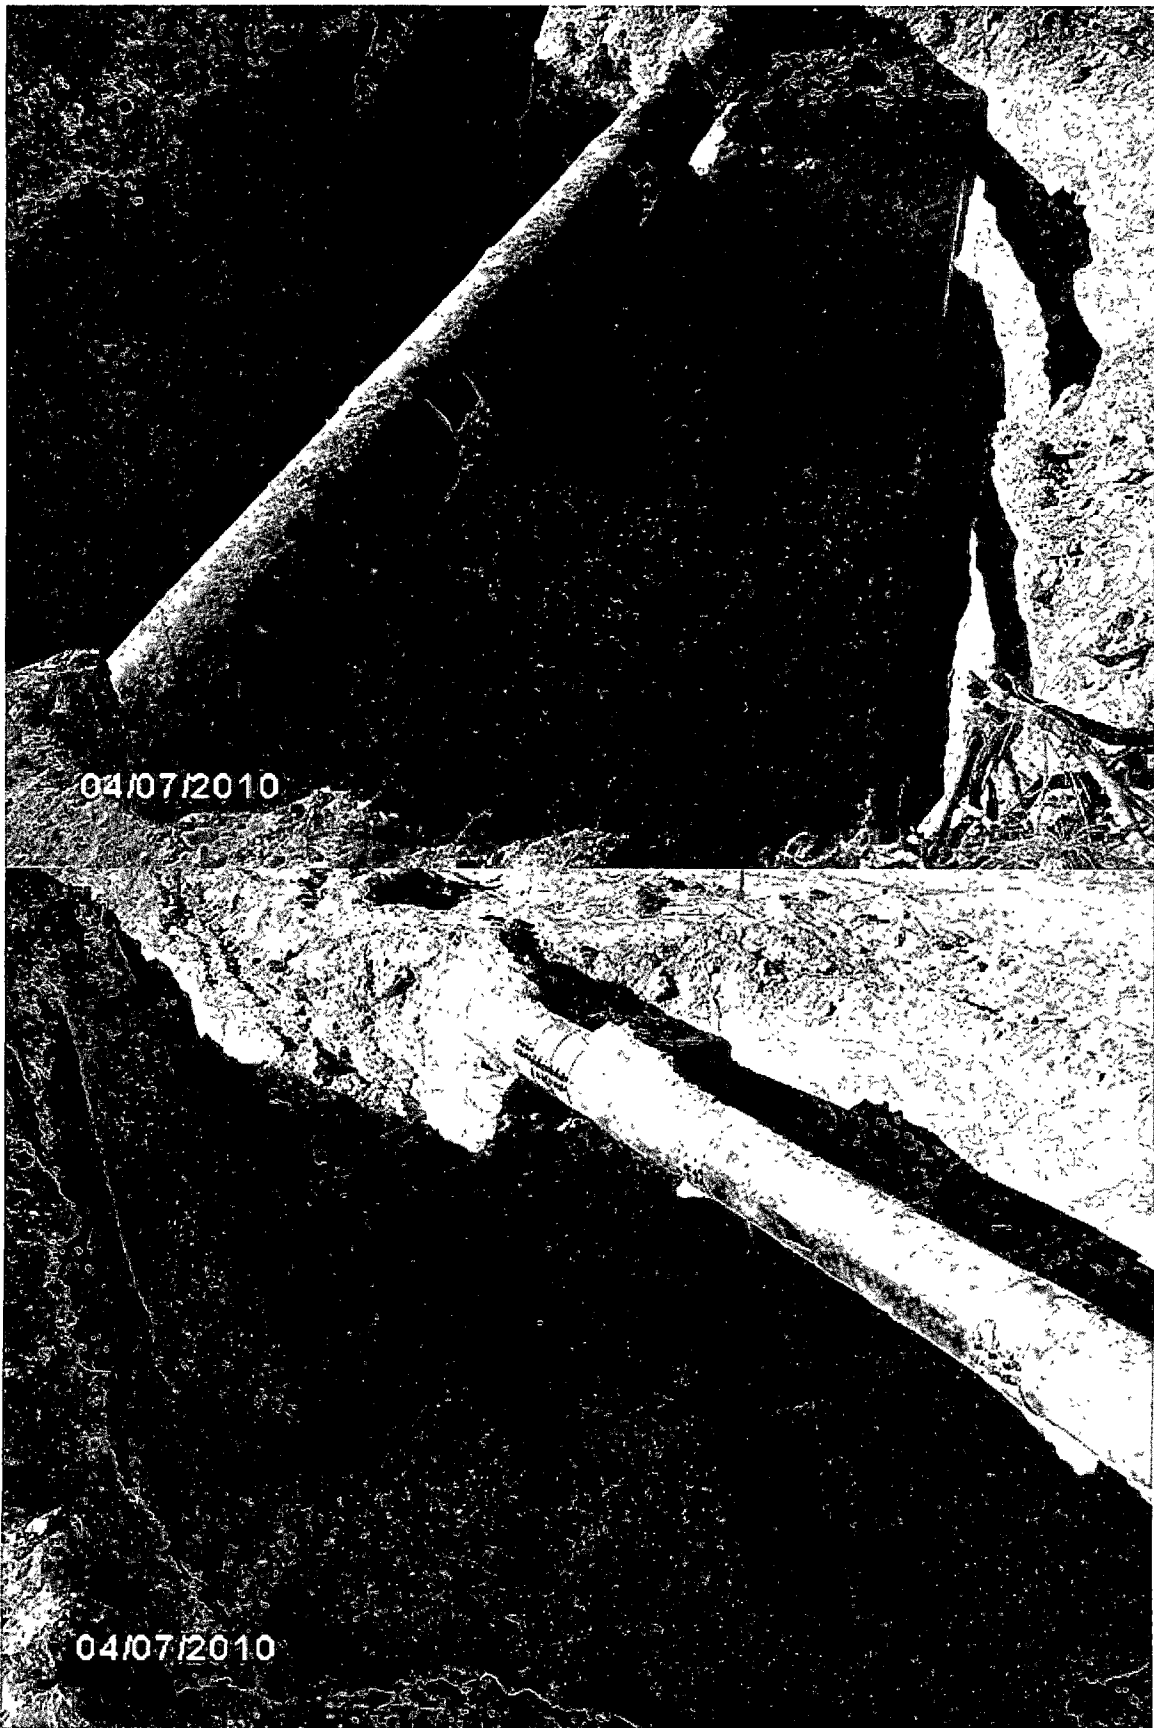
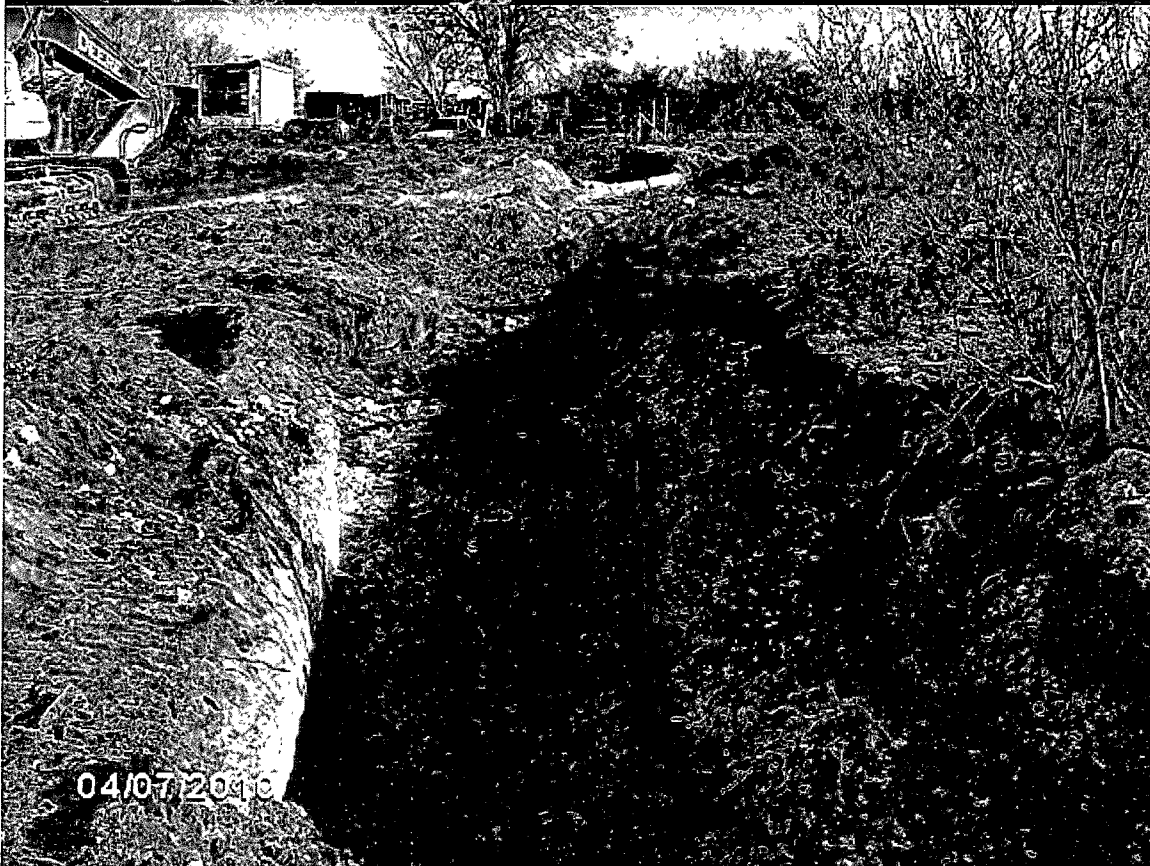
JD MARTIN 20"

20 inch natural gas gathering line developed a 1 inch hole from corrosion. Line was excavated and leak repaired. Contaminated soil will be excavated and disposed of in an OCD approved landfarm.

The area affected was excavated and 396 yards of contaminated soil disposed of. New soil will be used to fill excavation upon closure approval. Area has been cleaned and sampled to insure compliance with OCD guidelines.
