CHESAPEAKE / PONDEROSA 20 site NO. 1

RE: PONDEROSA 20 STATE #1

Received:	03/10/2011	Sampling Date:	03/09/2011
Reported:	03/17/2011	Sampling Type:	Soil
Project Name:	PONDEROSA 20 STATE #1	Sampling Condition:	Cool & Intact
Project Number:	NONE GIVEN	Sample Received By:	Jodi Henson
Project Location:	LOCO HILLS, NM

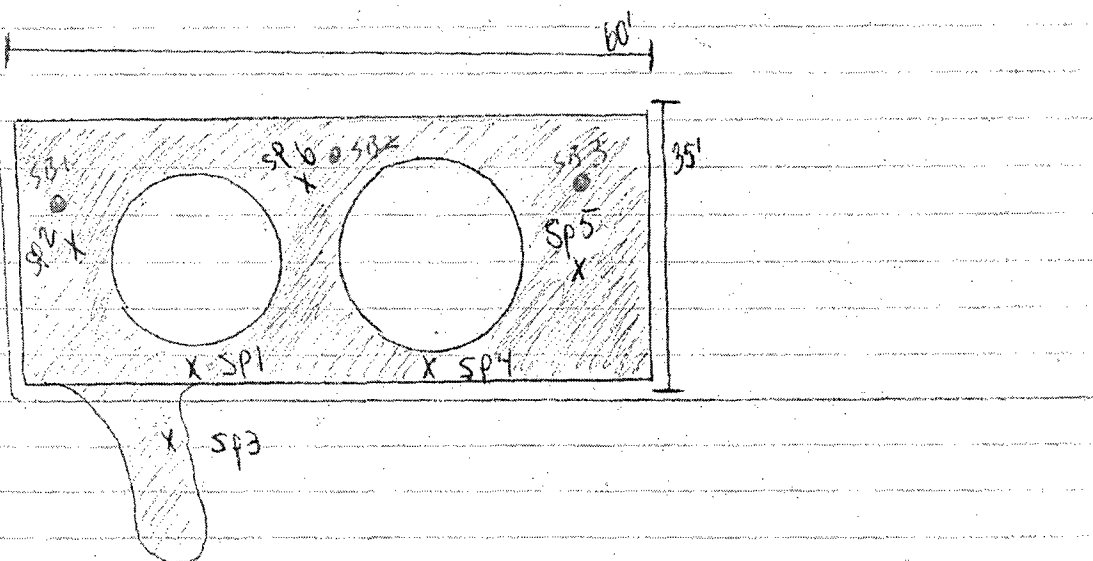
GPS

SP1	N. 32. 72977°	N. 104. 19442°
2	N. 32. 72976°	N. 104. 19445°
3	N. 32. 72966°	N. 104. 19437°
4	N. 32. 72978°	N. 104. 19437°
5	N. 32. 72987°	N. 104. 19432°
6	N. 32. 72975°	N. 104. 19446°
