Corbin; Bone Spring, South Pool (Pool Code: 13160) Structure Map (Top 2nd Bone Spring Subsea)

Eland 32-18S-33E RN State Com #124H

BEFORE THE OIL CONSERVATION
DIVISION
Santa Fe, New Mexico
Exhibit No. 8
Submitted by: MATADOR PRODUCTION
Hearing Date: August 4, 2016

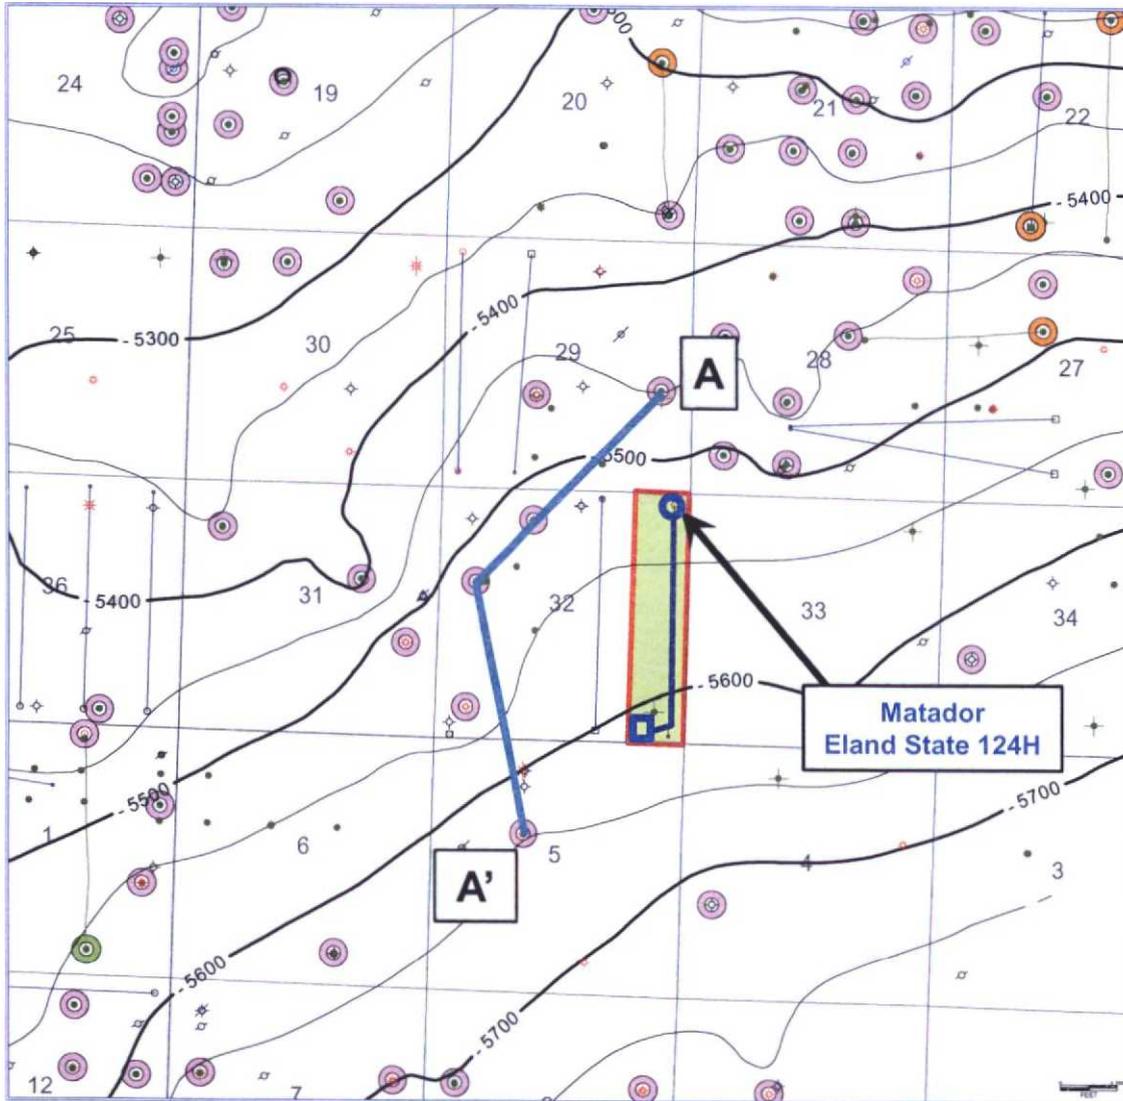
C.I. = 50'
