Robert L. Bayless, Producer LLC

East Horseshoe Gallup Unit
 San Juan County, New Mexico
 Plan of Development

EXHIBIT 4

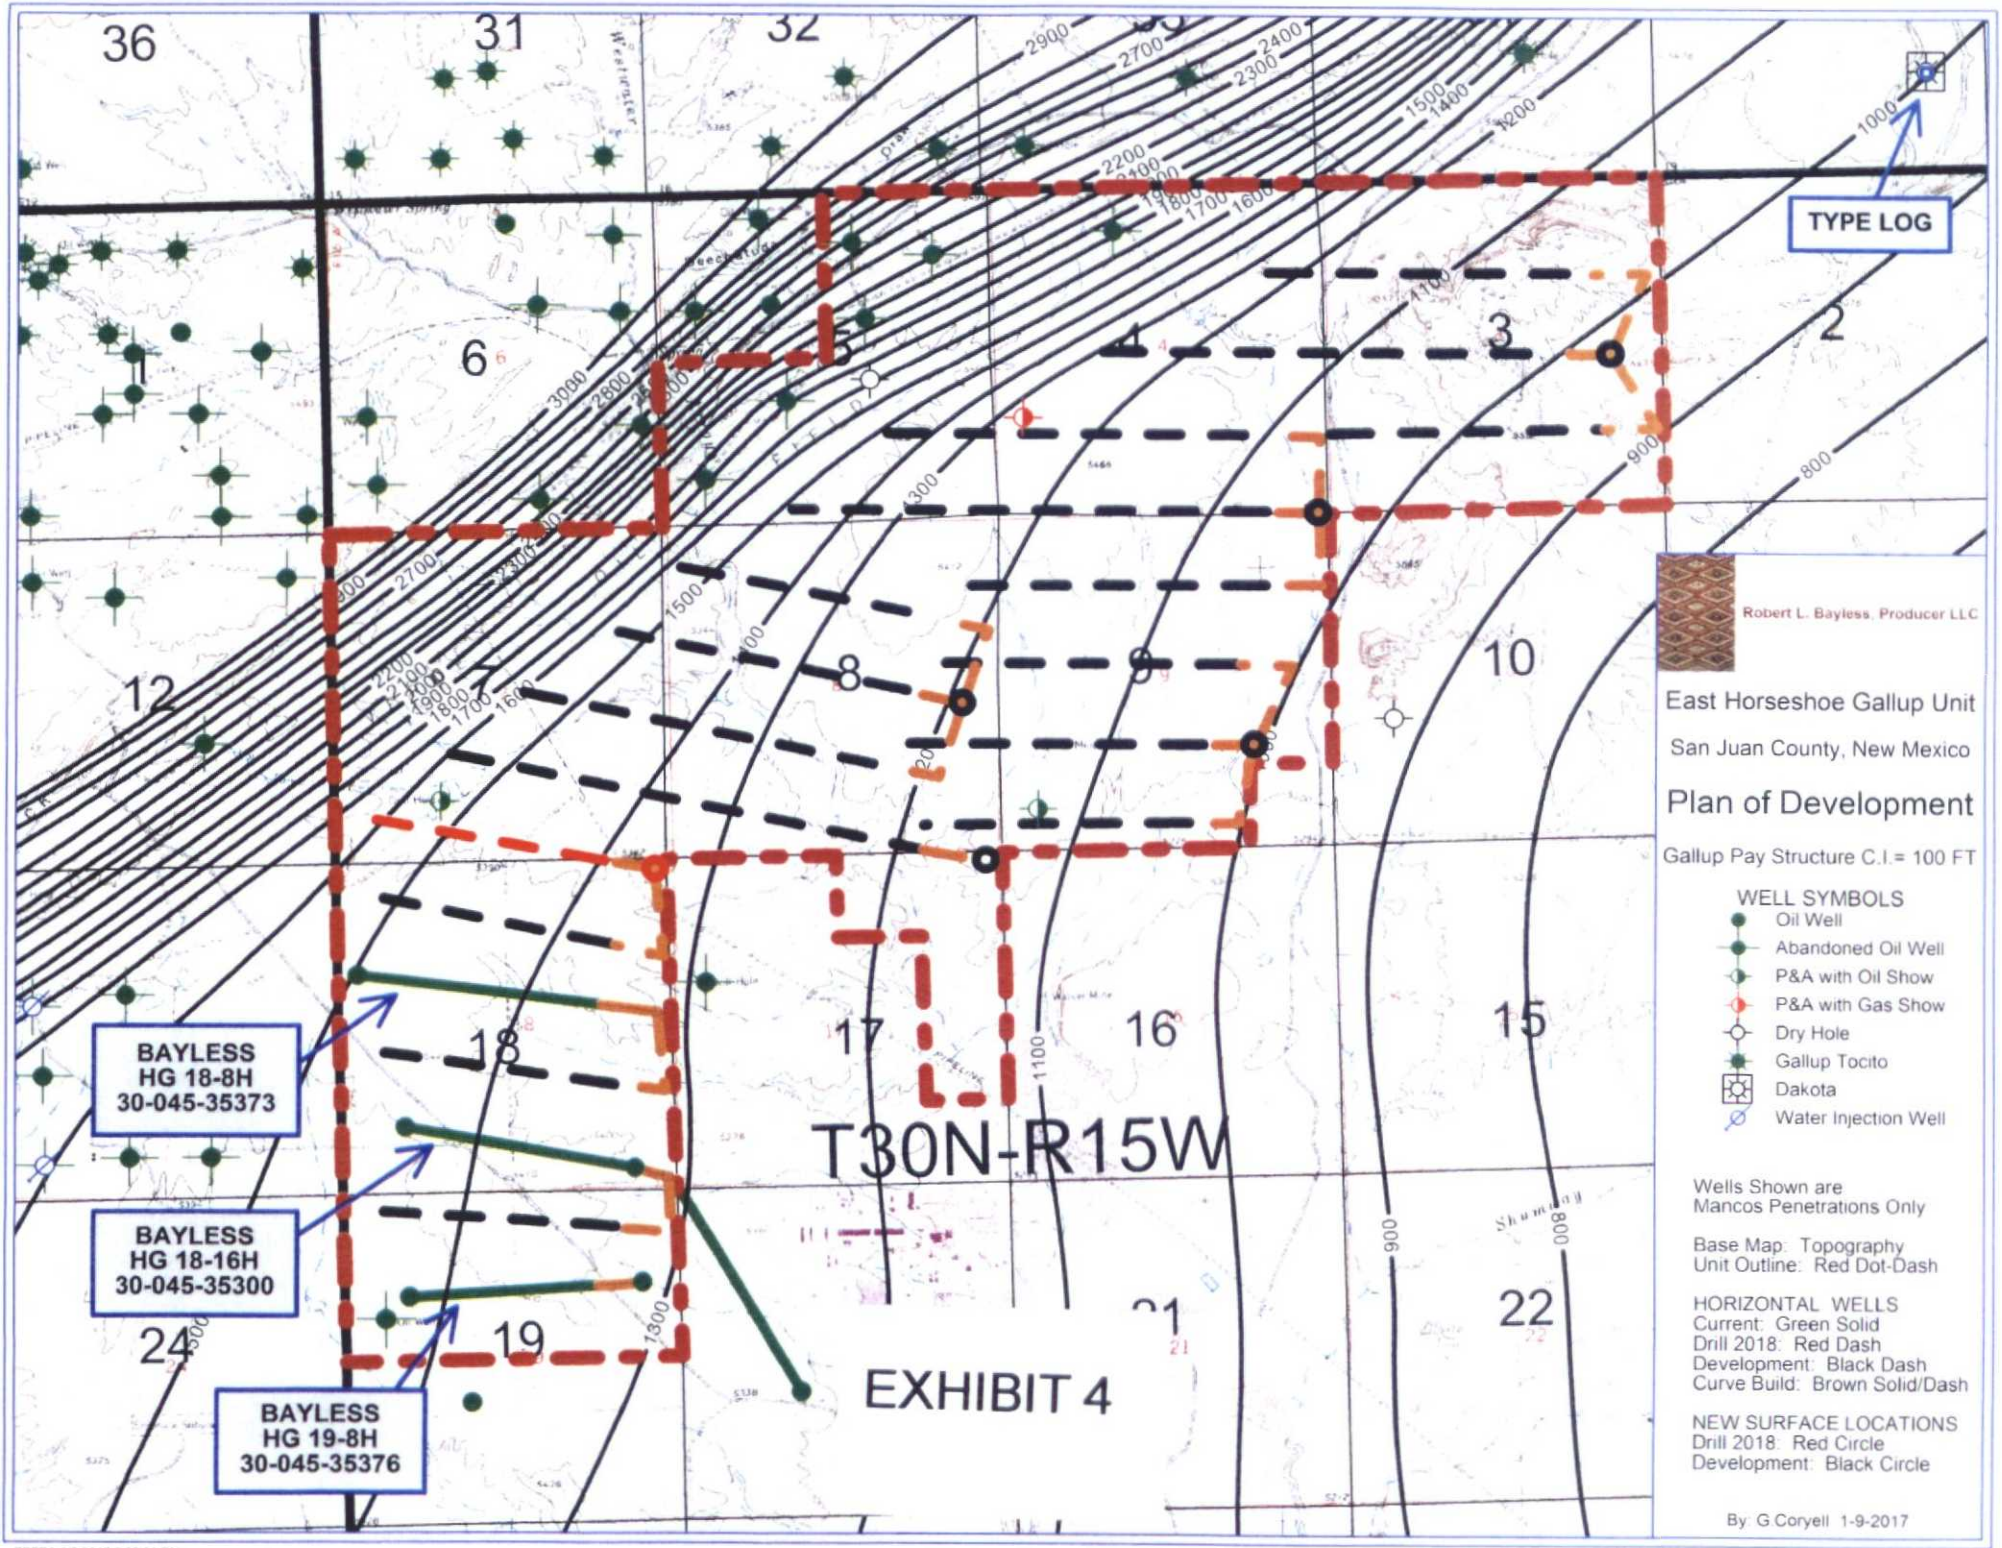
Gallup Pay Structure C.I. = 100 FT

Wells Shown are Mancos Penetrations Only

HORIZONTAL WELLS
 Current: Green Solid
 Drill 2018: Red Dash
 Development: Black Dash
 Curve Build: Brown Solid/Dash

NEW SURFACE LOCATIONS
 Drill 2018: Red Circle
 Development: Black Circle
