CASE NO. 1760  
FLOW DIAGRAM OF TEST STATION NO. 1  
ATLANTIC-NAVAJO "B" LEASE  
HORSESHOE GALLUP FIELD  
SAN JUAN COUNTY, NEW MEXICO  
EXHIBIT "B"

CASE NO. 1760  
DRAWING OF A DUMP TYPE METER  
ATLANTIC-NAVAJO "B" LEASE  
HORSESHOE GALLUP FIELD  
SAN JUAN COUNTY, NEW MEXICO  
EXHIBIT "C"

PROPOSED LACT INSTALLATION  
ATLANTIC-NAVAJO "B" LEASE  
**EXHIBIT "E"**  
CASE NO. 1760

DETAILS OF LACT UNIT  
ATLANTIC-NAVAJO "B" LEASE

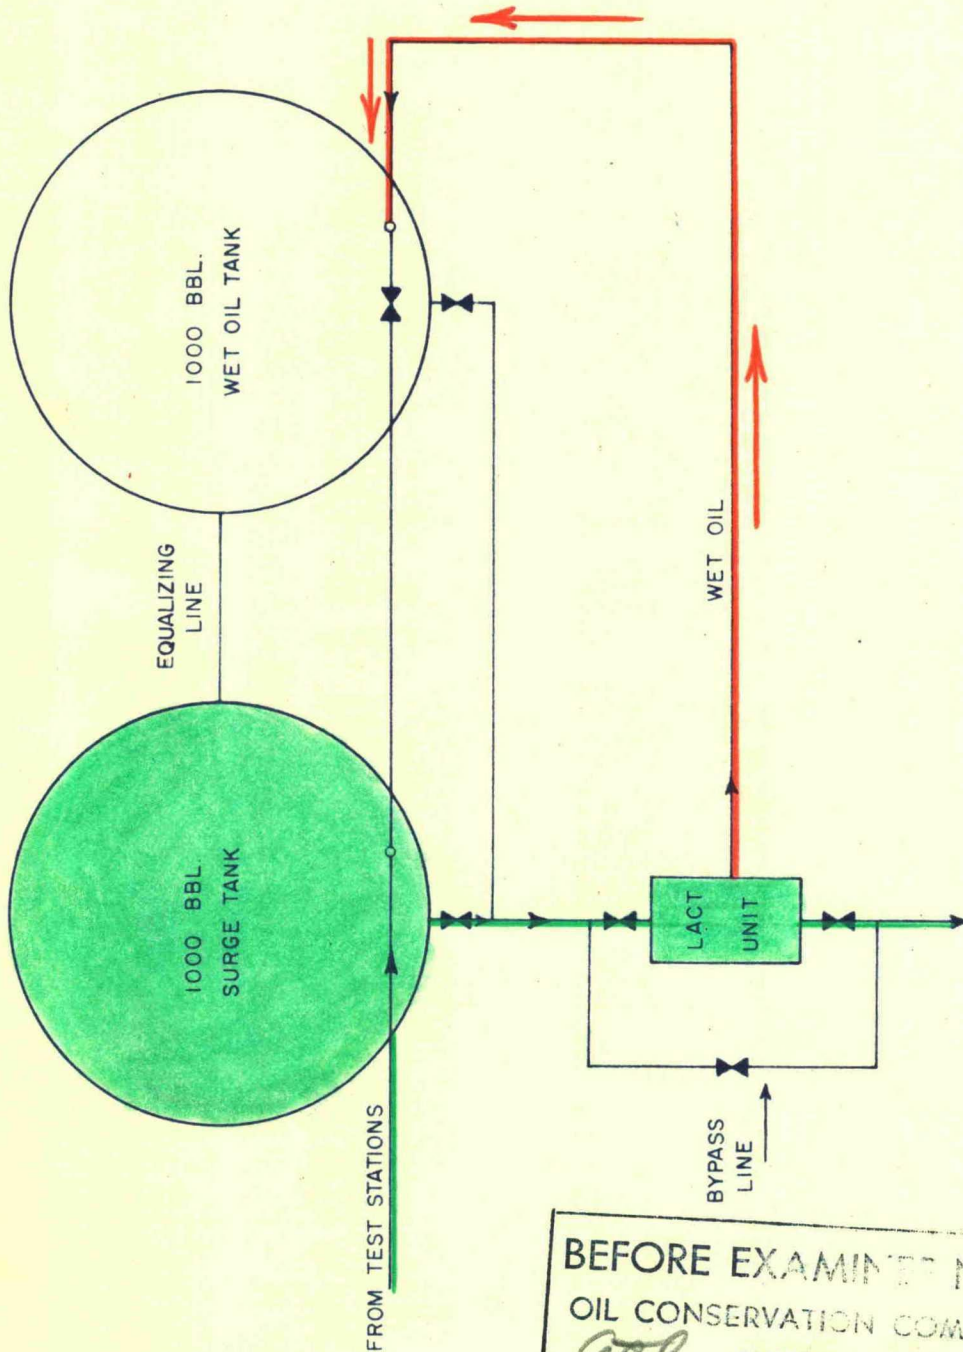
BEFORE EXAMINER NUTTER  
OIL CONSERVATION COMMISSION  
*act* EXHIBIT NO. E  
CASE NO. 1760

OIL FROM  
TEST STATION
