BEFORE EXAMINER UTZ
OIL CONSERVATION COMMISSION
EXHIBIT NO. 1
CASE NO. 1949

TRICE PRODUCTION COMPANY
LONGVIEW, TEXAS

DIAGRAM OF PROPOSED COMPLETION
TRICE PRODUCTION COMPANY
#1 FOUR LAKES STATE
LEA COUNTY, NEW MEXICO

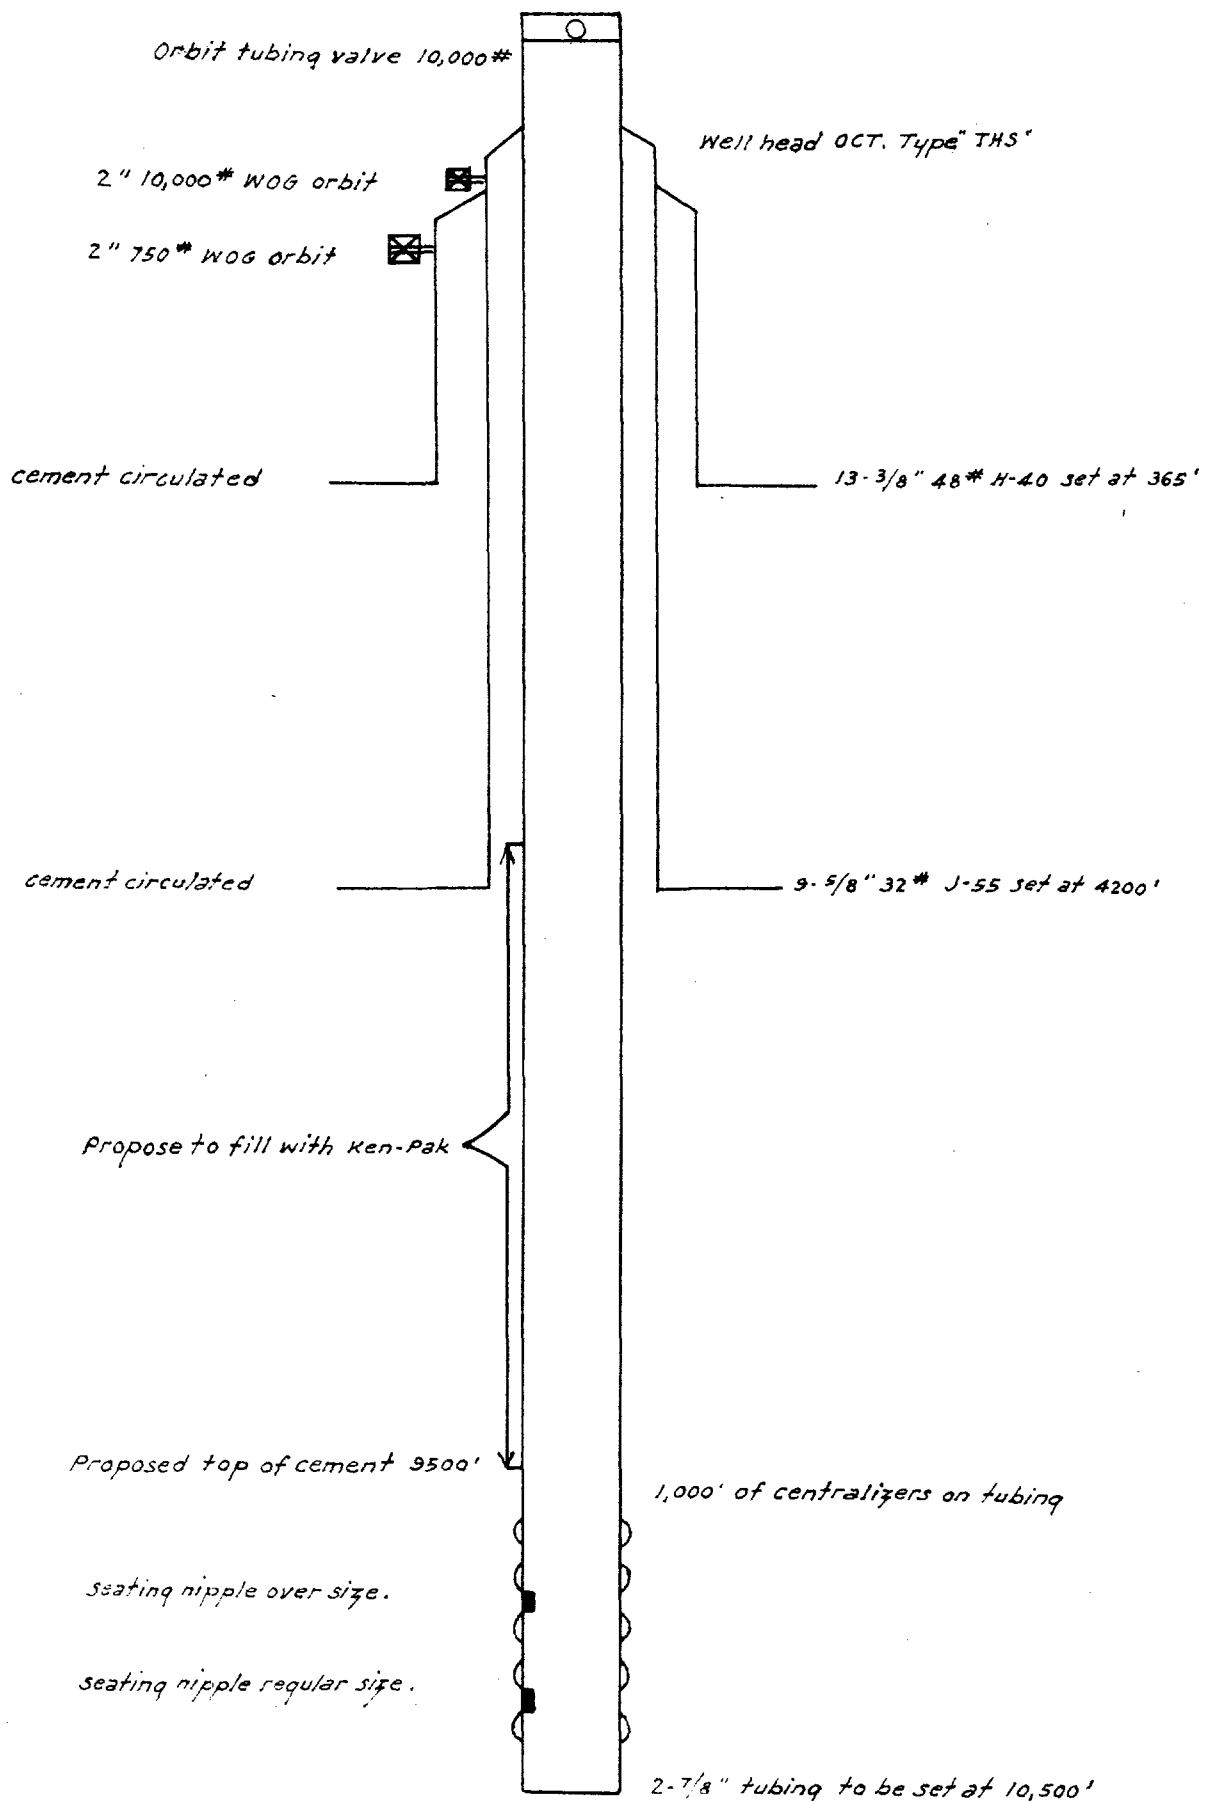
After much study, it is our opinion there are no corrosive fluids or heaving formation from bottom of 9-5/8 to top of cement.

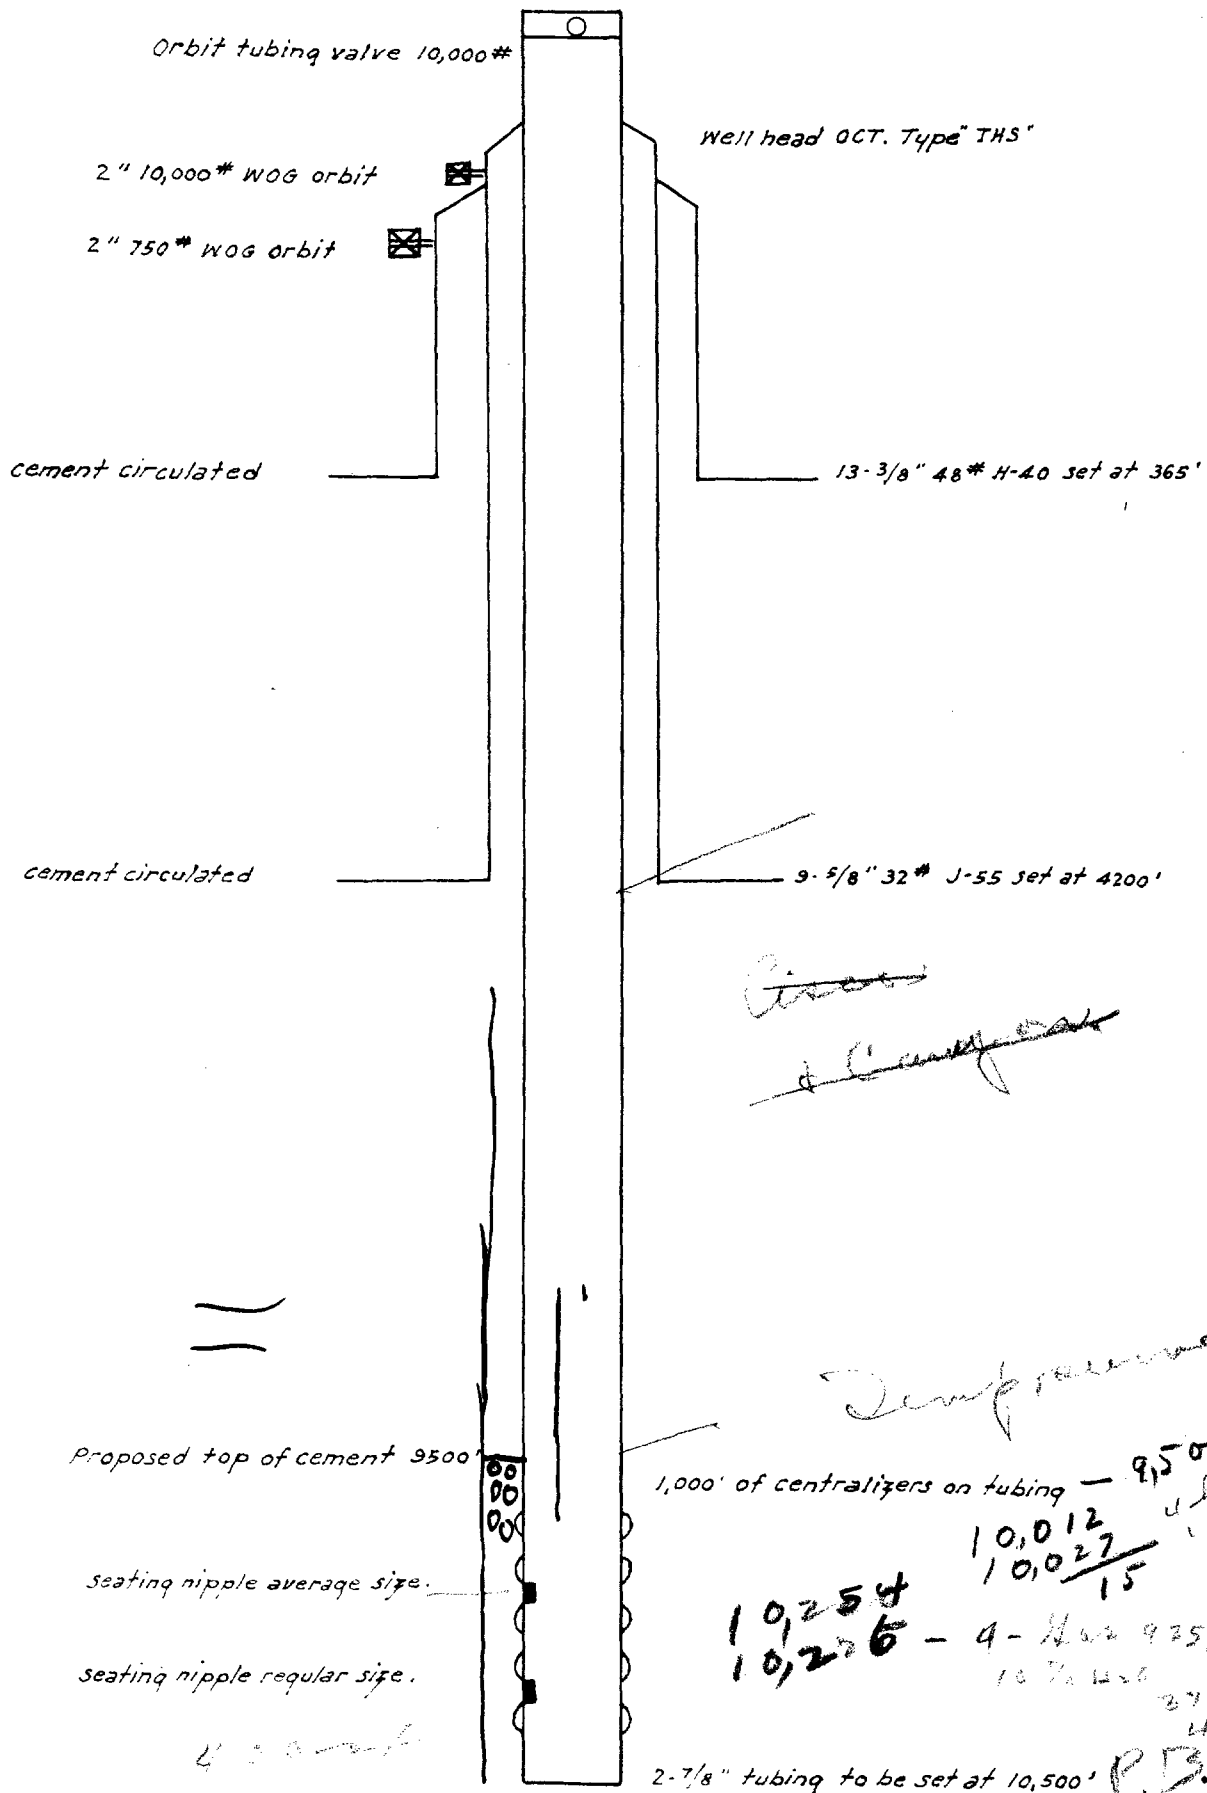
DIAGRAM OF PROPOSED COMPLETION
 TRICE PRODUCTION COMPANY
 #1 FOUR LAKES STATE
 LEA COUNTY, NEW MEXICO

After much study, it is our opinion there are no corrosive fluids or heaving formation from bottom of 9-5/8 to top of cement.
