BEFORE EXAMINER
De la Macia
 OIL CONSERVATION DIVISION
 EXHIBIT NO. 1
 CASE NO. 9830

PROPOSED DRAIN HOLE
 FOR
 STRATA No. 1 YESO HILLS
 ASSUMED FRACTURE ORIENTATION
 N 45° W

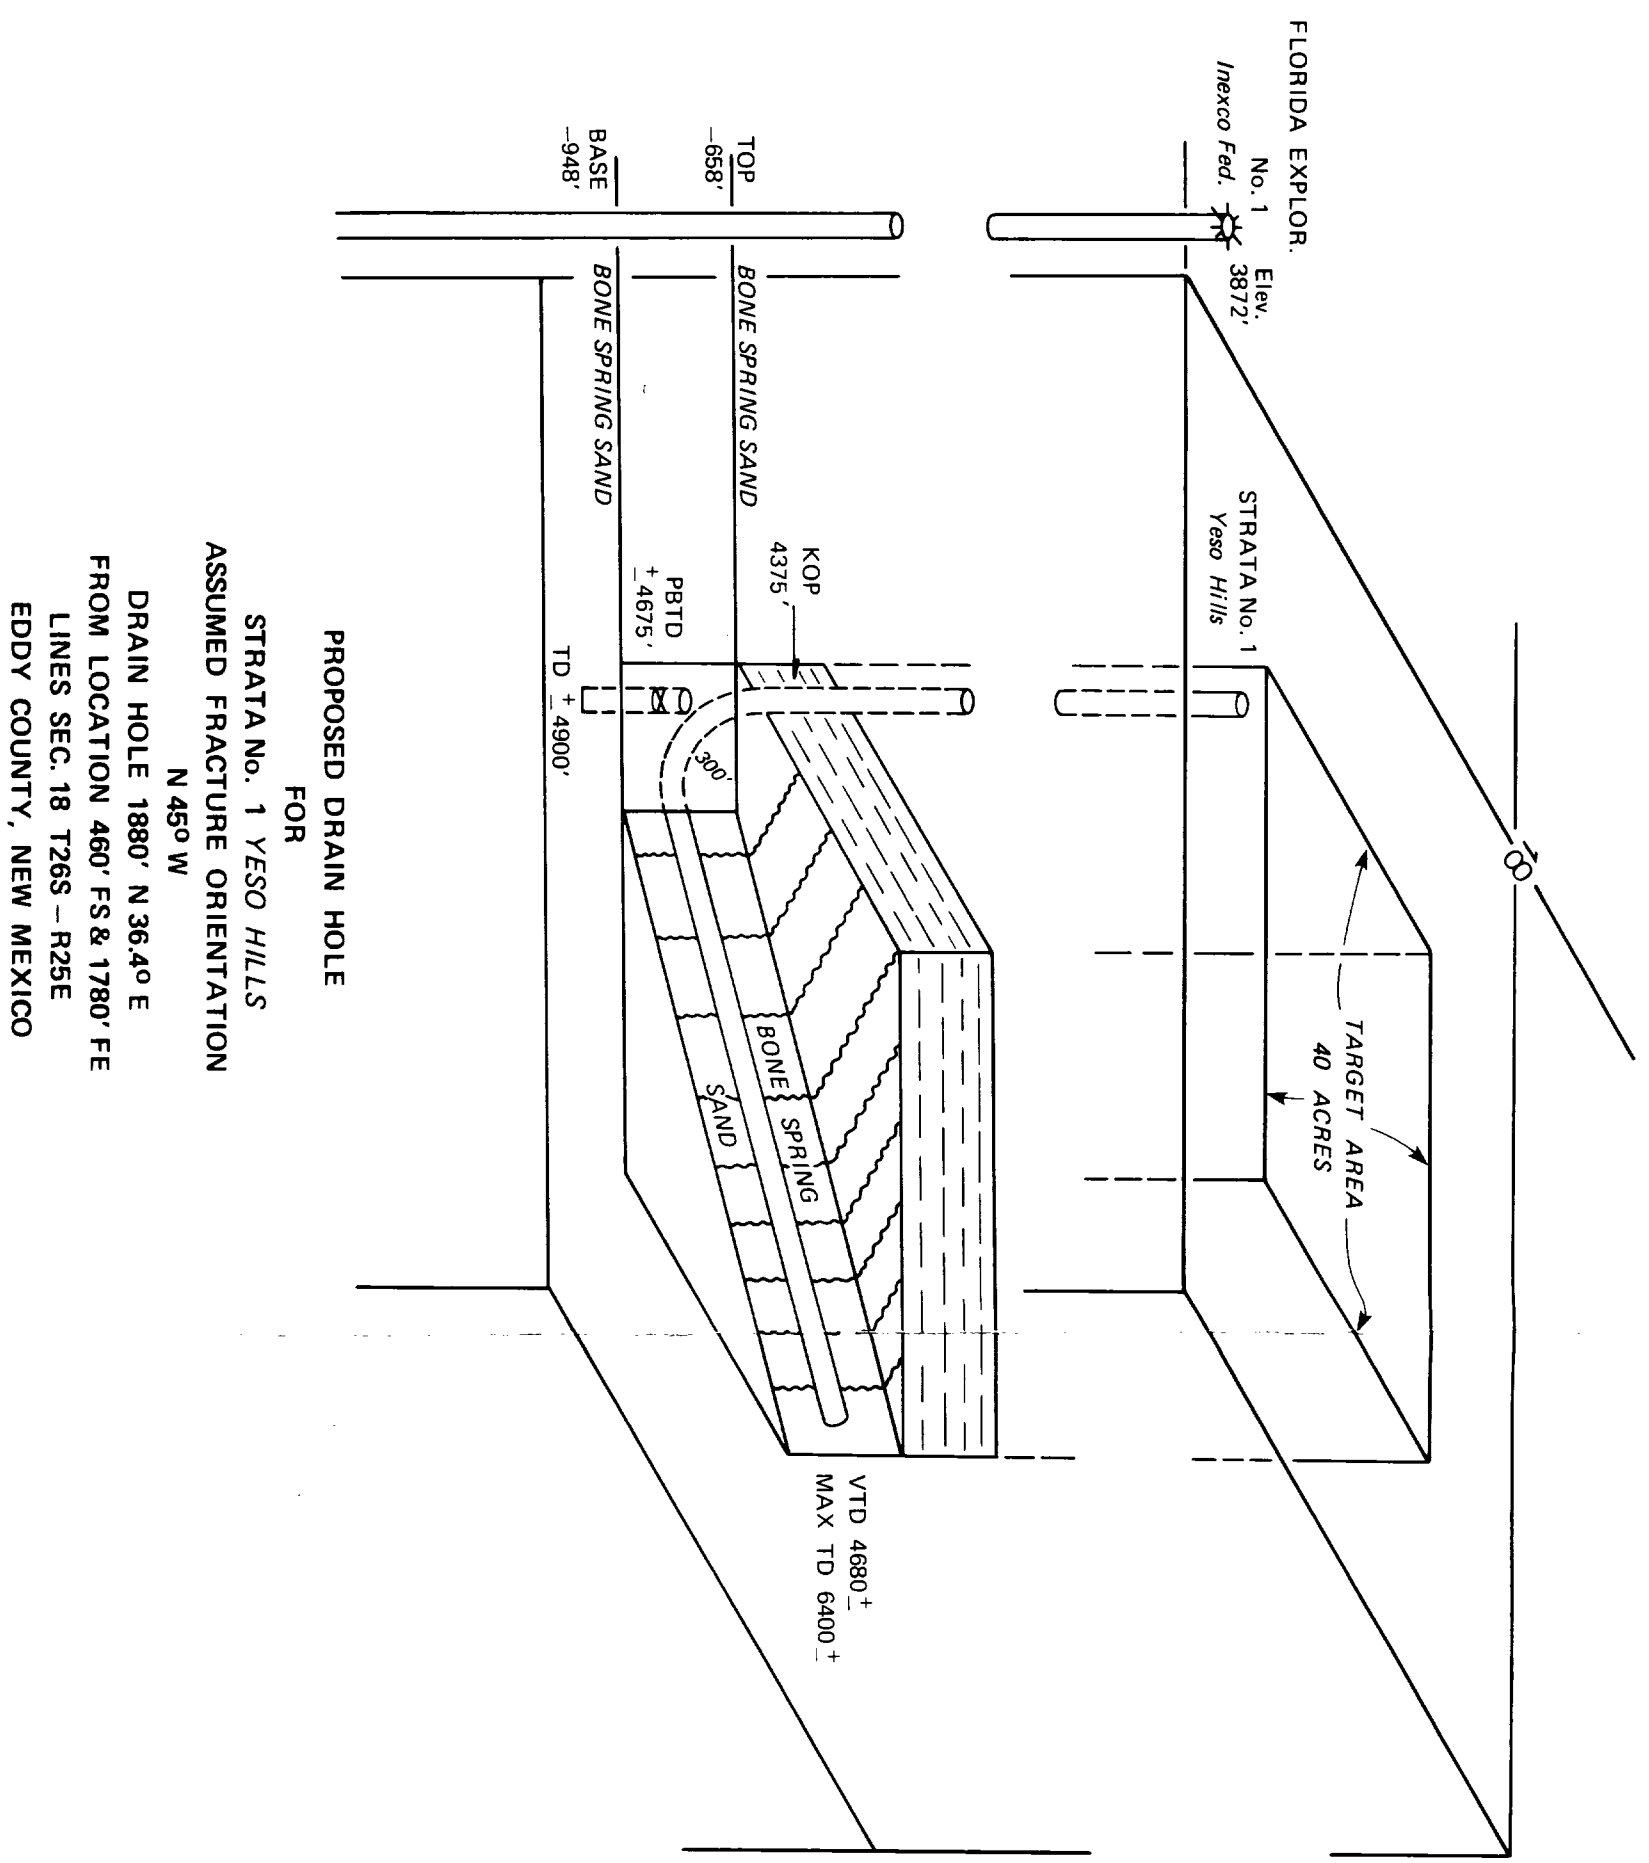
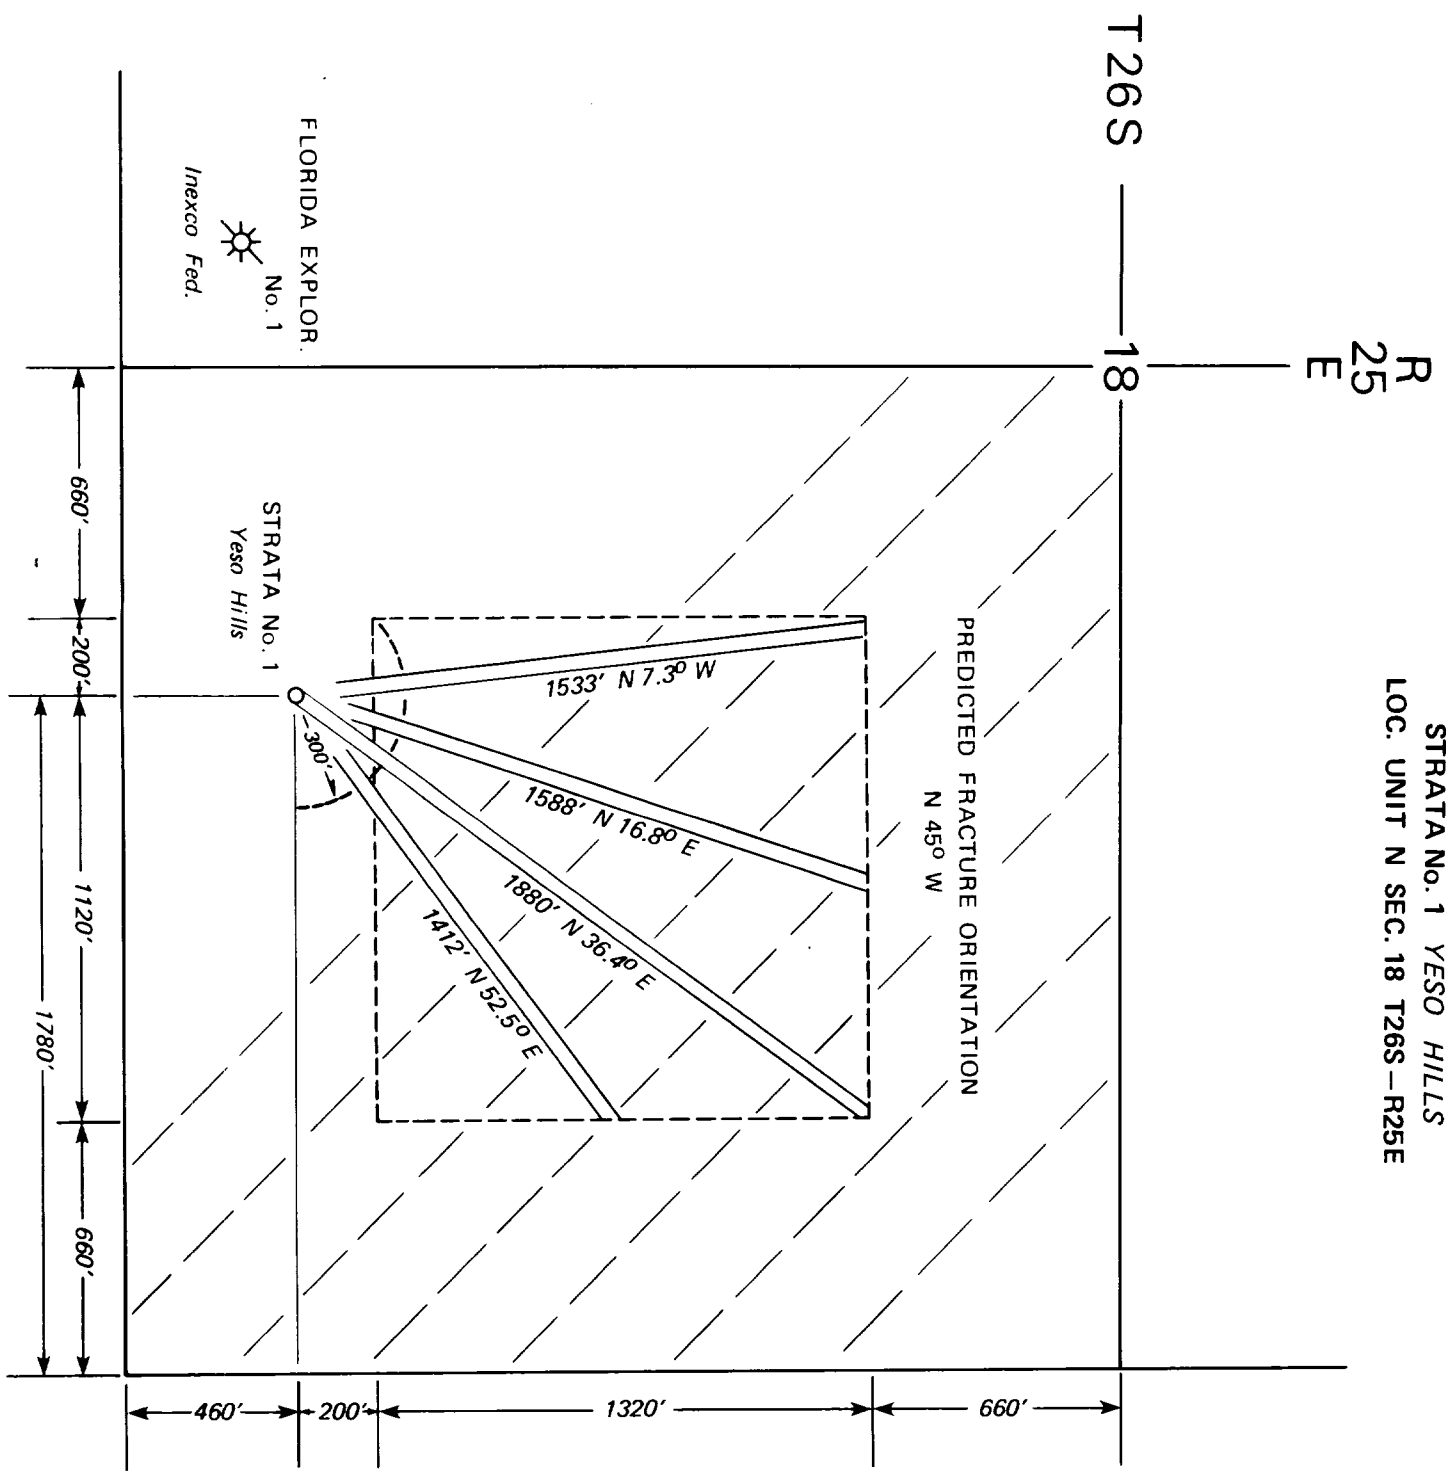
DRAIN HOLE 1880' N 36.4° E
 FROM LOCATION 460' FS & 1780' FE
 LINES SEC. 18 T26S - R25E
 EDDY COUNTY, NEW MEXICO
