**From:** [McCartney, Gregory J.](#)  
**To:** [Pierard, Kevin, NMENV](#)  
**Cc:** [Chavez, Carl J. EMNRD](#); [Cobrain, Dave, NMENV](#); [Tsinnajinnie, Leona, NMENV](#); [Robinson, Kelly](#); [Scott Crouch](#)  
**Subject:** [EXT] Bloomfield Terminal Response to Approval with Modifications IWP Slop Line Release  
**Date:** Tuesday, May 5, 2020 1:35:59 PM  
**Attachments:** [BT Response to Approval IWP Slop Line Release.pdf](#)

**RE: Response to Approval with Modifications  
Investigation Work Plan May 17, 2018 Slop Oil Line Release  
Western Refining Southwest, Inc. – Bloomfield Terminal  
EPA ID# NMD089416416  
HWB-WRB-18-014**

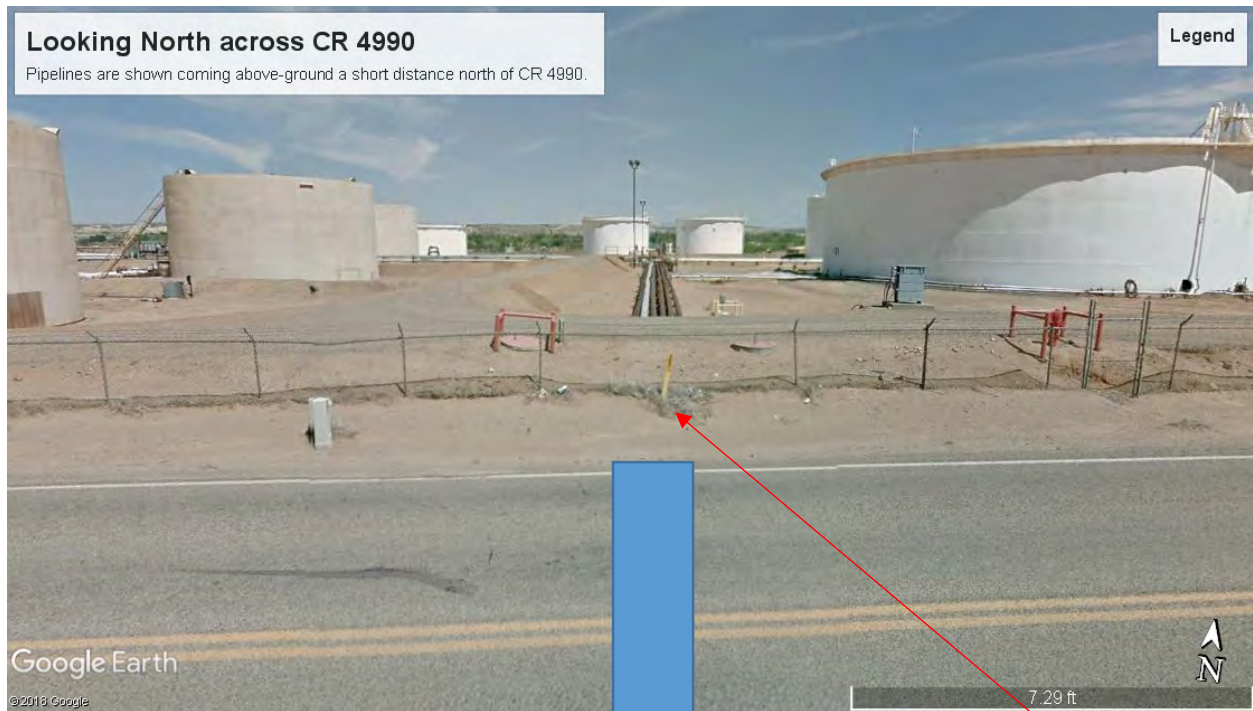
Image of location prior to excavation.  
Pipelines pass beneath CR 4990 inside culvert at this location.

pipeline  
corridor

approximate location of  
excavation

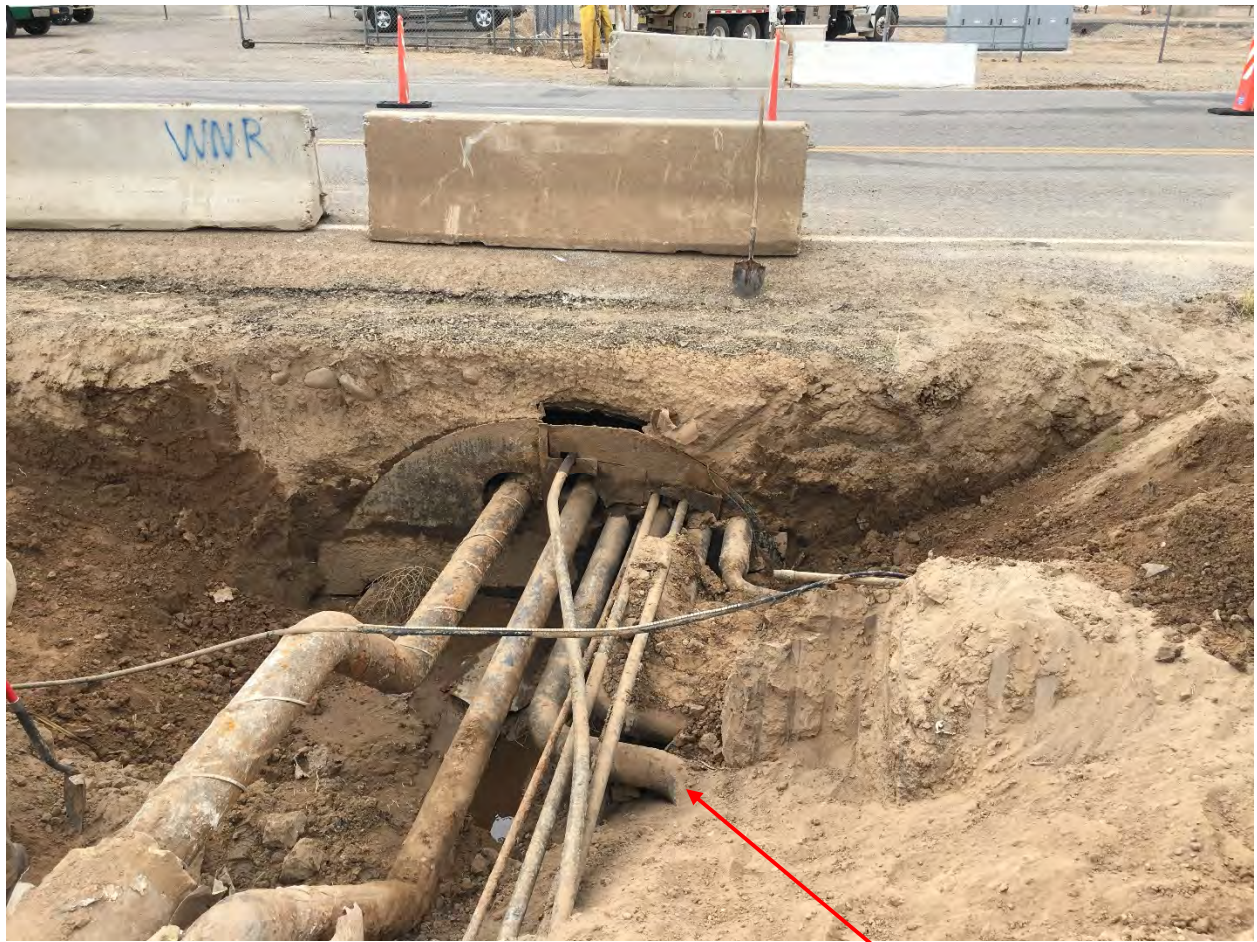
Picture of excavation looking south at County Road 4990.

Slop Oil Pipeline

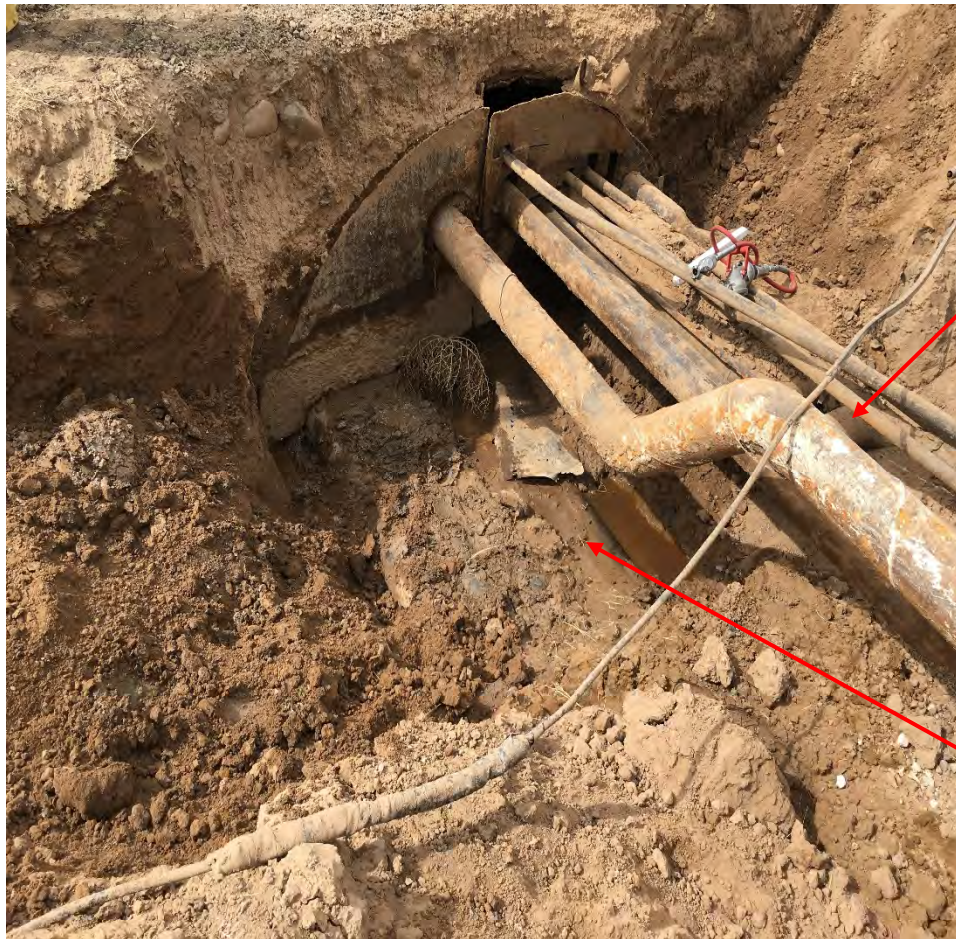
Slop oil pipeline

Additional  
lines below  
slop oil line

Additional pipelines exposed beneath slop oil pipeline.

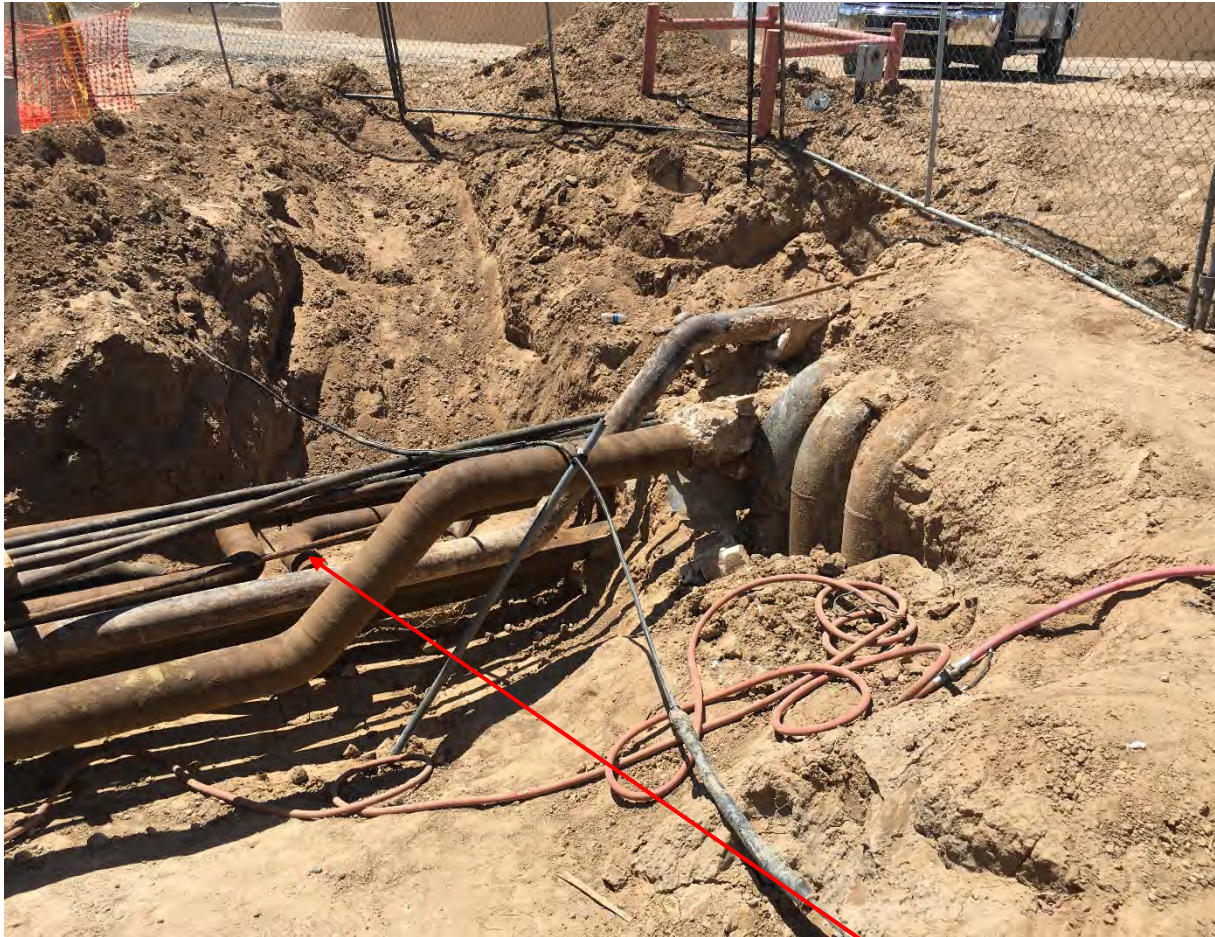
Looking northwest towards tank farm on north side of CR 4990

Slop oil pipeline
