**RICE OPERATING COMPANY  
JUNCTION BOX FINAL REPORT**

| SWD SYSTEM | JUNCTION | UNIT | SECTION | TOWNSHIP | RANGE | COUNTY | BOX DIMENSIONS - FEET | | |
|---|---|---|---|---|---|---|---|---|---|
| EME | M-34 | M | 34 | 19S | 37E | LEA | Length<br>12 | Width<br>10 | Depth<br>6 |

## EME M-34 Junction Box Upgrade

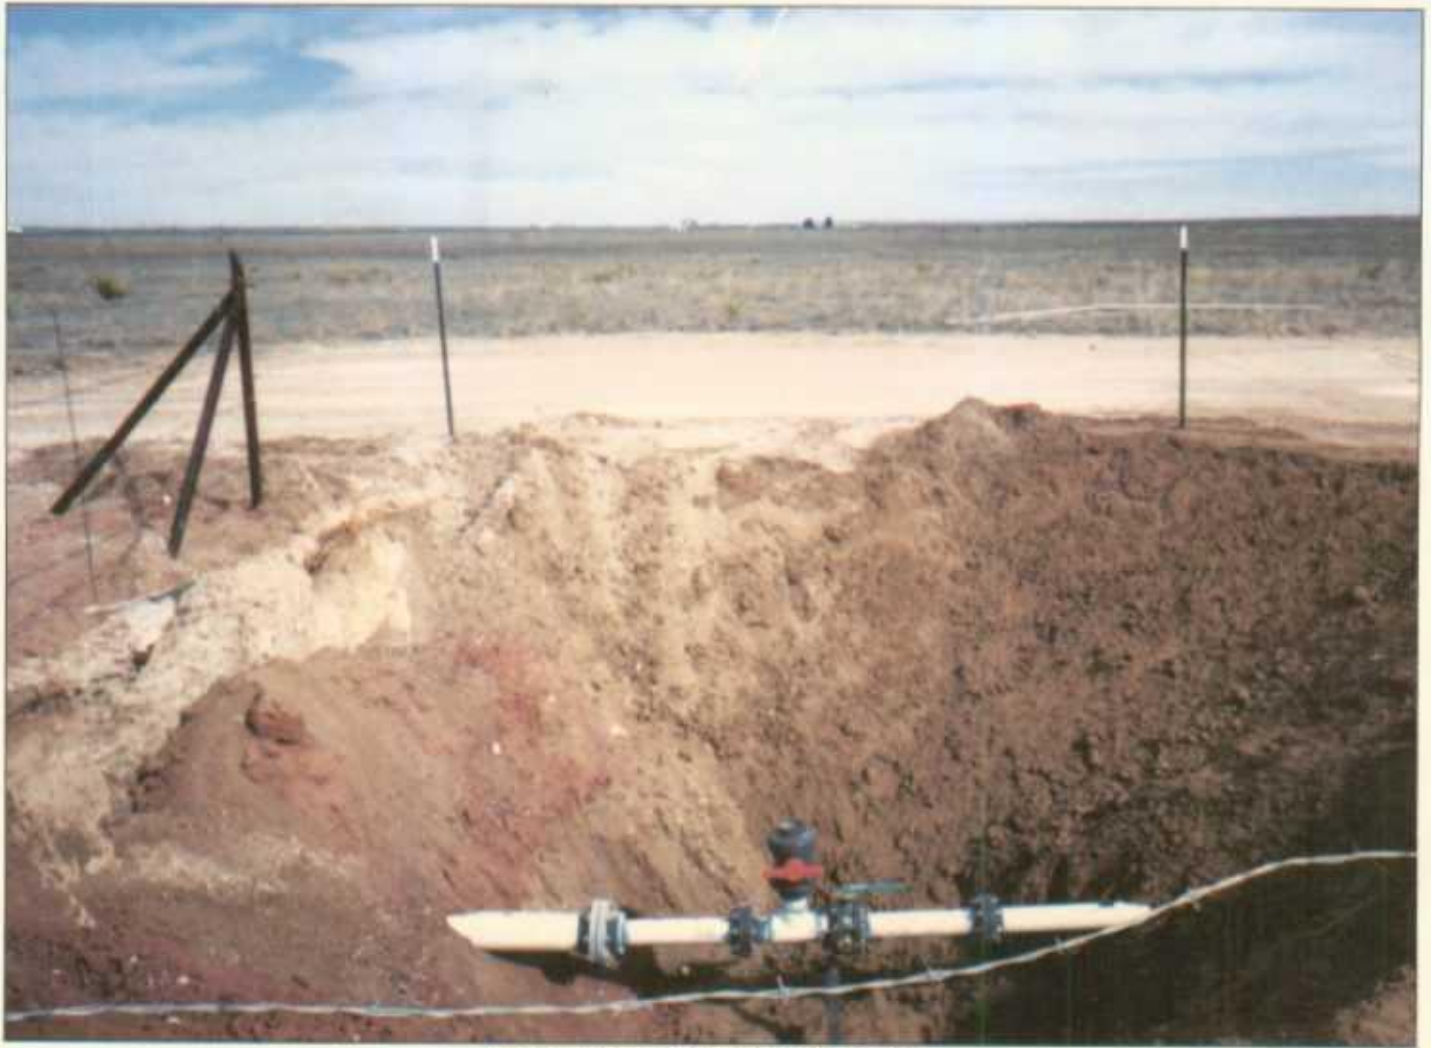
Remediation with New Plumbing

Vertical delineation found TPH clean at 9' bgs. A soil boring found chlorides declined from 950 ppm @ 20' to 71 ppm @ 35' bgs. This demonstrates that impact stopped before reaching groundwater. A compacted clay barrier and water tight junction box was installed and backfilled. High impacted soil was hauled to a permitted disposal facility. Natural attenuation will remediate the remaining hydrocarbon.
