## Closure Report

### 2RP-5524

| Site Name: | Height CC 6-7 Fed Com 34H | Incident ID: NRM2002750398 |

# Oxy Height CC 6-7 Fed Com 34H

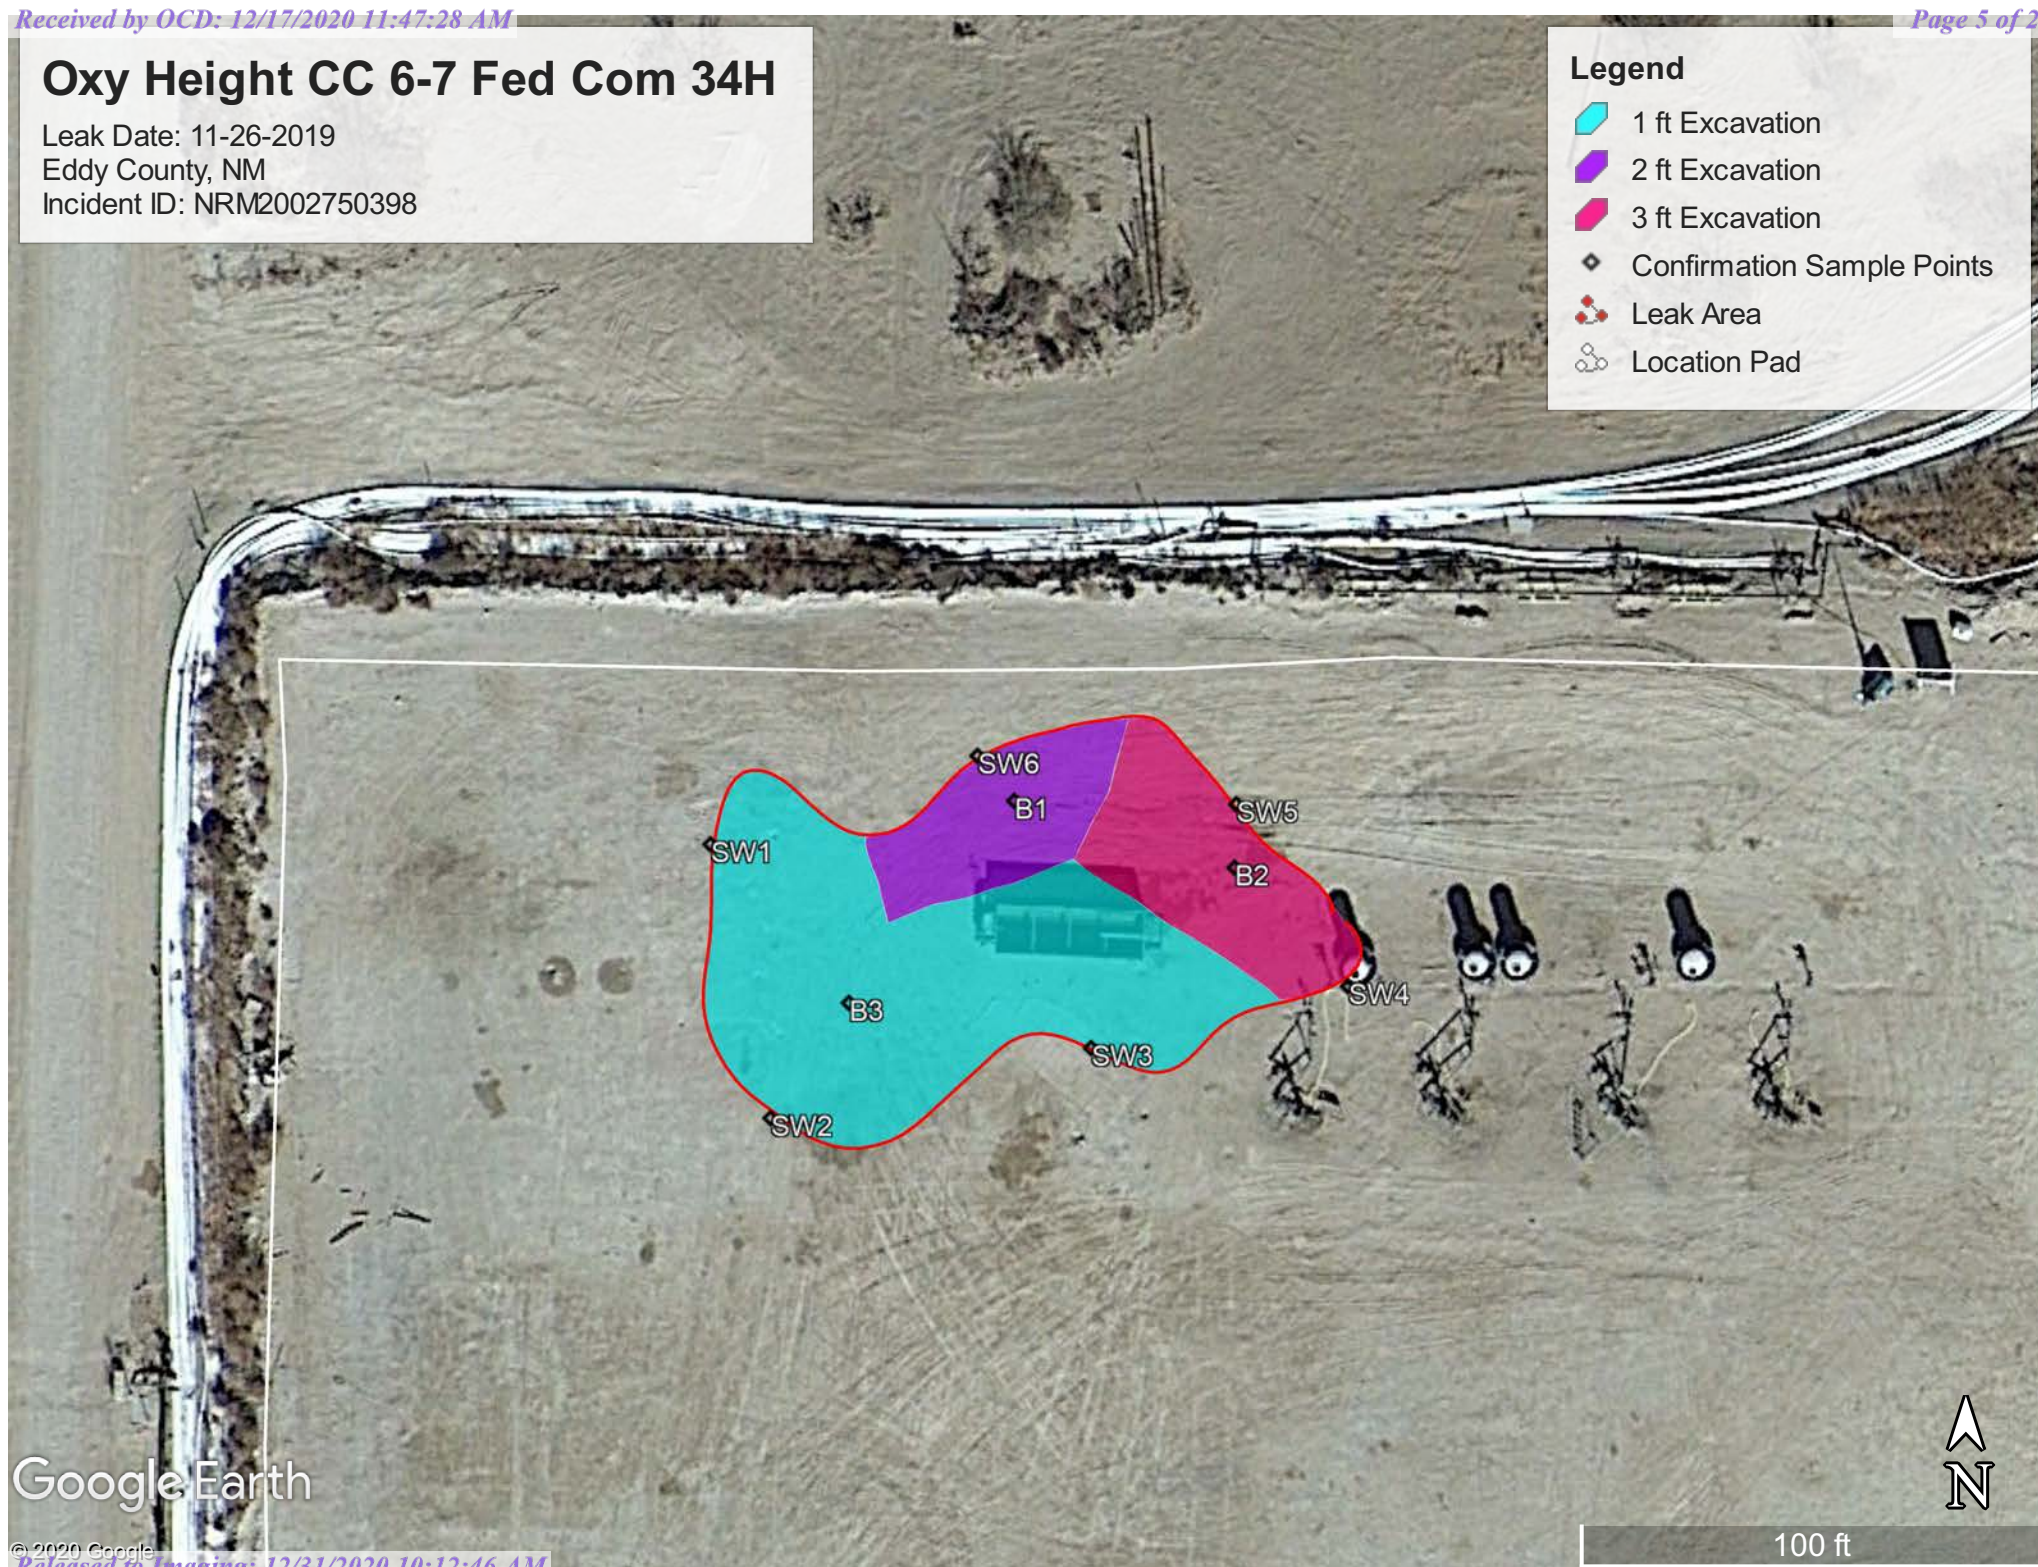
Google Earth

| Remediation Parameters: | Excavated the leak areas SP1 and SP2 to a depth of 1 foot. Excavated SP3 to a depth of 2 feet, and SP4 to a depth of 3 feet. Collected bottom and sidewall confirmation samples every 50 feet. The entire site was backfilled with clean soil. |

- 1 ft Excavation
- 2 ft Excavation
- 3 ft Excavation
- Confirmation Sample Points
- Leak Area
- Location Pad

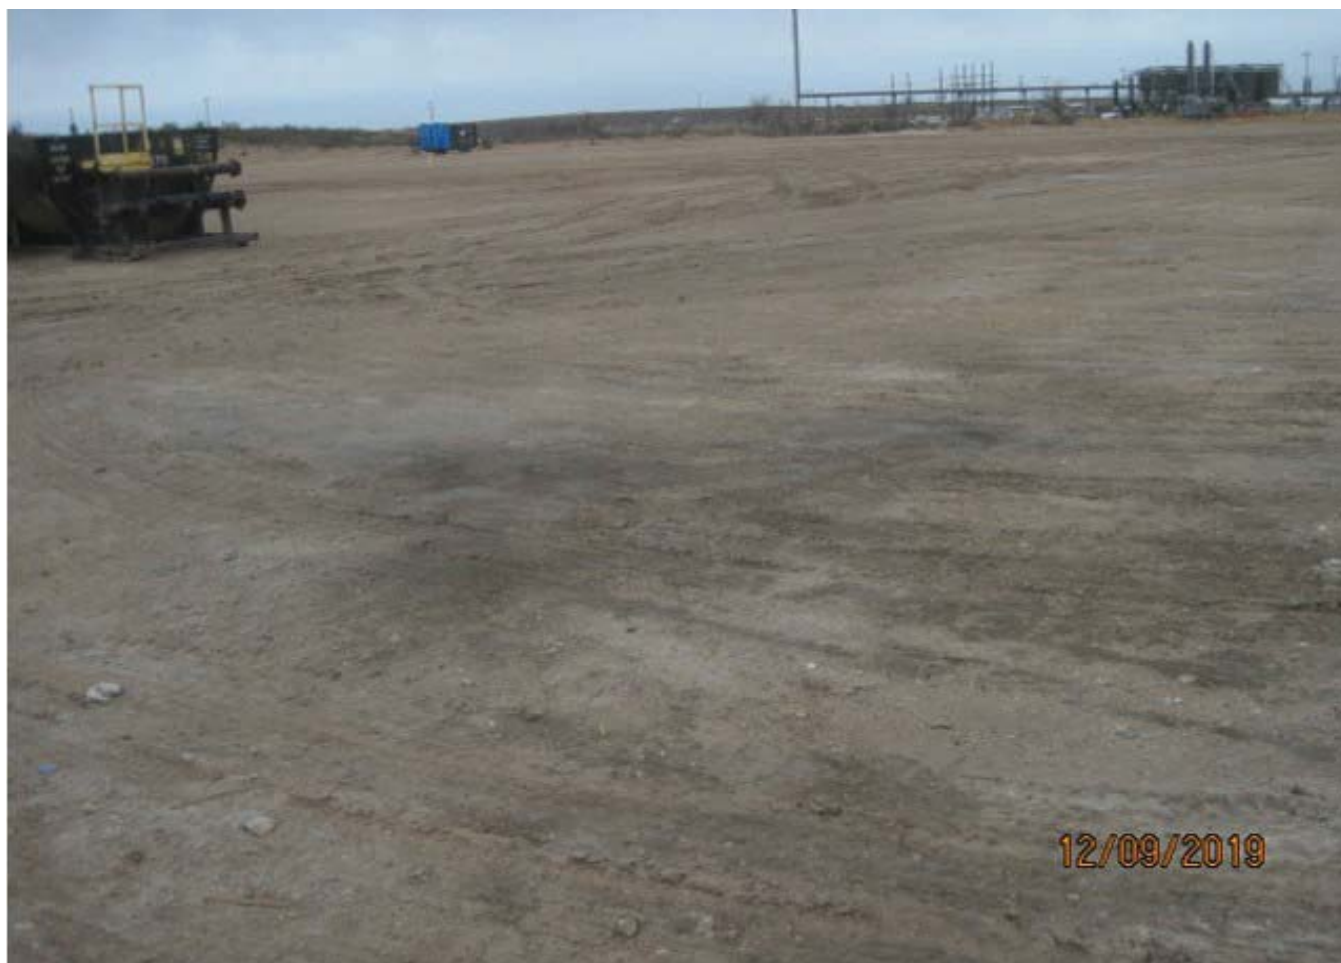
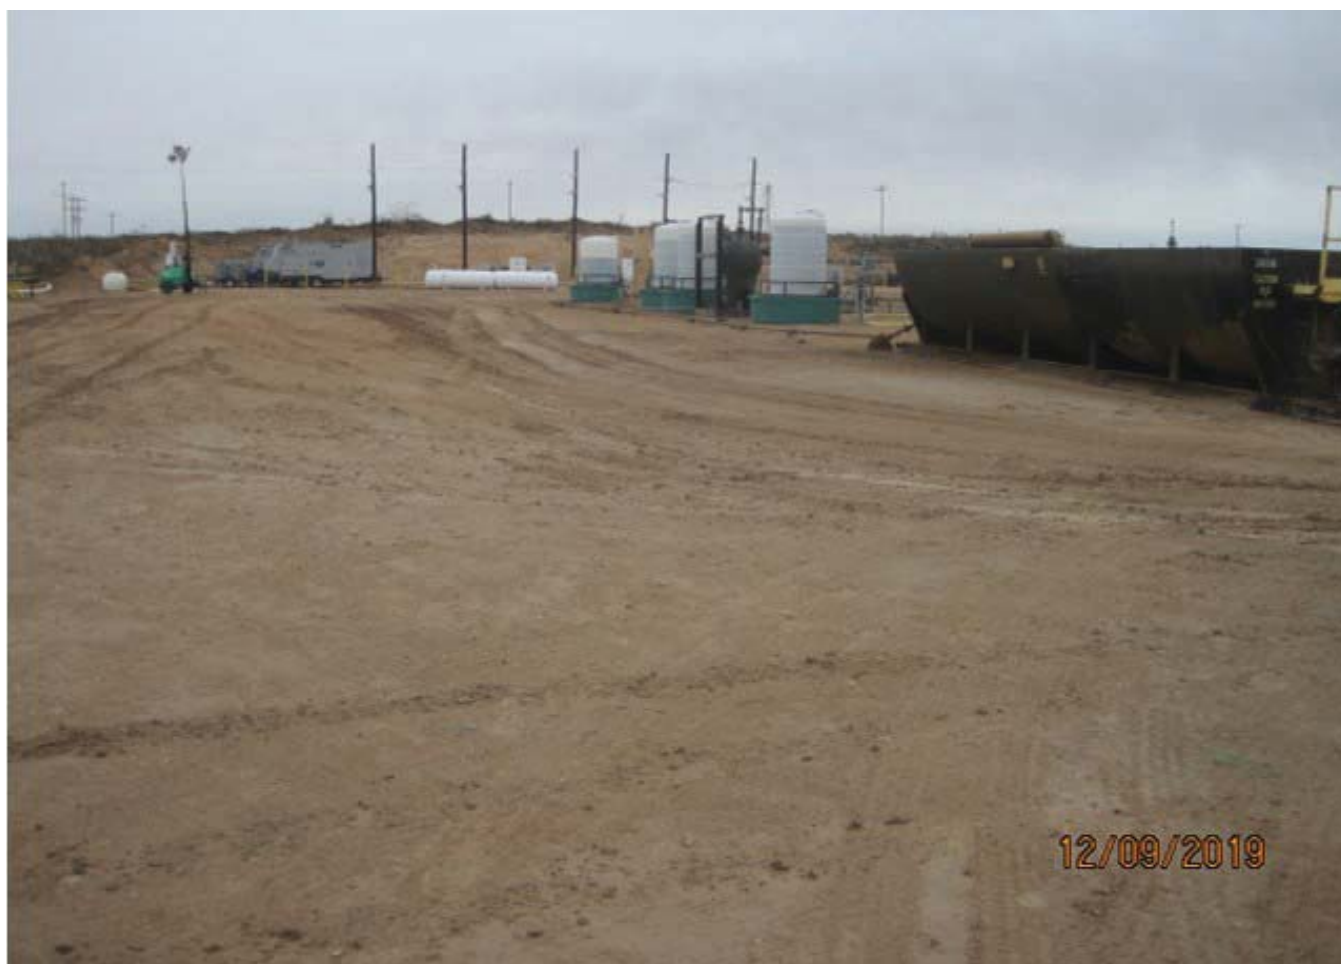
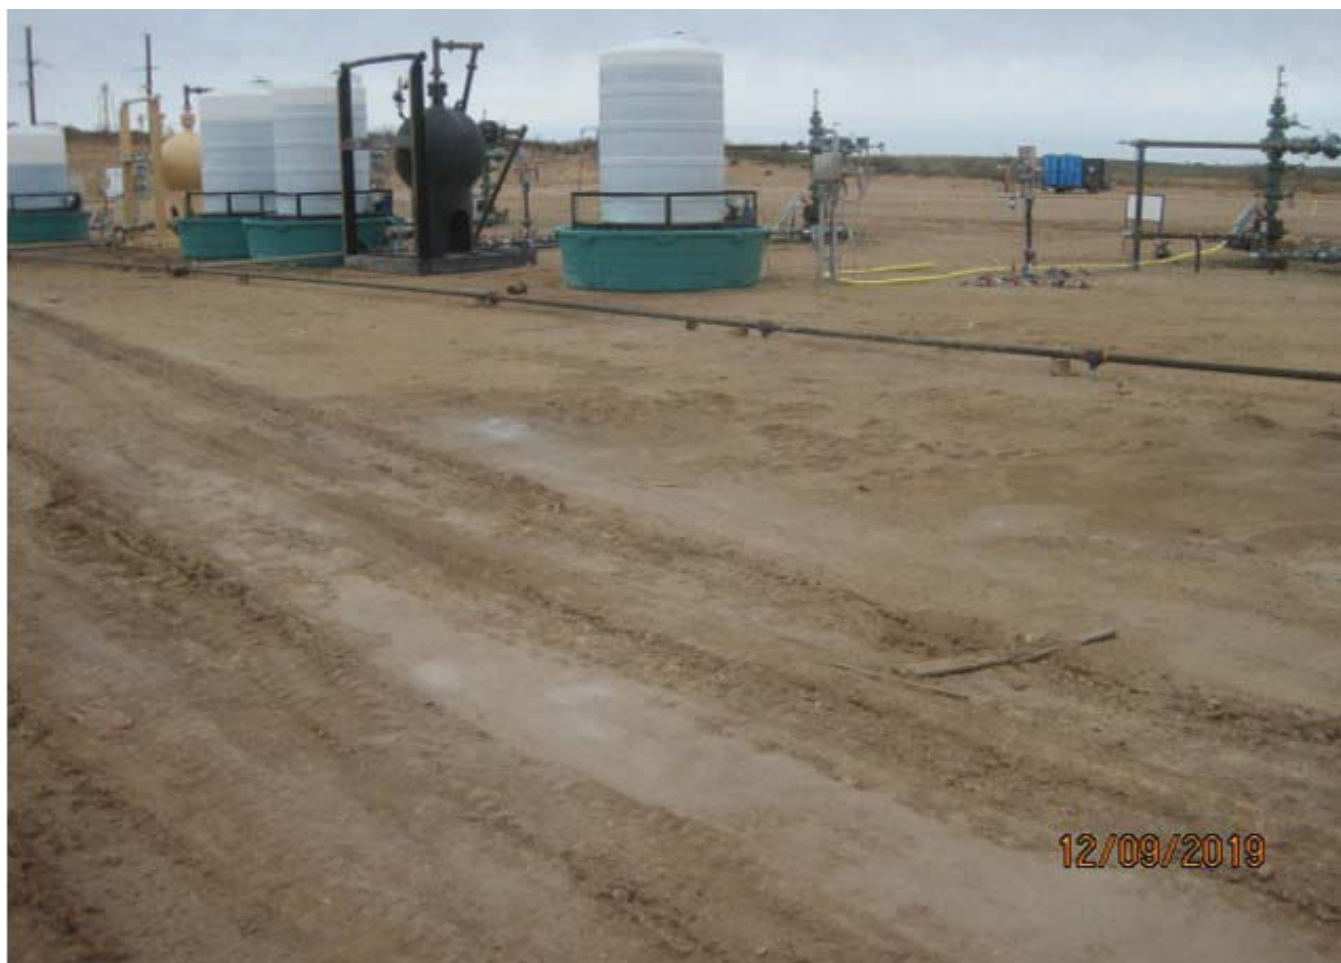
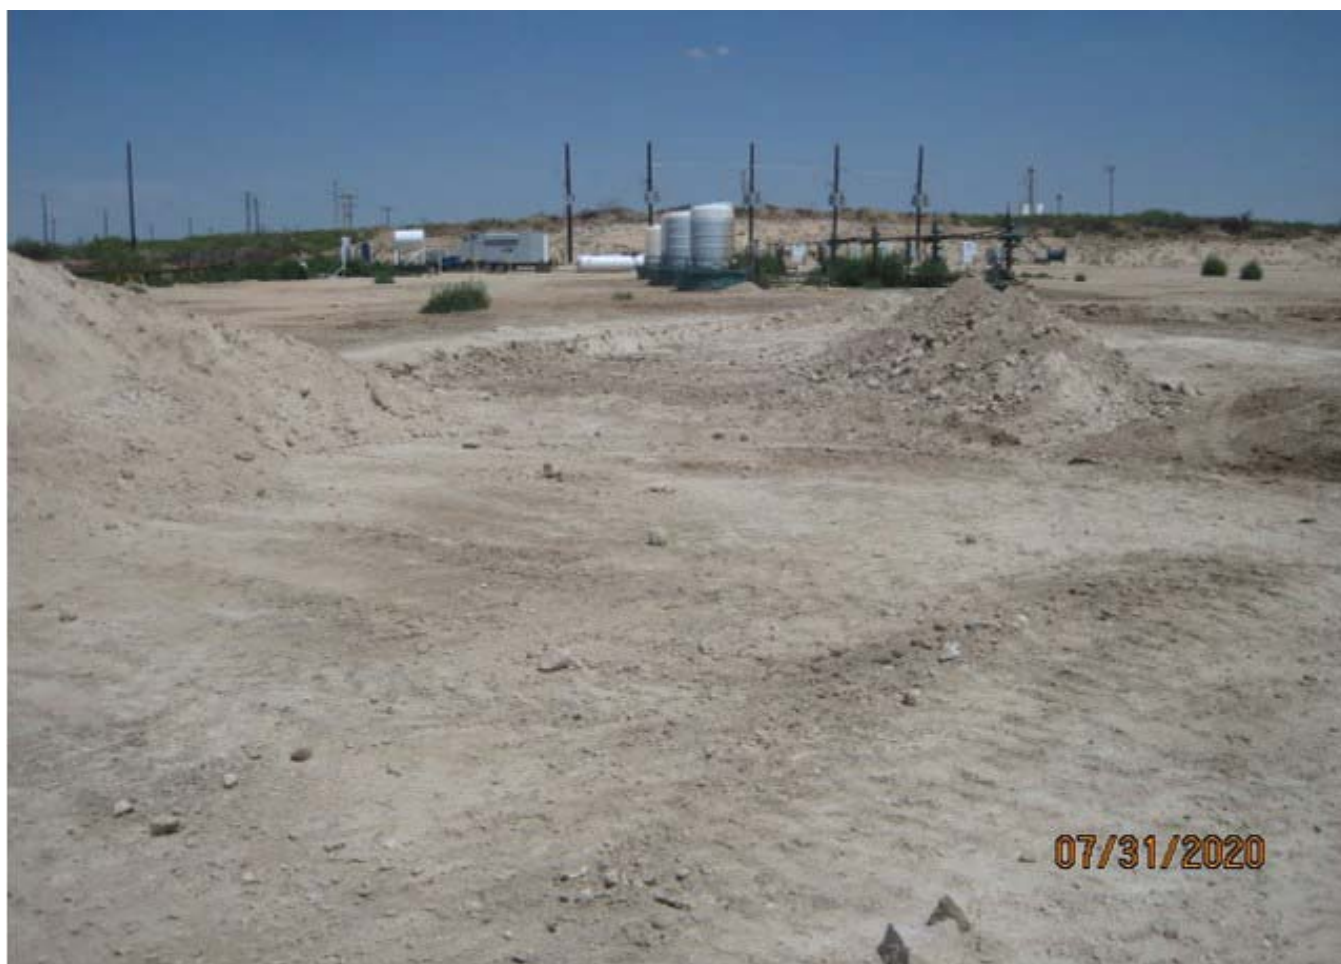
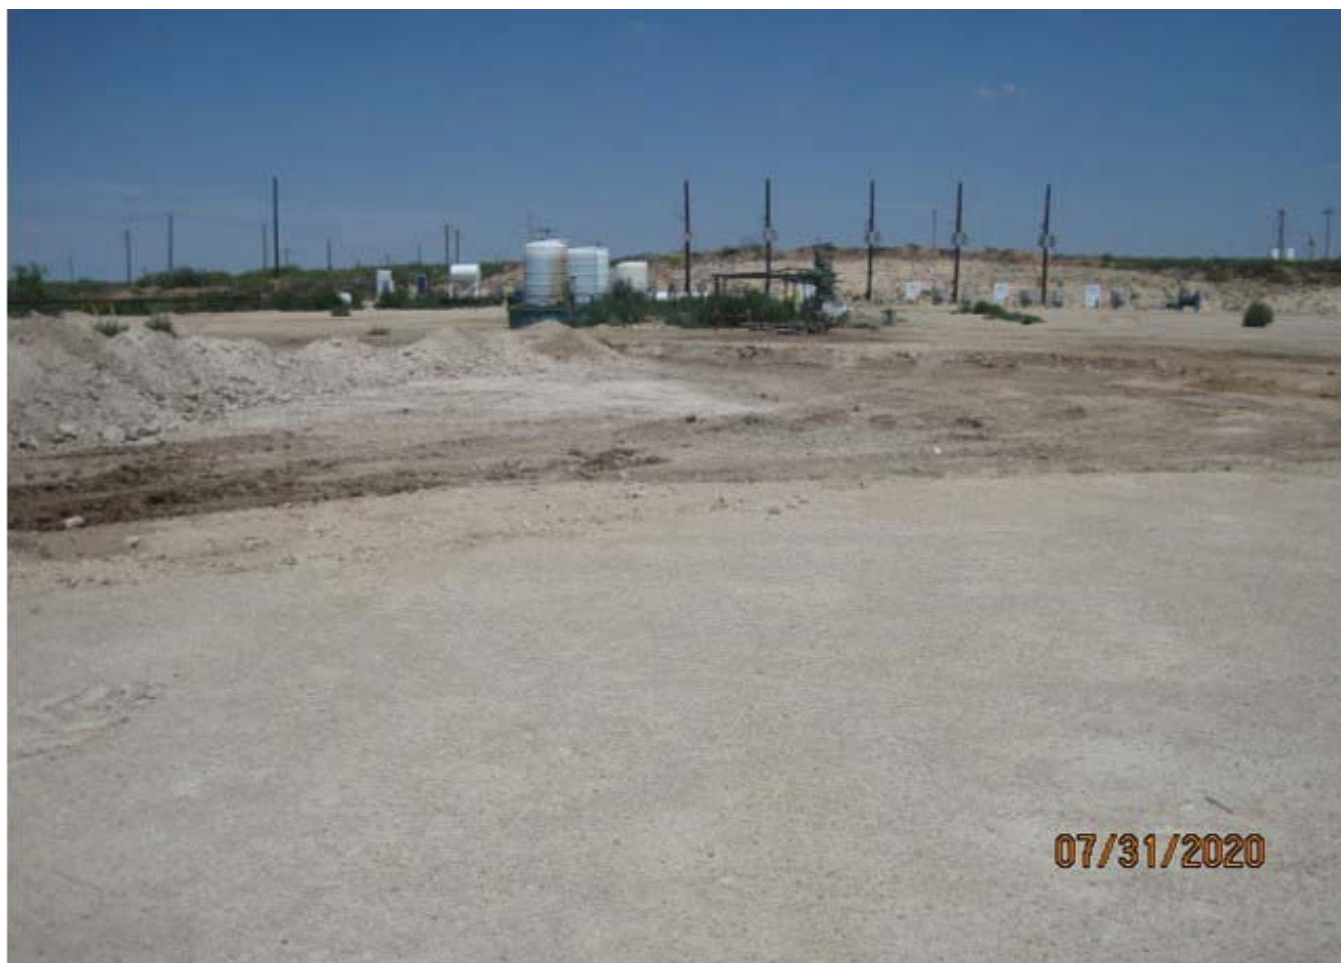
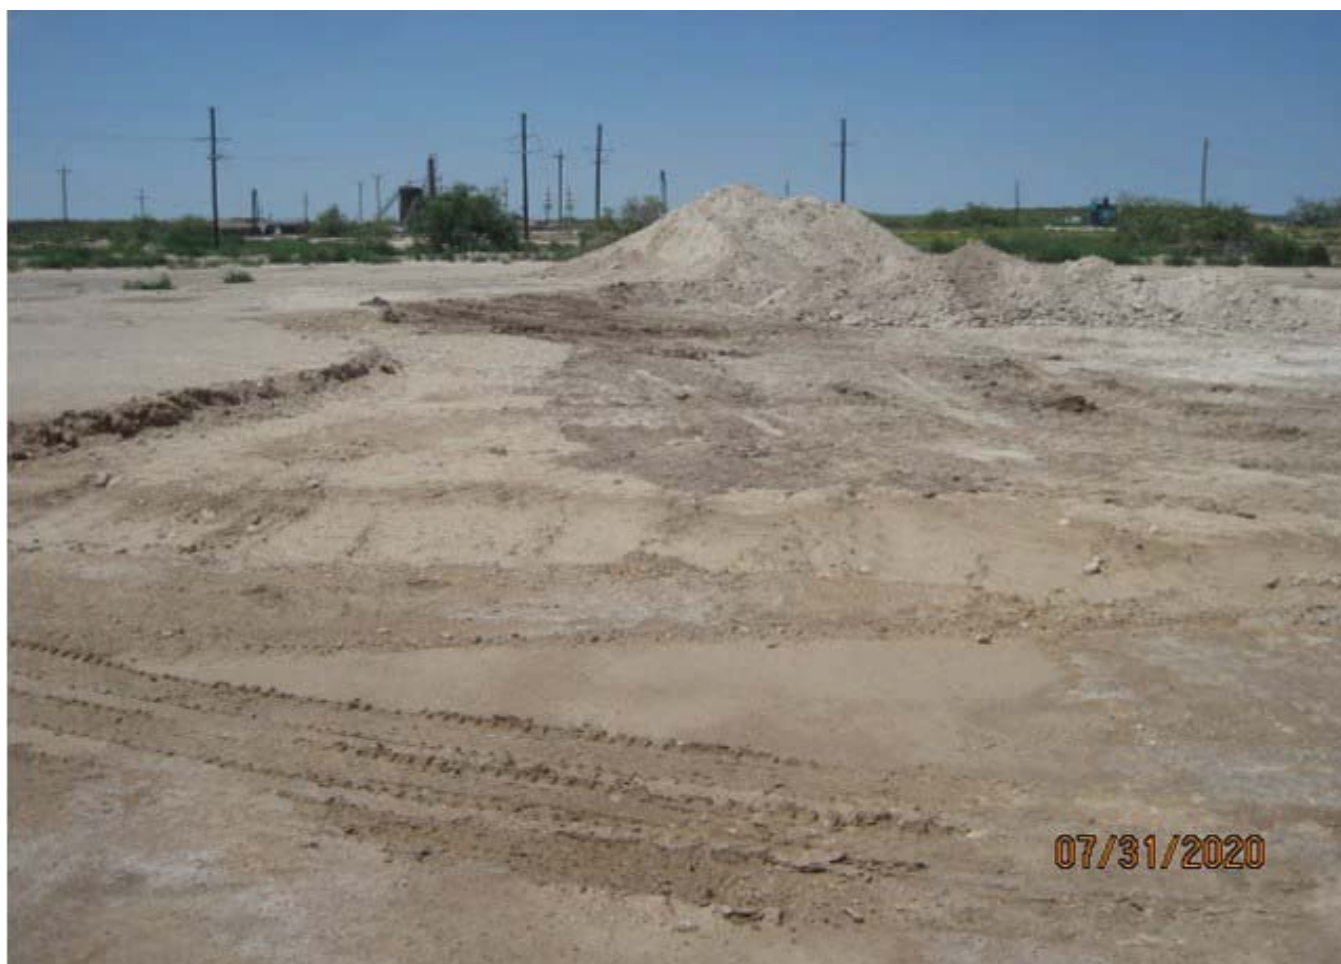
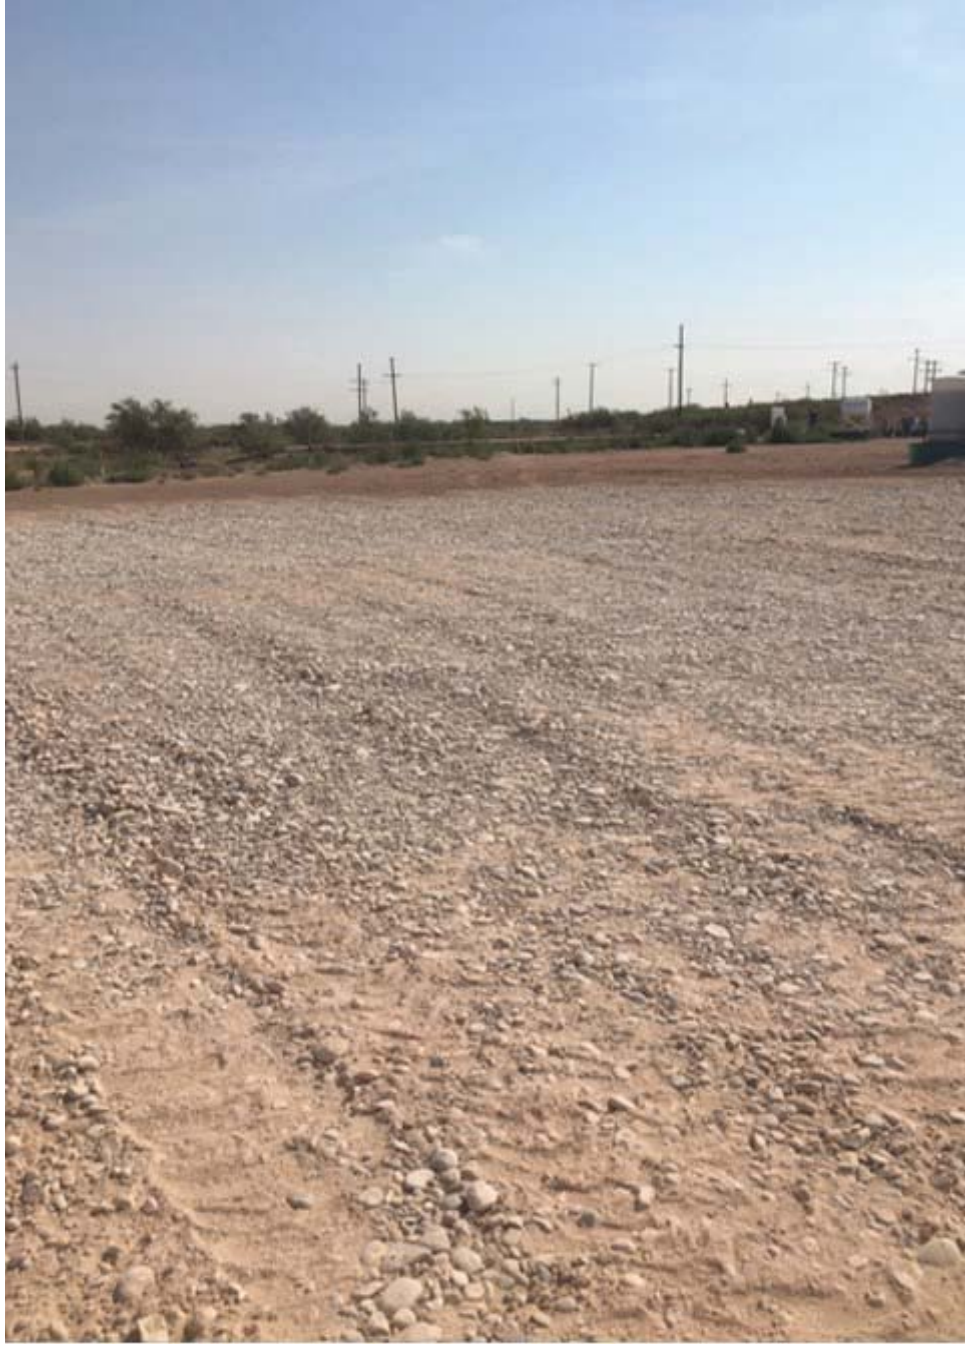
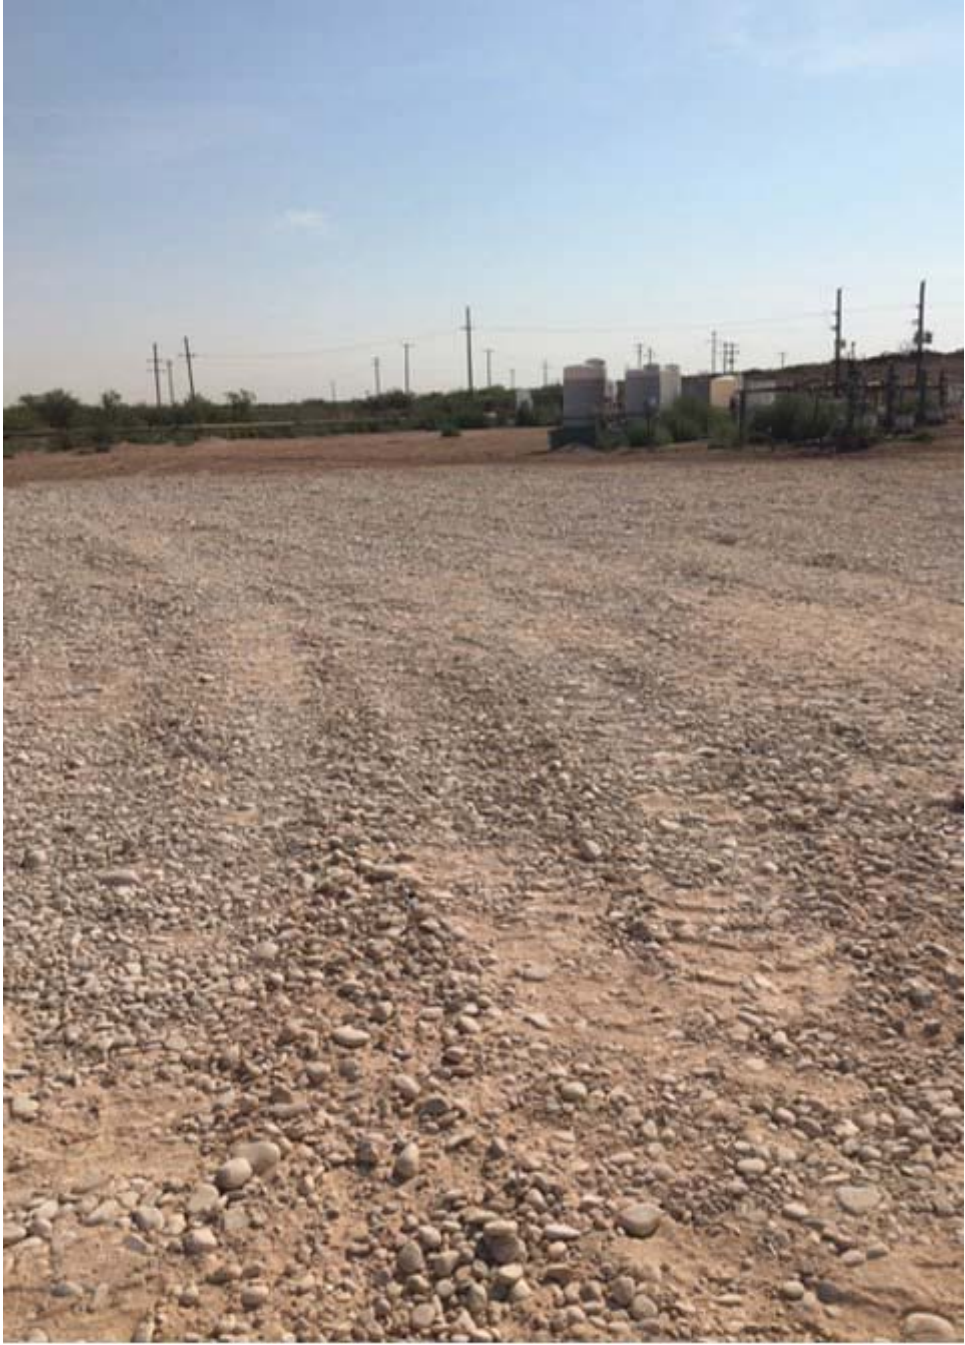
| Pictures | Remediation photos | |
