State of New Mexico  
Energy Minerals and Natural  
Resources Department

## Release Notification

| Site Name | James Ranch Unit SWD riser #105 nearest JRU DI1 #161H | Site Type | Salt Water Disposal line riser |

ATTACHMENT 2: PHOTOGRAPHIC LOG

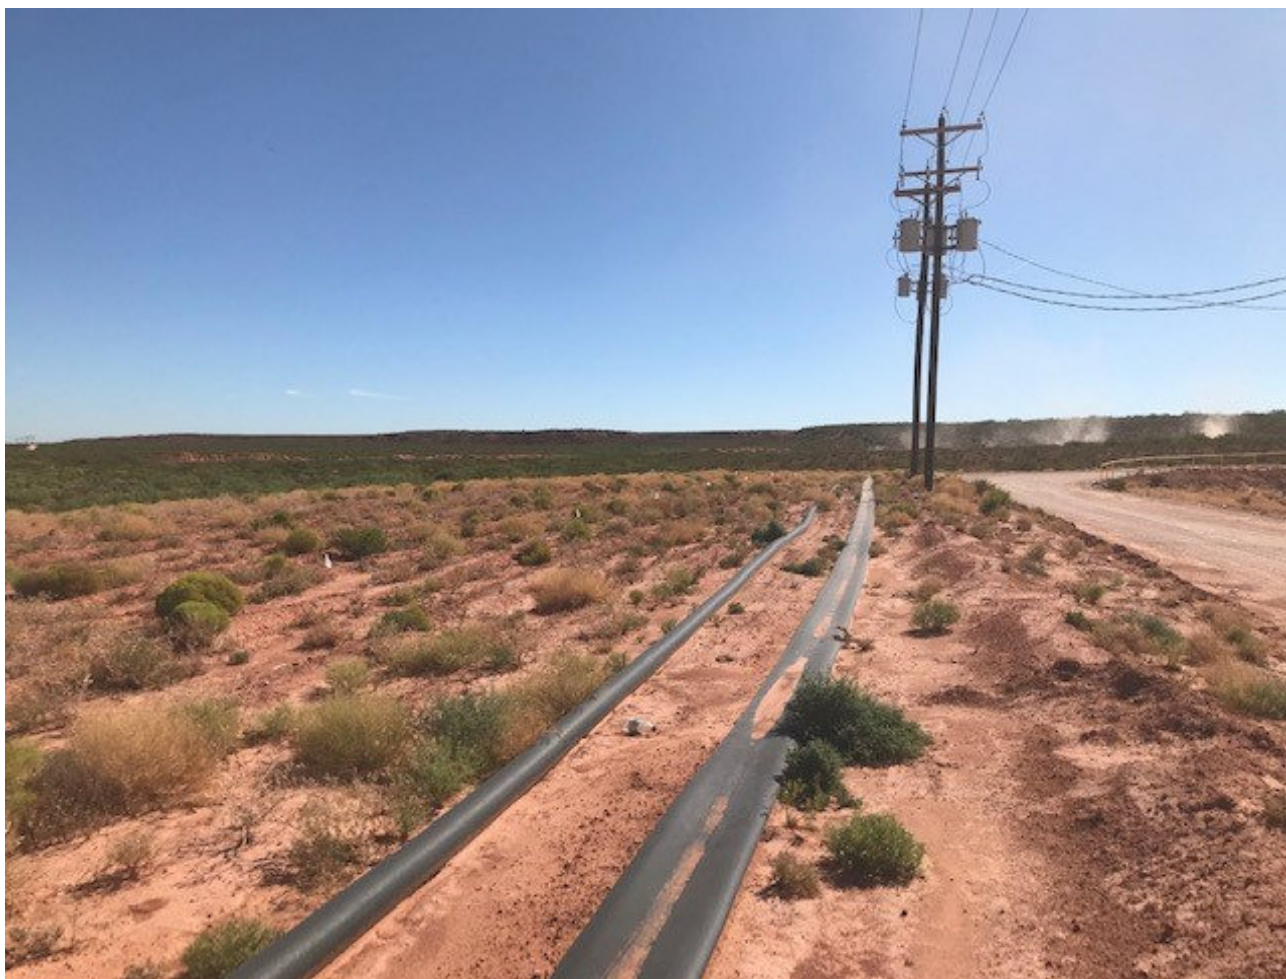
**Eastern view of release area during site assessment activities.**

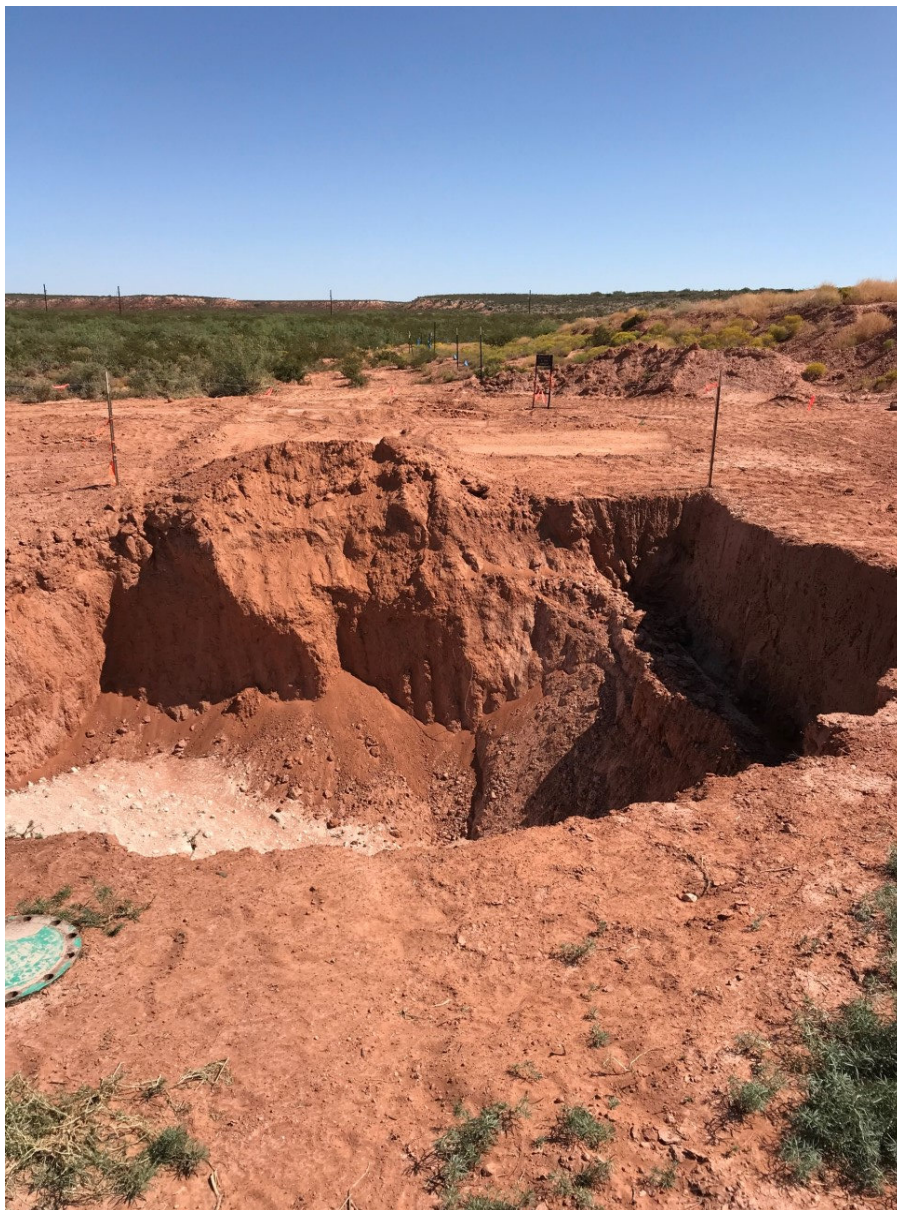
**Northern view of final excavation extent during confirmation soil sampling activities.**
