## Well Inclination Report

SM ENERGY

KEY #888

ESDU #33.

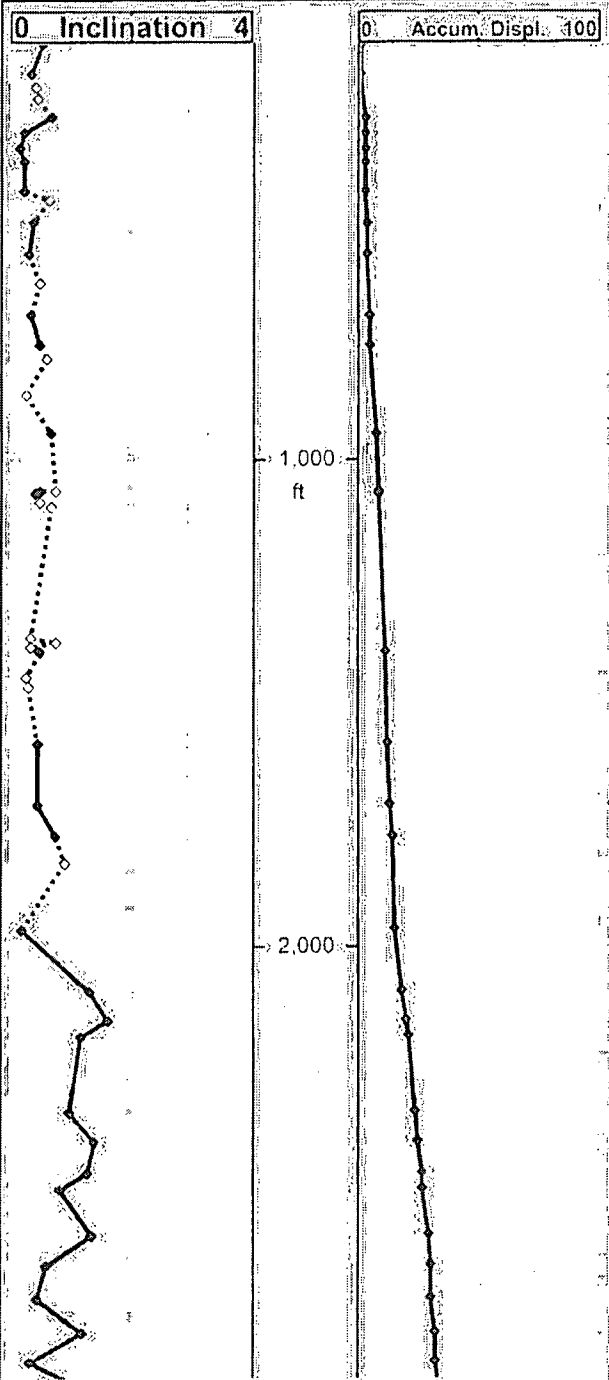
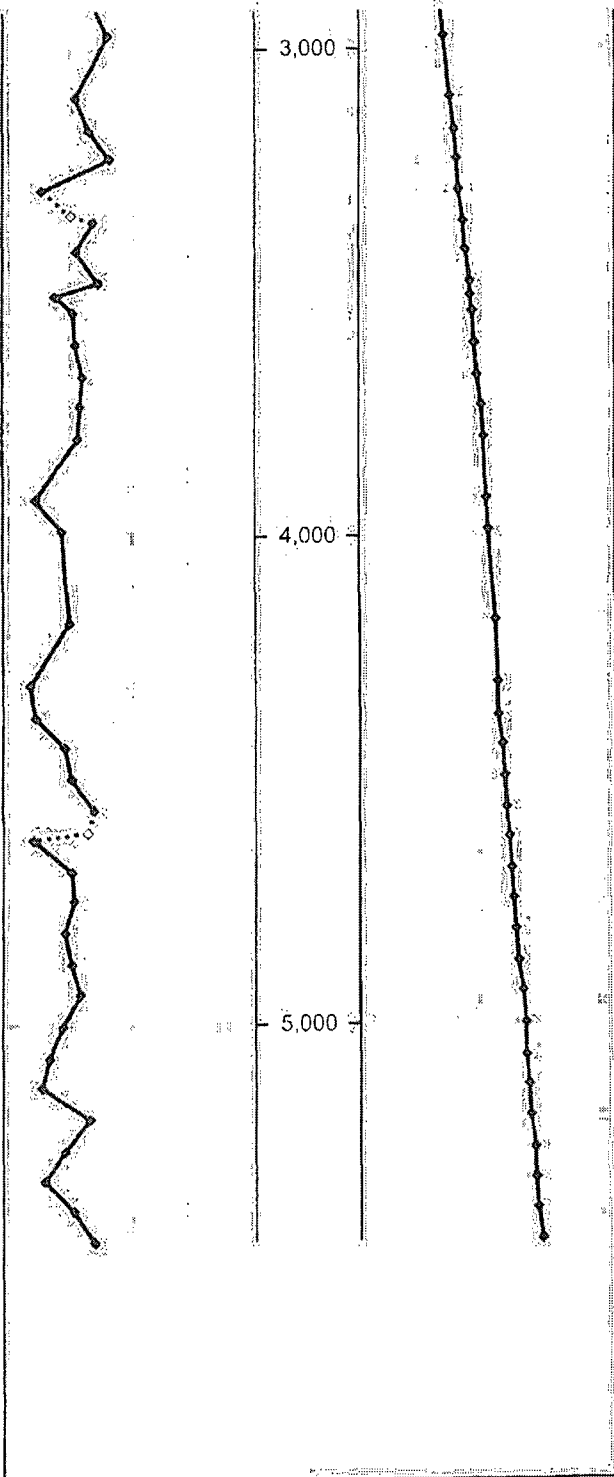
Data enclosed in [ ] are interpolated. The Driller chose not to enter depths for these surveys. These interpolated surveys are marked in the graph with unfilled boxes and are joined with dotted lines. Interpolated surveys are not used in the accumulative displacement calculation.

Inclination readings displayed in a small font were measured with slightly lower decoding accuracy than normal. This could occur, for example, if the Driller changed pump speed or tagged bottom prior to obtaining survey. These surveys are often very accurate. However, any such measurement that appears 'out of line' should be confirmed with a repeat survey.
