Release Notification and Corrective Action

Name of Company	GP II Energy, Inc. <b>8359</b>	Contact	Joe Compton
Address	PO Box 50682	Telephone No.	432-684-4748
Facility Name	Federal Littlefield "BO" Tank Battery	Facility Type	Tank Battery - Oil and Produced Water Storage

**LITTLEFIELD BO FEDERAL 002**  
**30-015-24529**

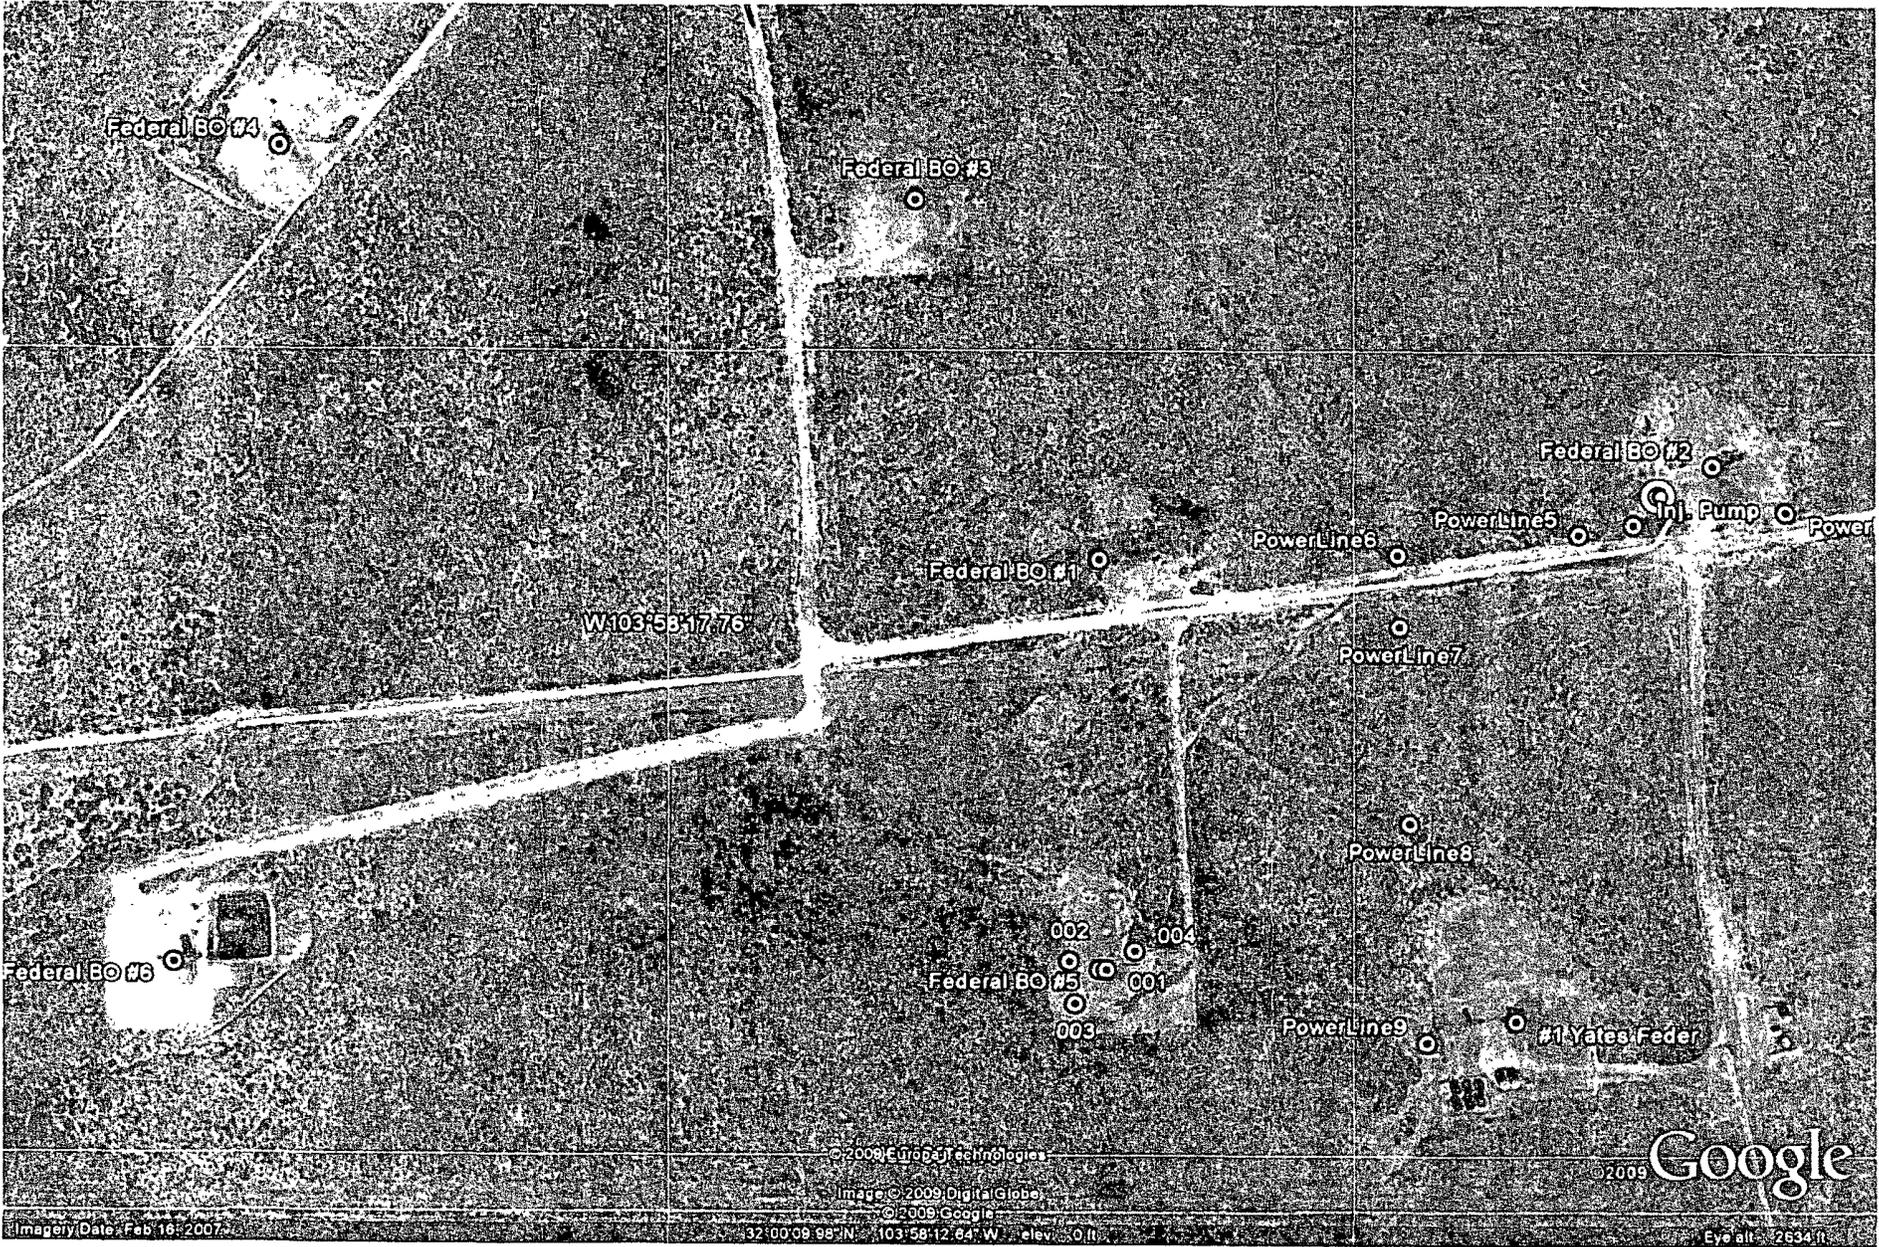
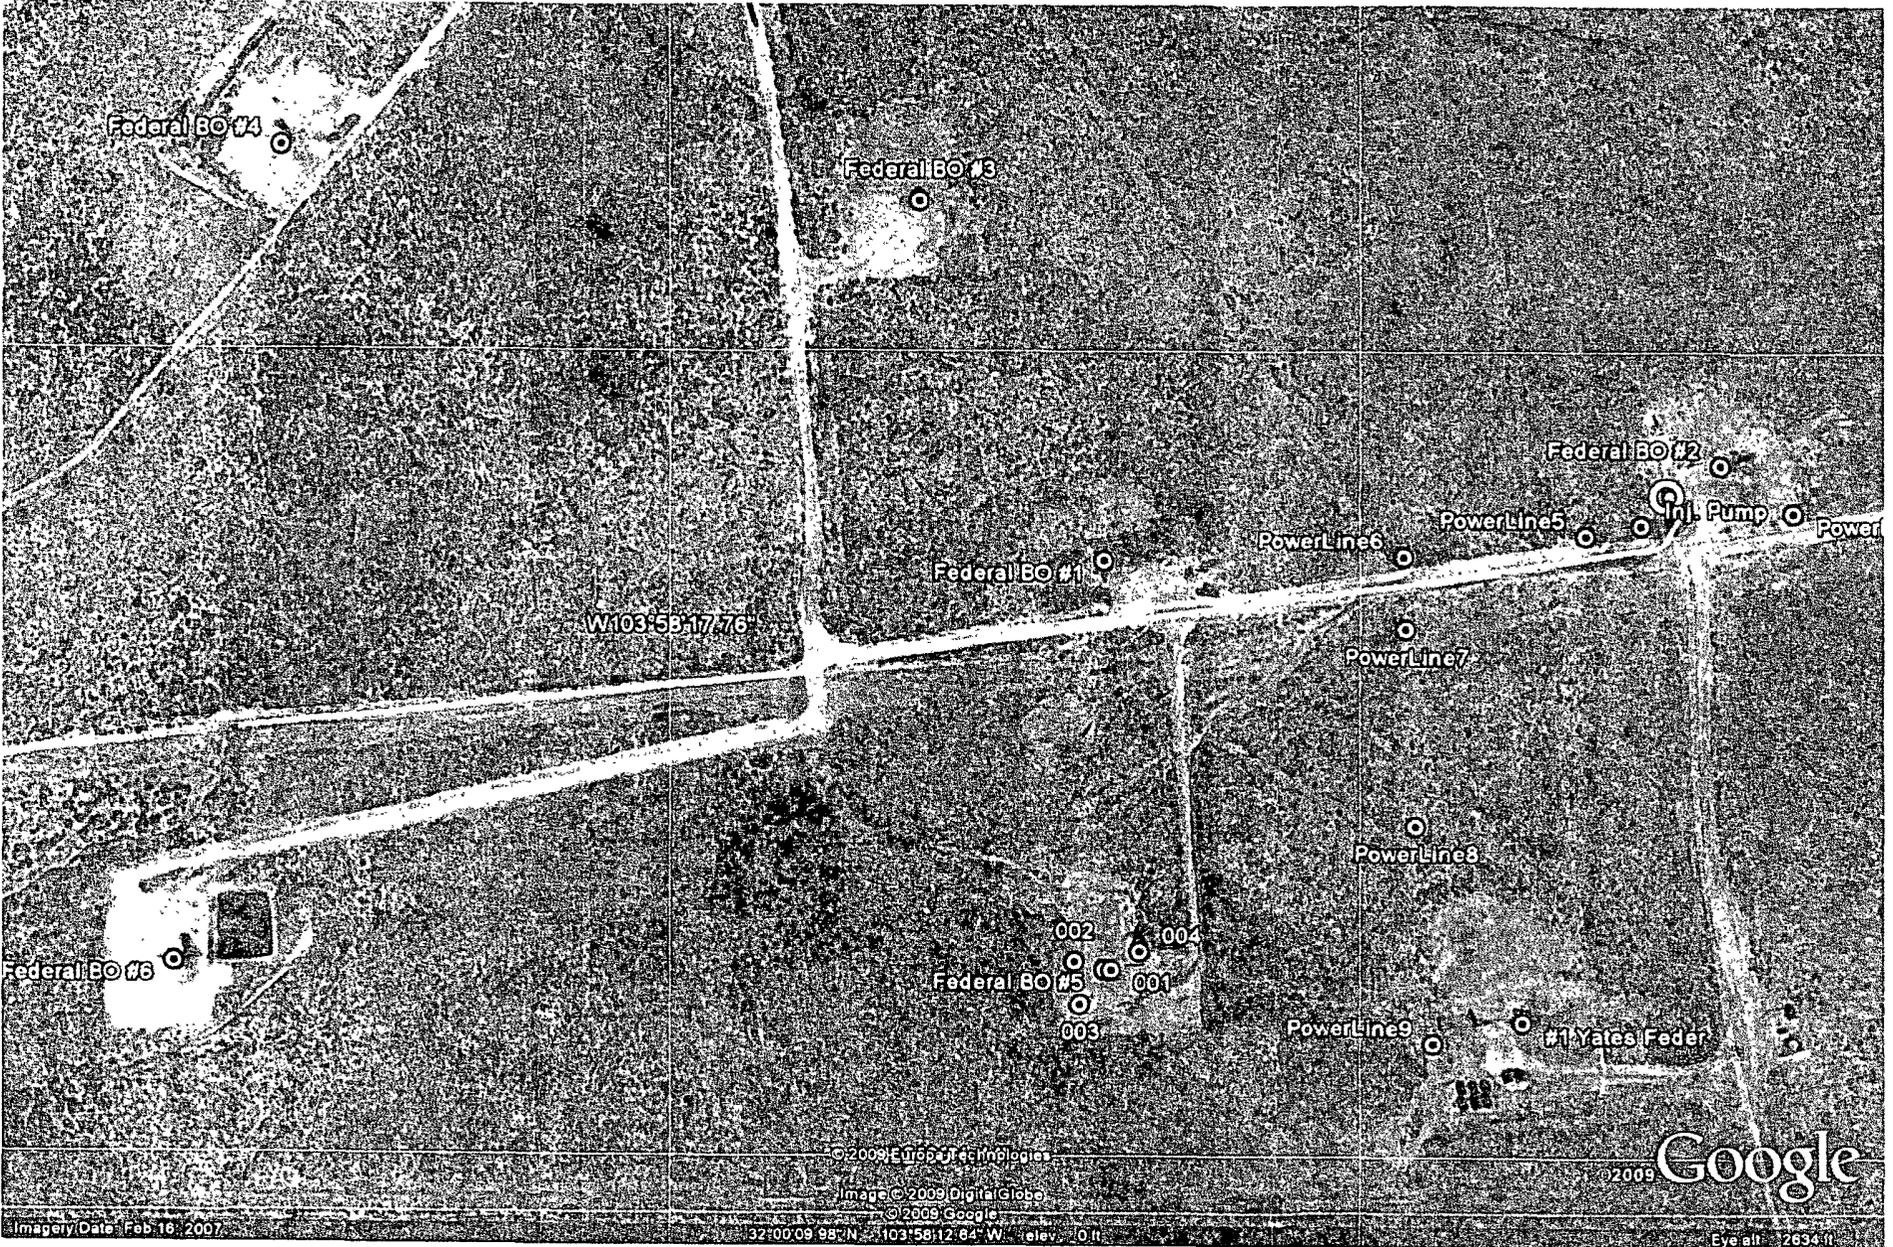
Describe Area Affected and Cleanup Action Taken.\* **Please refer to attached google earth map. The green line marks the length and path of the spill. We are currently removing contaminated soil and cleaning up the road under the direct supervision of a BLM field agent. We will have the cut areas sampled and analyzed for contamination prior to backfilling with approved soil or road material.**

Describe Cause of Problem and Remedial Action Taken.\* **Worked over Federal "BO" #6. Well flowed during night and pushed water from the gun barrel into oil storage tank. Equalizer was unable to accommodate flow and oil ran over the storage tank. We are going to install a larger gun barrel capable of handling production surges of this volume.**
