Details of bop test

Hondo Drilling Company

TX State #1

Test by Yellow Jacket Tools and Services, Inc.

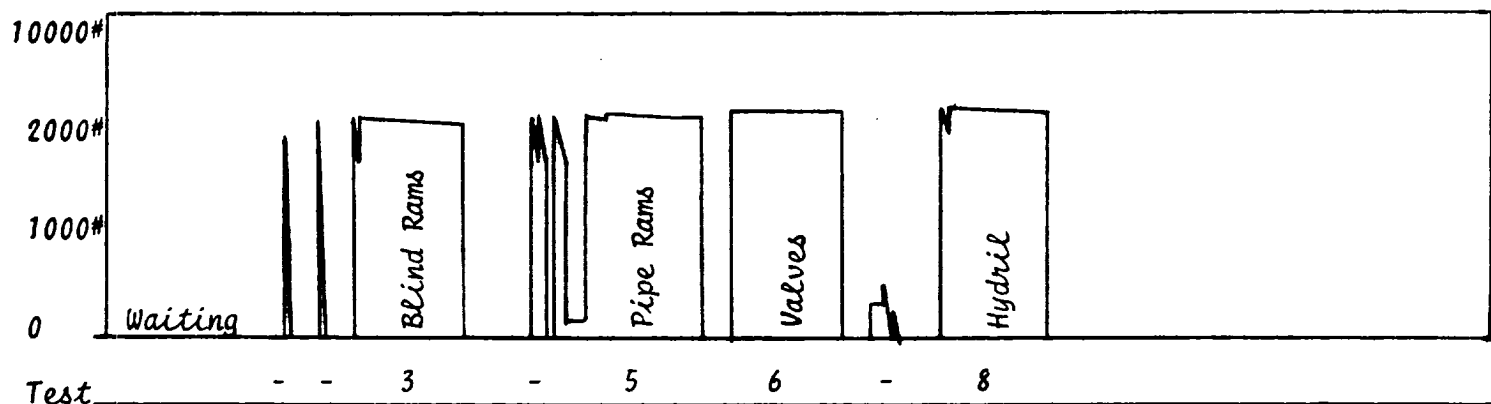
=====Transposition of the pressure recorder chart=====

The above is a transposition of the pressure recorder chart covering test to the blowout control equipment in service on your well drilling in the Carlsbad, New Mexico Area, Midland District, Texas. Test was made with test plug landed in casing head with the following test results:

TESTING: Blind Rams with outside valve closed off stack on kill line, outlet valve closed off choke-manifold cross, and outside wing valves closed off manifold cross - pressure applied thru guage connection.

Test #1 Pressured to 1800# with leak to flange between valve next to stack and chokeline. Tightened.

Test #2 Repeated test. Pressured to 2000# with leak to flange between inlet valve off choke-manifold cross and chokeline. Tightened.

Test #3 Repeated test. Pressured to 2000# with loss of pressure; re-pressured to 2000# with loss of approximately 100# during first seventeen minutes then leveling out for remaining one minute of test.

NO VISIBLE LEAK. PRESSURE LEVELING OUT TOWARDS APPROXIMATELY 1900#.
