Details of bop test

Coquina Oil Company

Midwest State #1

Test by Yellow Jacket Tools and Services, Inc.

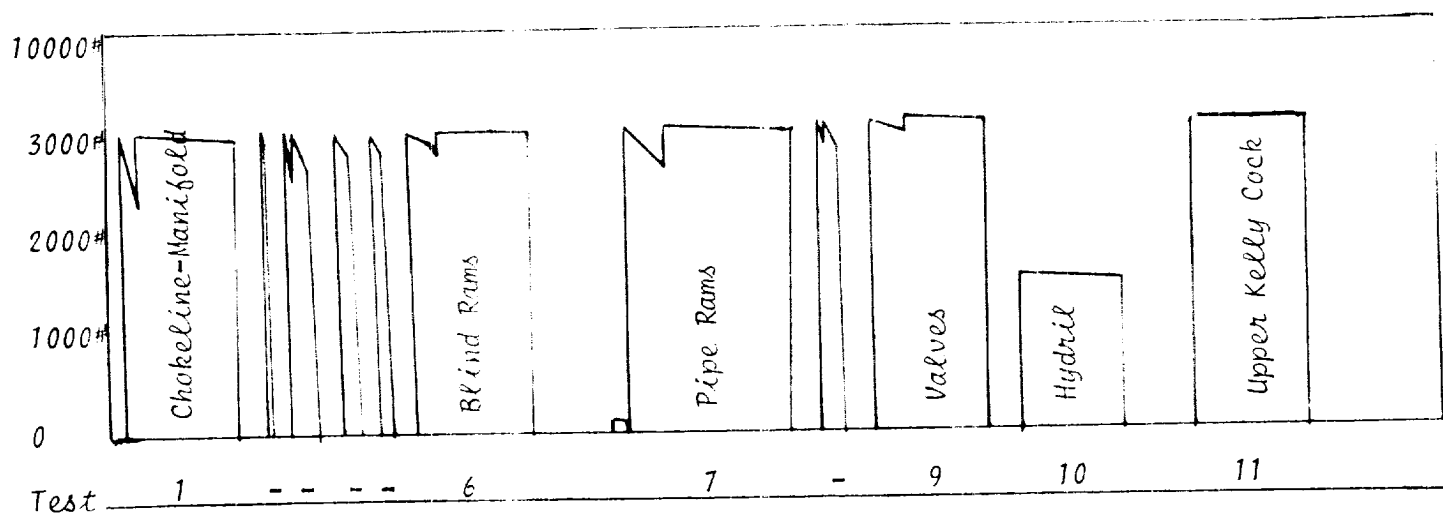
=====Transposition of the pressure recorder chart=====

The above is a transposition of the pressure recorder chart covering test to the blowout control equipment in service on your well drilling in the Sitting Bull Falls, New Mexico Area, Midland District, Texas. Test was made with test plug landed in casing head with the following test results:

TESTING: Chokeline-Manifold with valve closed next to stack on chokeline, outlet valve closed off choke-manifold cross, and outside wing valves closed off manifold cross - pressure applied thru guage connection.

Test #1 Pressured to 3000# with loss of pressure; repressured to 3000# with loss of approximately 100# during first ten minutes then leveling out for remaining five minutes of test.

NO VISIBLE LEAK. PRESSURE LEVELING OUT TOWARDS APPROXIMATELY 2900#.
