Details of bop test

Southern Union Production Company

Montray #1

8/5/74

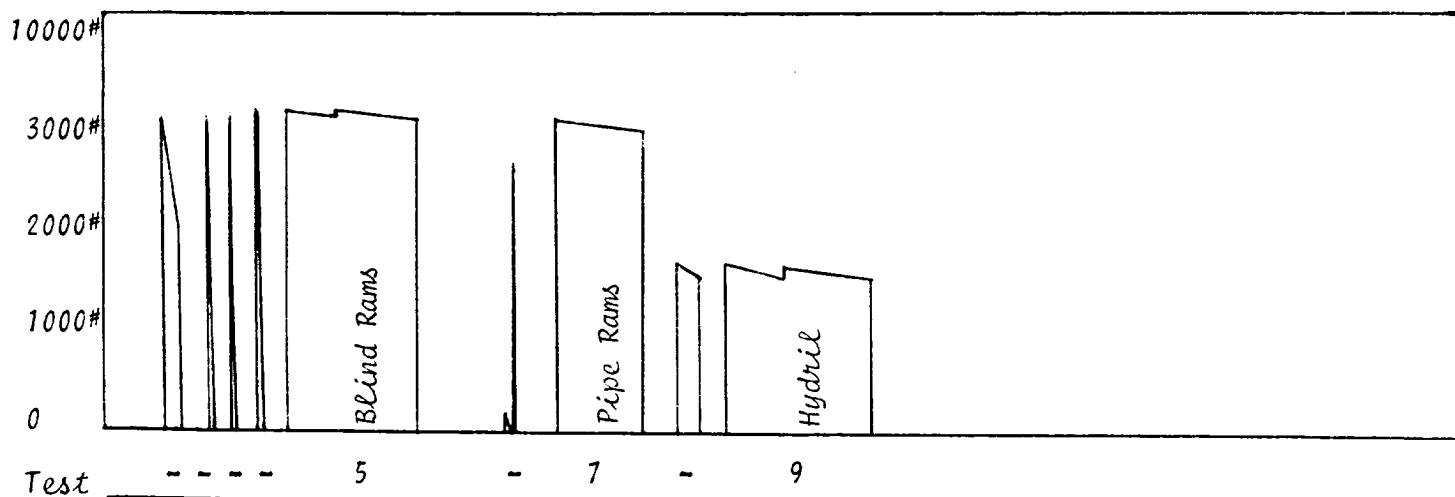
====Transposition of the pressure recorder chart====

The above is a transposition of the pressure recorder chart covering test to the blowout control equipment in service on your well drilling in the Sitting Bull Falls Area, Dallas District, Texas. Test was made with test plug landed in casing head with the following test results:

Test #1 Pressured to 3000# with leak to flange between pipe rams bop and adaptor spool. Tightened.

Test #2 Repeated test. Pressured to 3000# with loss of pressure. No test.

Test #3 Repeated test. Pressured to 3000# with leak to door seal of blind rams bop (doghouse side). Tightened.

Test #4 Repeated test. Pressured to 3000# with leak to both rod packings of blind rams bop. Tightened.

Test #5 Repeated test. Pressured to 3000# with slight loss of pressure;
