MARALO, INC.  
 Hanson Federal Lease - Well No. 3  
 Eddy County, New Mexico

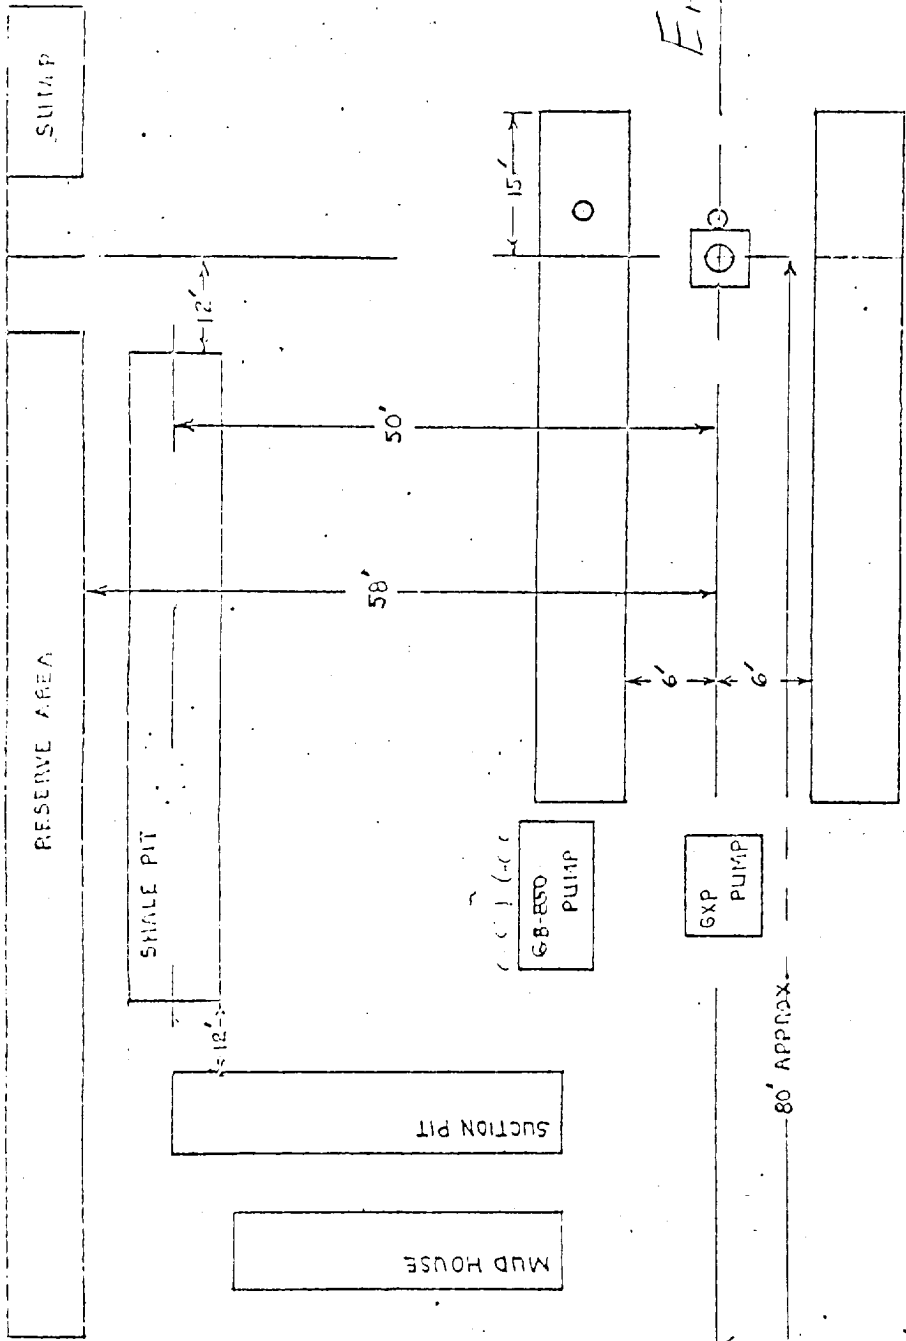
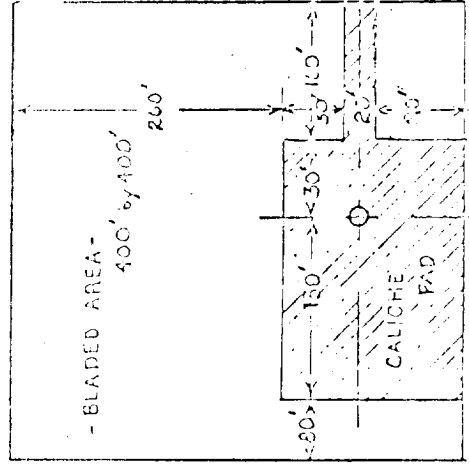
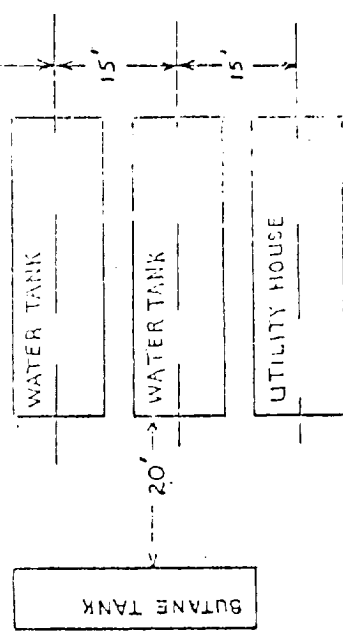
PER LAP, INC.  
 FIG-1  
 NO SCALE

SUBSTRUCTURE HEIGHT: 18'  
 RATHOLE: 10' NORTH & 6' EAST  
 20' DEEP - 1/2 BUBBLE  
 MOUSE HOLE: 4 1/2' EAST & 0' SOUTH  
 1/2 BUBBLE; 19' DEEP
