Details of bop test

H N G Oil Company

Pardue #1

Test by Yellow Jacket Tools and Services, Inc.

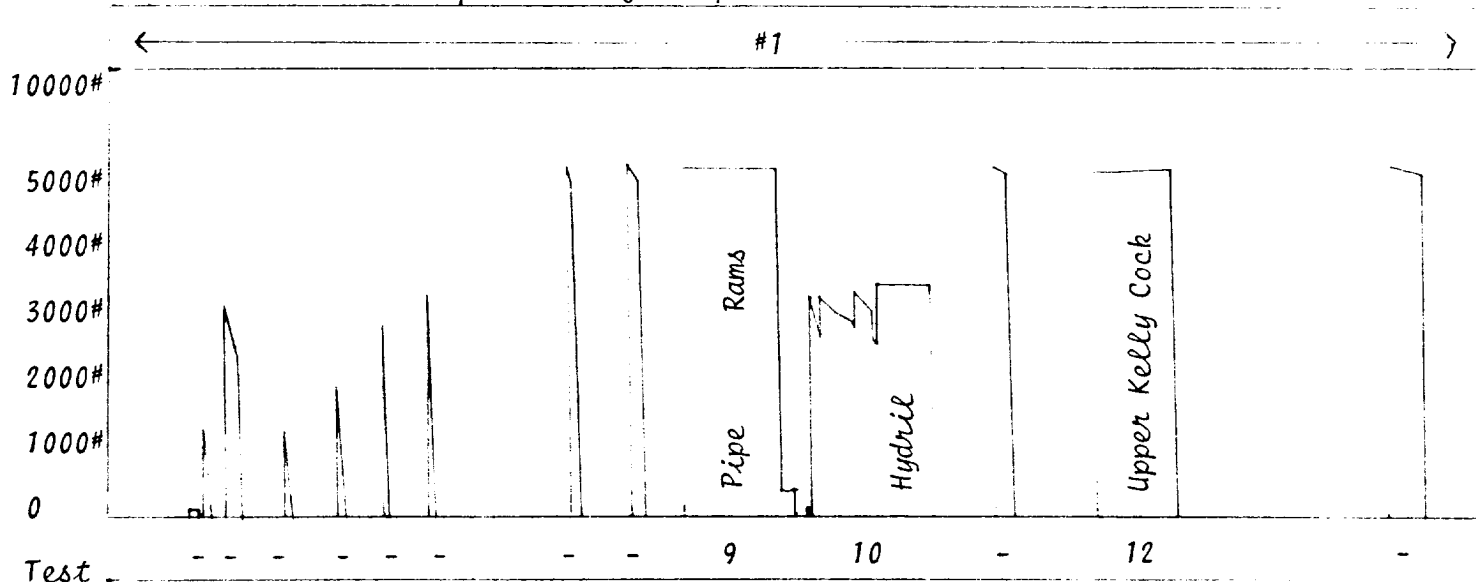
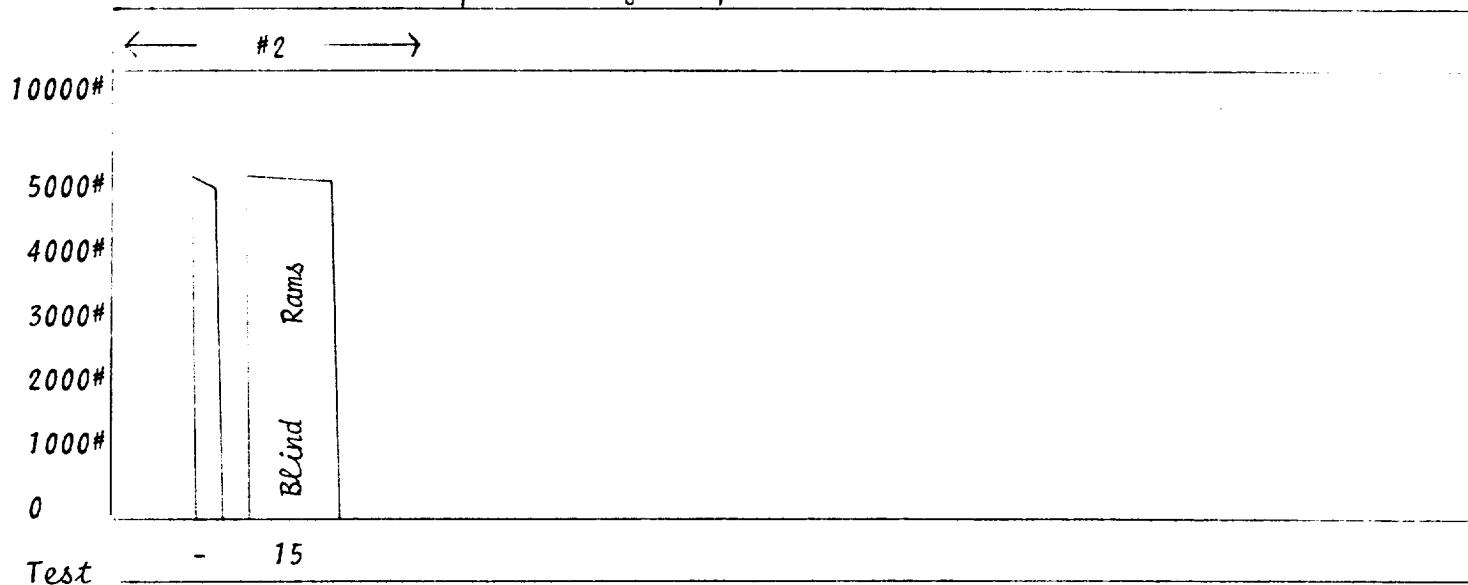
=====Transposition of the pressure recorder charts=====

The above is a transposition of the pressure recorder charts covering test to the blowout control equipment in service on your well drilling in the Carlsbad, New Mexico Area, Midland District, Texas. Test was made with test plug landed in casing head with the following test results:
