Details of bop test

Mobil Oil Corporation

Etter #1

2/27/74

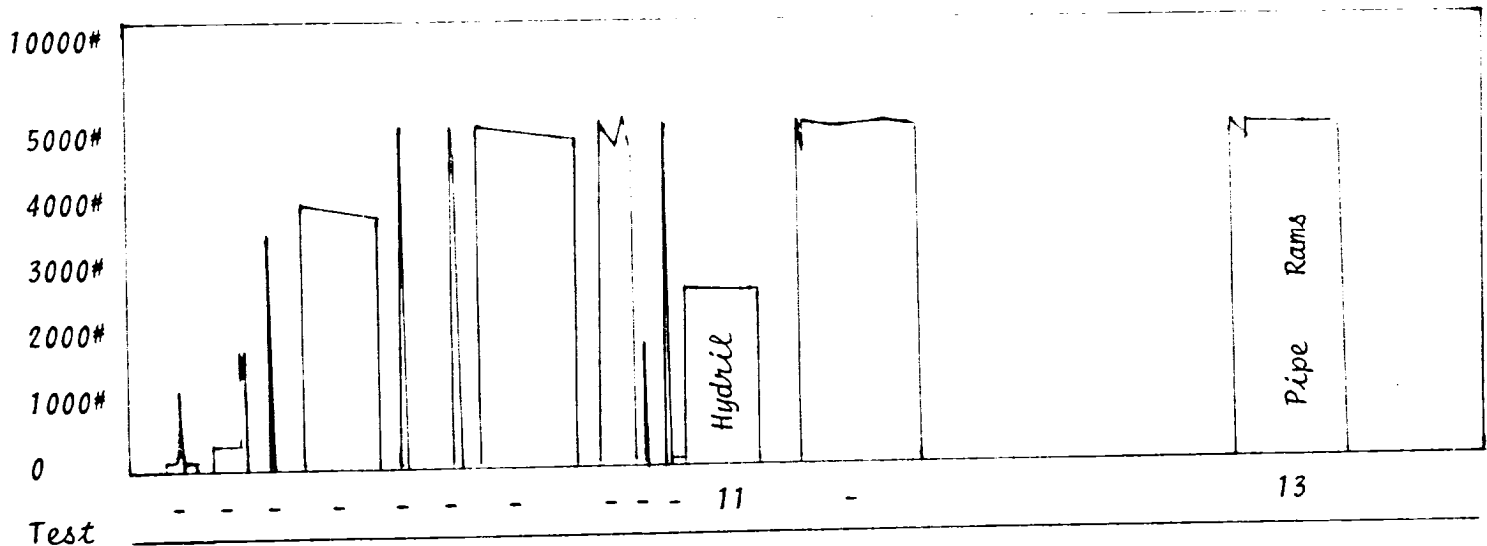
=====Transposition of the pressure recorder chart=====

The above is a transposition of the pressure recorder chart covering test to the blowout control equipment in service on your well drilling in the Carlsbad Area, Hobbs District, New Mexico. Test was made with test packer landed in top of casing with the following test results:

TESTING: Pipe Rams with valve closed next to stack on kill line and all valves closed off choke-manifold cross - pressure applied down drill pipe.

Test #1 Pressured to 1000# and released air. No test.

Test #2 Repeated test. Pressured to 400# with pressure steady; re-pressured to 1500# with loss of pressure; repressured to 1500# with leak to flange between stack and valve next to stack on kill line. Tightened.

Test #3 Repeated test. Pressured to 3500# with leak to flange between spacer spool and casing spool. Tightened.
