Details of bop test      AMOCO Production Company      Trails Canyon Unit #1      6/13/74

Contractor: Noble Drlg. Rig N-83      Test by Yellow Jacket Tools and Services, Inc.

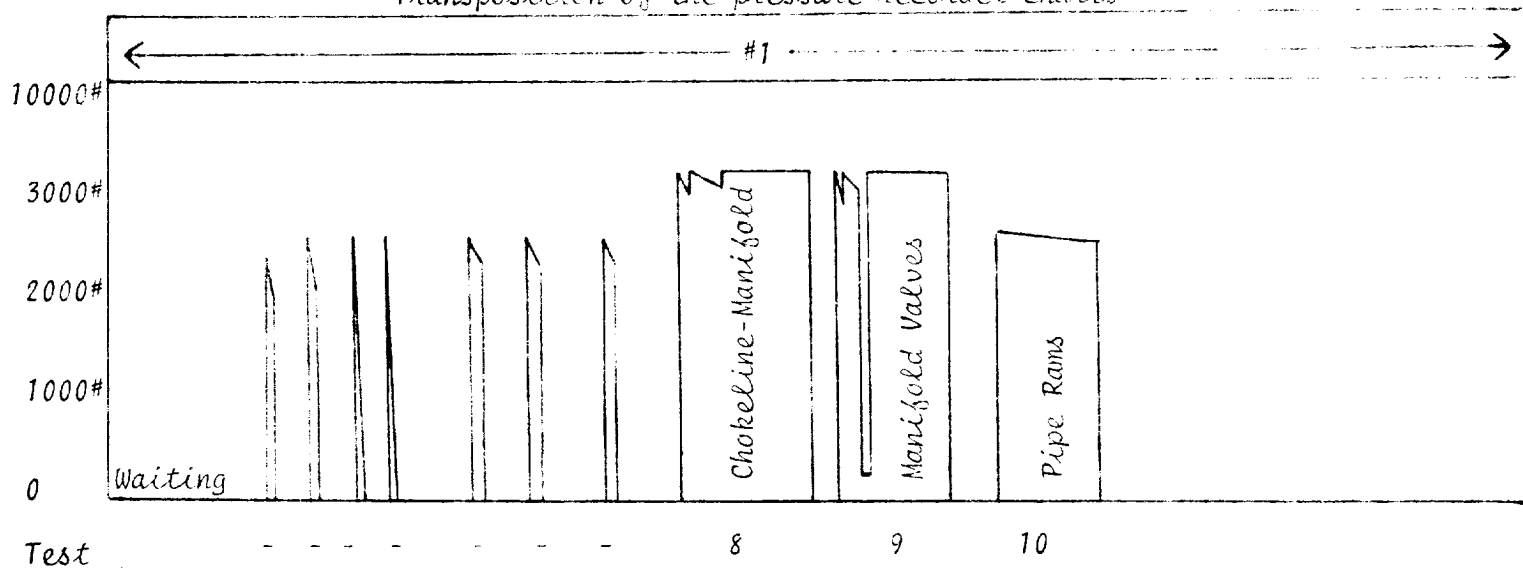
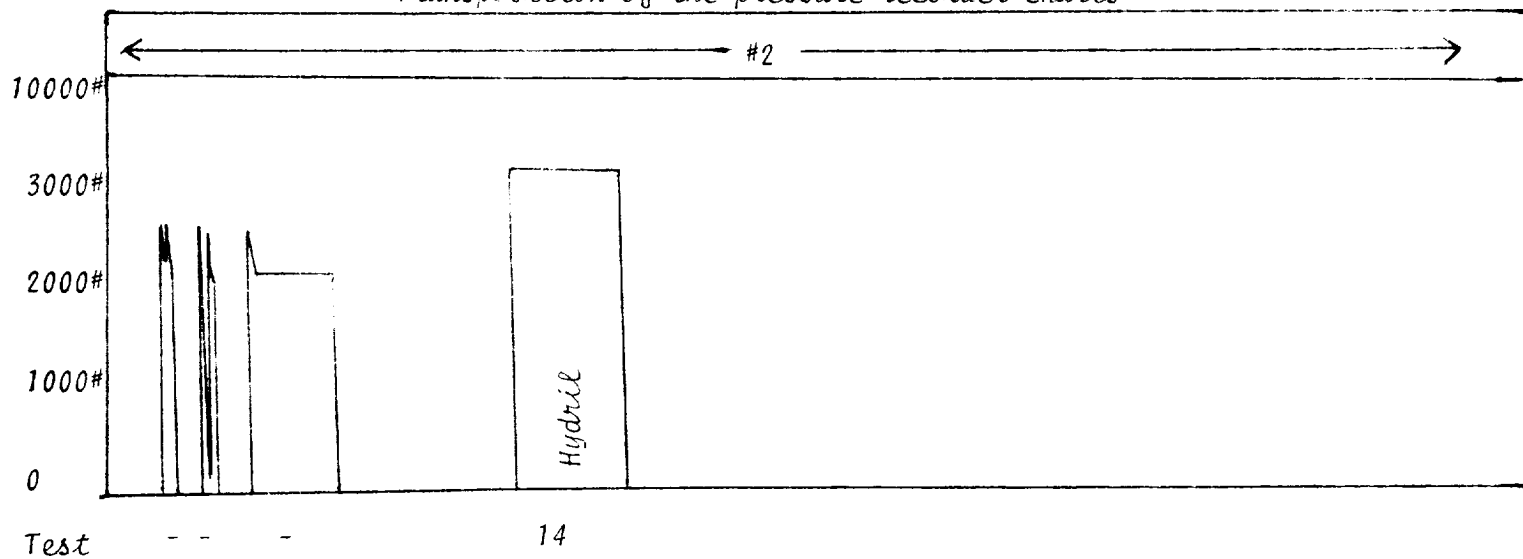
The above is a transposition of the pressure recorder charts covering test to the blowout control equipment in service on your well drilling in the Sitting Bull Falls, New Mexico Area, Hobbs District, New Mexico. Test was made with test packer landed in top of casing with the following test results:
