Details of bop test

Coquina Oil Company

Jack State #1

10/4/74

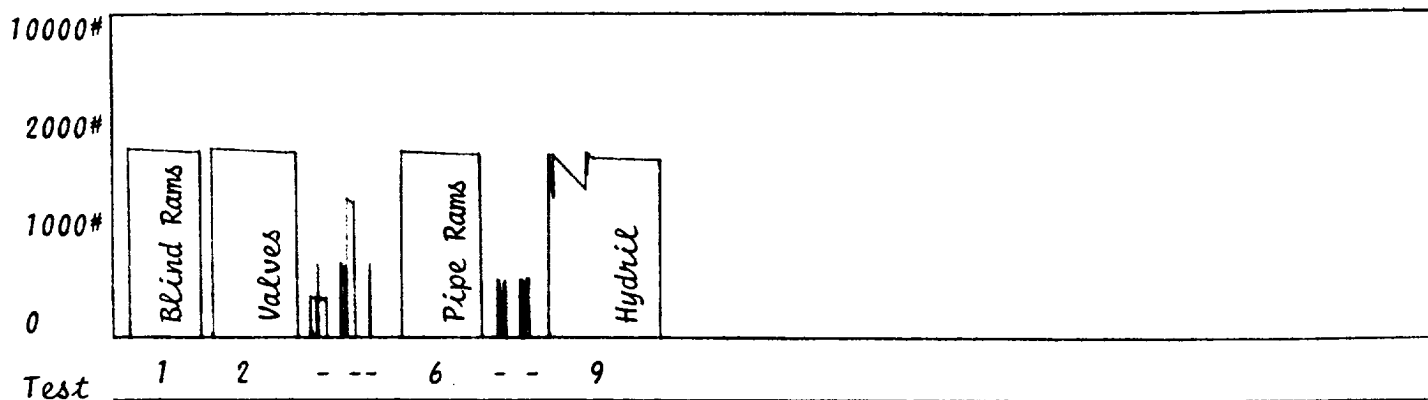
=====Transposition of the pressure recorder chart=====

The above is a transposition of the pressure recorder chart covering test to the blowout control equipment in service on your well drilling in the Carlsbad, New Mexico Area, Midland District, Texas. Test was made with test plug landed in casing head with the following test results:

TESTING: Blind Rams with outlet valve closed off choke-manifold cross and inside wing valves closed off manifold cross - pressure applied thru guage connection.

Test #1 Pressured to 1800# with loss of approximately 100# during first eleven minutes then leveling out for remaining one minute of test.

NO VISIBLE LEAK. PRESSURE LEVELING OUT TOWARDS APPROXIMATELY 1700#.

TESTING: Outlet valve off choke-manifold cross and outside wing valves off manifold cross with blind rams closed - pressure applied as before.

Test #2 Pressured to 1800# with loss of approximately 100# during first twelve minutes then leveling out for remaining one
