Details of bop test

Apexco, Inc.

Henry Grady #1

Test by Yellow Jacket Tools and Services, Inc.

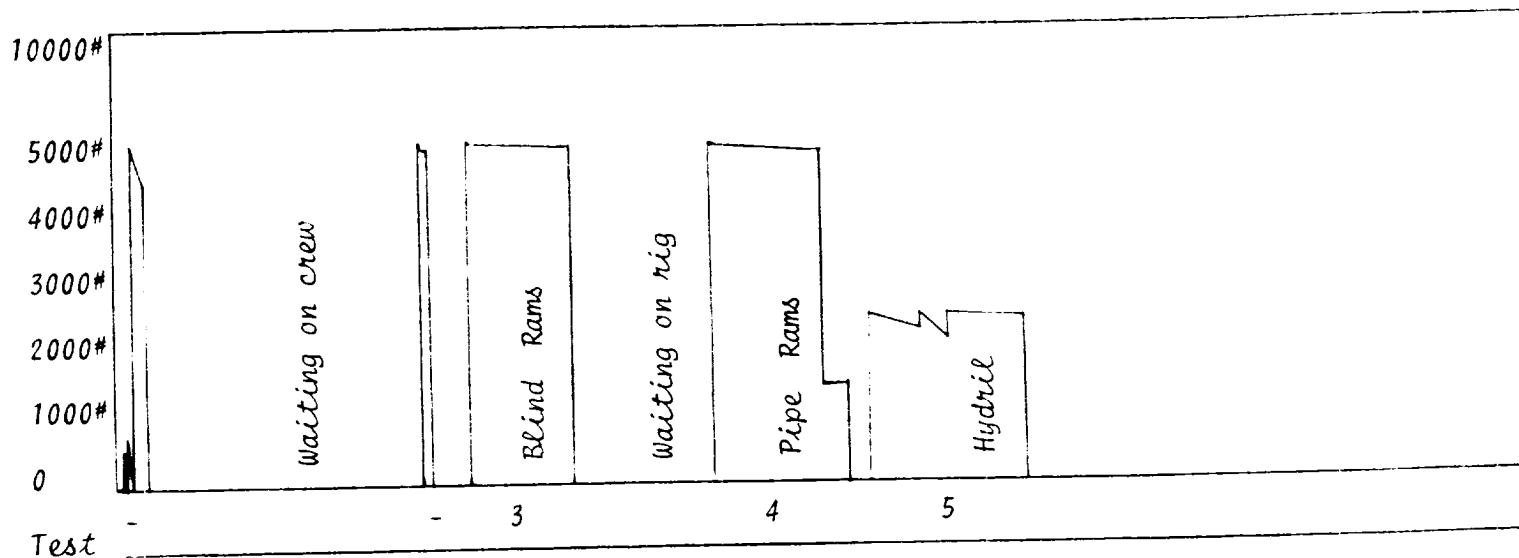
=====Transposition of the pressure recorder chart=====

The above is a transposition of the pressure recorder chart covering test to the blowout control equipment in service on your well drilling in the Carlsbad, New Mexico Area. Levelland District, Texas. Test was made with test plug landed in casing head with the following test results:

TESTING: Blind Rams with valve closed next to stack on kill line, outlet valve closed off choke-manifold cross, and outside wing valves closed off manifold cross - pressure applied thru guage connection.

Test #1 Pressured to 400# and released air; repressured to 600# and released air; repressured to 5000# with leak to flange between blind rams bop and casing spool.

Test #2 Repeated test. Pressured to 5000# with leak to flange between tee and chokeline. Tightened.

Waiting on crew to tighten.
