Details of bop test

American Quasar

Huber State #1

2/11/75

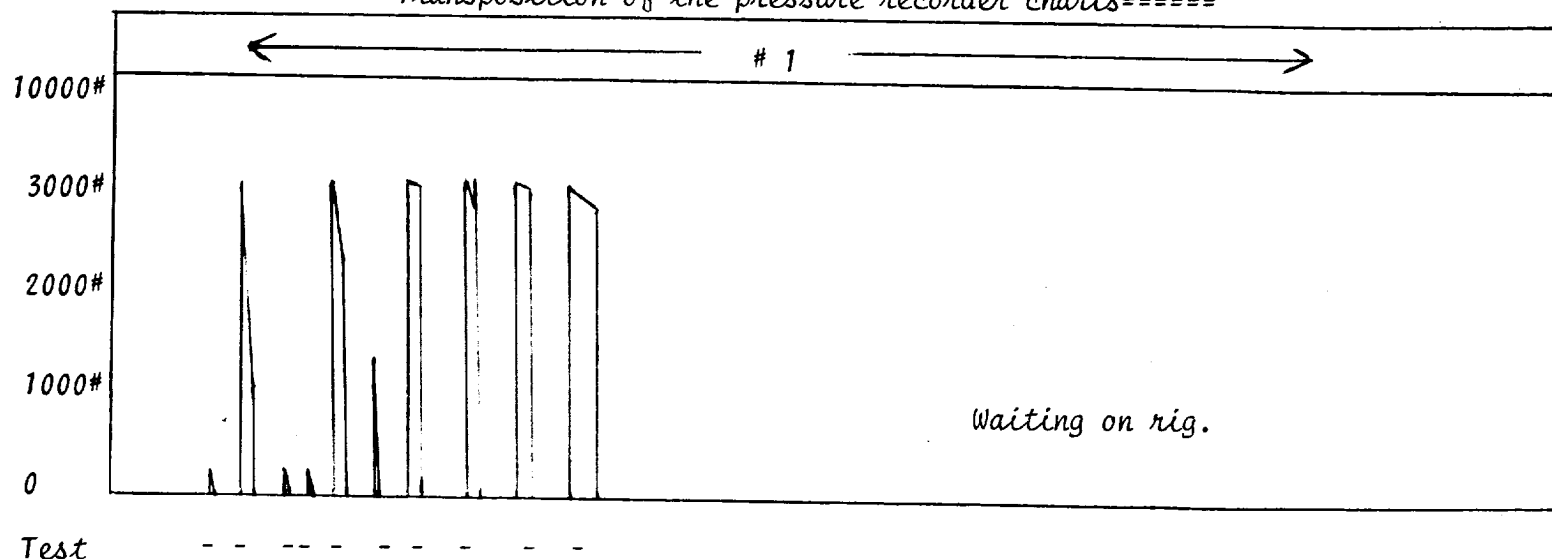
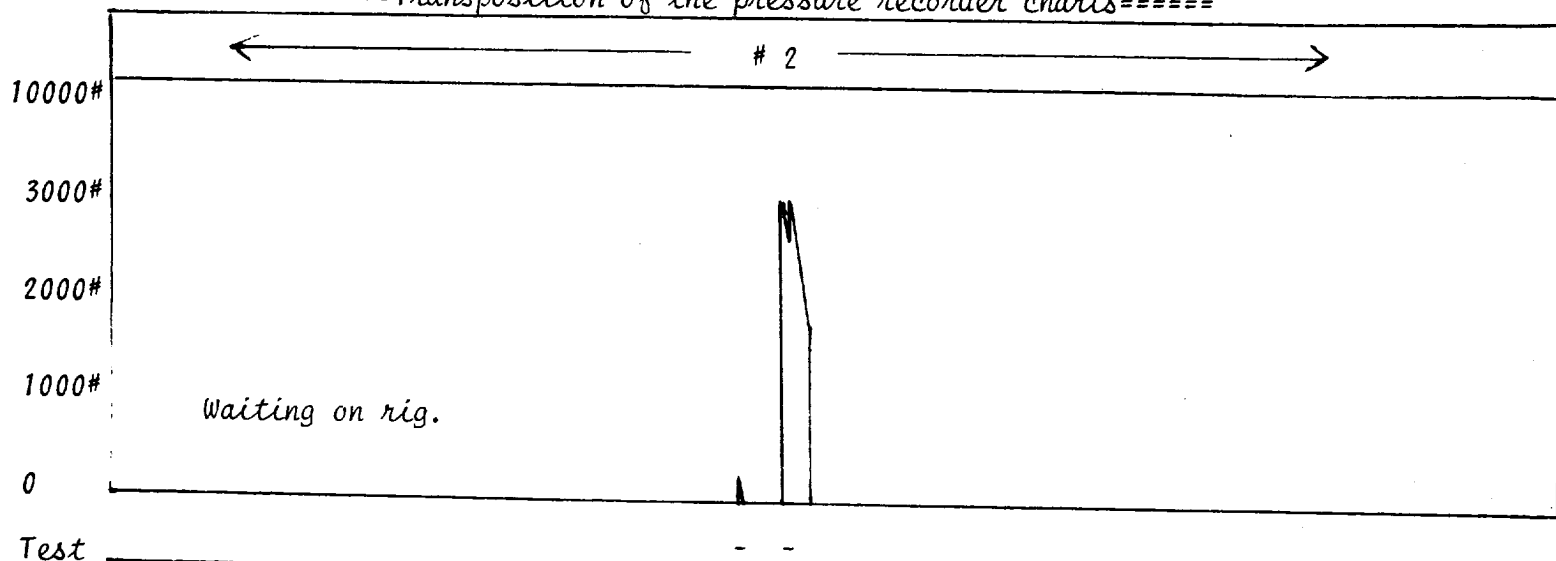
=====Transposition of the pressure recorder charts=====

The above is a transposition of the pressure recorder charts covering test to the blowout control equipment in service on your well drilling in the Sitting Bull Falls, New Mexico Area, Midland District, Texas. Test was made with test plug landed in casing head with the following test results:

TESTING: Blind Rams with valve closed next to stack on kill line, outlet valve closed
