**PIT REMEDIATION AND CLOSURE REPORT**

30-039-07624

Facility Or: SJ 29-6 # 36

Location: Unit or Qtr/Qtr Sec H Sec 15 T 29 N R 6 W County Rio Arriba

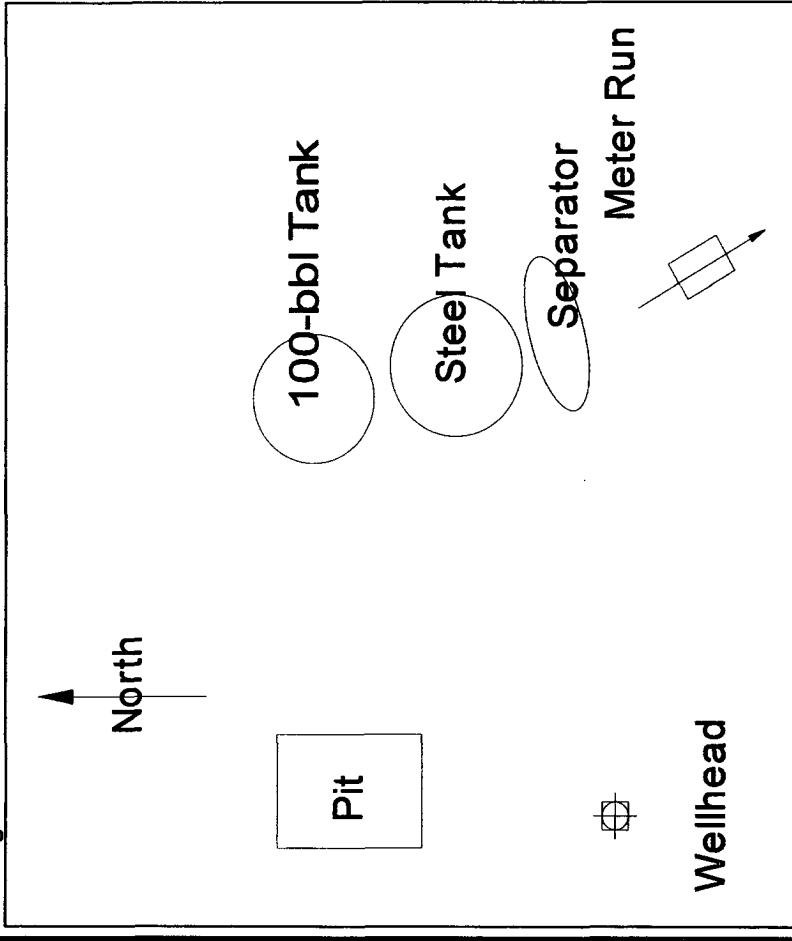
Site Diagram:

Sample location Soil sample collected from center of pit with hand probe

Sample depth 3-feet below pit bottom

Initial size: 12' X 12' X 3' deep

Final Size: 12' X 12' X 3' deep

Not to Scale
