**PIT REMEDIATION AND CLOSURE REPORT**

Facility Or: SJ 29-6 # 32A

Location: Unit or Qtr/Qtr Sec F Sec 11 T 29 N R 6 W County Rio Arriba

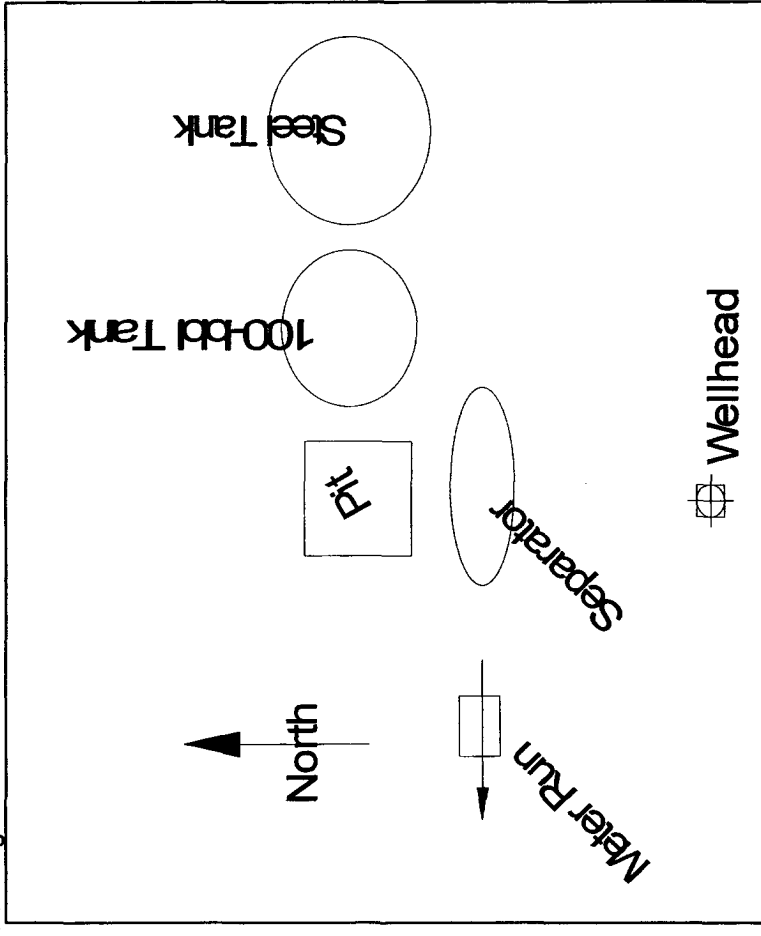
Site Diagram:

Final Pit: Sample location Soil sample collected from center of pit with hand probe

Sample depth 3-feet below pit bottom

**Initial size:** 25' X 15' X 3' deep
