**PIT REMEDIATION AND CLOSURE REPORT**

Facility Or: SJ 29-6 # 33 A

Location: Unit or Qtr/Qtr Sec XJ Sec 13 T 29 N R 6 W County Rio Arriba

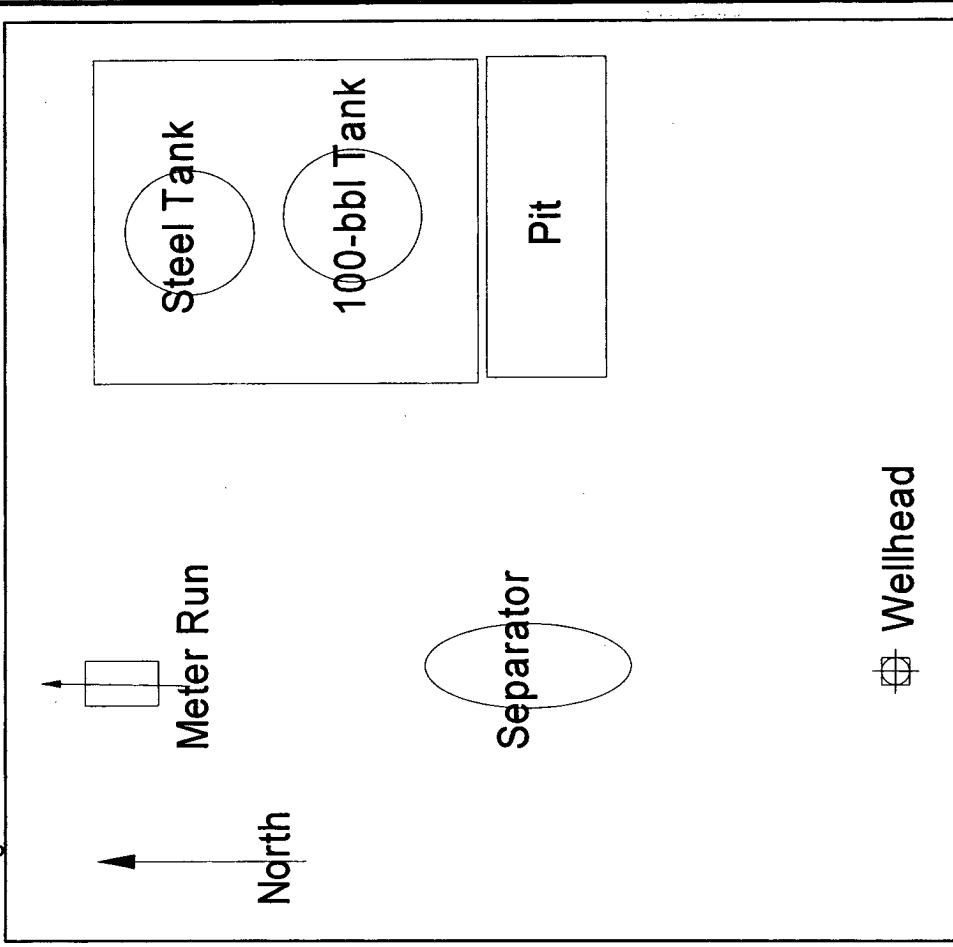
Site Diagram:

Final Pit: Sample location Soil sample collected from center of pit with hand probe

Sample depth 3-feet below pit bottom

Initial size: 25' X 15' X 3' deep

Final Size: 25' X 15' X 3' deep
