**PIT REMEDIATION AND CLOSURE REPORT**

30-039-21575

Facility Or: SJ 29-6 # 41 A  
Well Name

Location: Unit or Qtr/Qtr Sec XJ Sec 24 T 29 N R 6 W County Rio Arriba

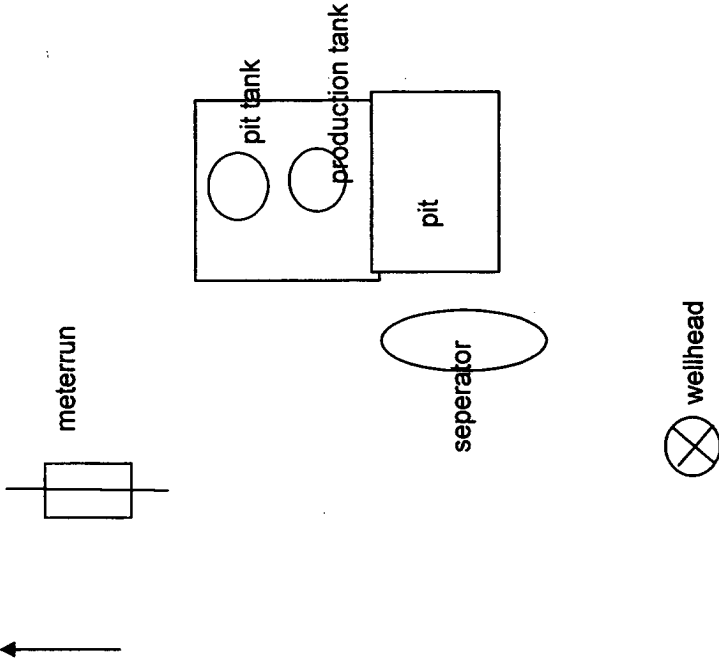
Site Diagram:

Final Pit: Sample location Soil sample collected from center of pit with hand probe

Sample depth 3-feet below pit bottom

Not to Scale
