**PIT REMEDIATION AND CLOSURE REPORT**

Operator: ConocoPhillips Telephone: 505-599-3400

Facility Or: SJ 29-6 # 30 30-039-07663  
Well Name

Location: Unit or Qtr/Qtr Sec H Sec 10 T 29 N R 6 W County Rio Arriba

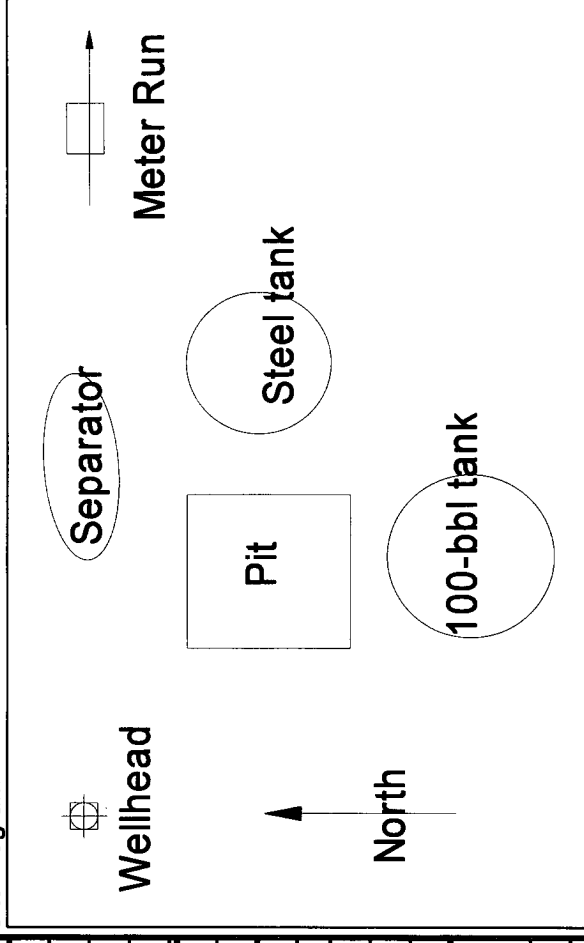
**Site Diagram:**

Final Pit: Sample location Soil sample collected from center of pit with hand probe  
Closure Sampling: \_\_\_\_\_  
(if multiple samples,  
attach sample results  
and diagram of sample  
locations and depths) Sample depth 3-feet below pit bottom

Soil is brown sandy/clayey loam. H-C odor was present, slight H-C staining
