**PIT REMEDIATION AND CLOSURE REPORT**

Operator: ConocoPhillips Telephone: 505-599-3400

Facility Or: SJ 29-6 # 1 A 30-039-21124  
Well Name

Location: Unit or Qtr/Qtr Sec P Sec 3 T 29 N R 6 W County Rio Arriba

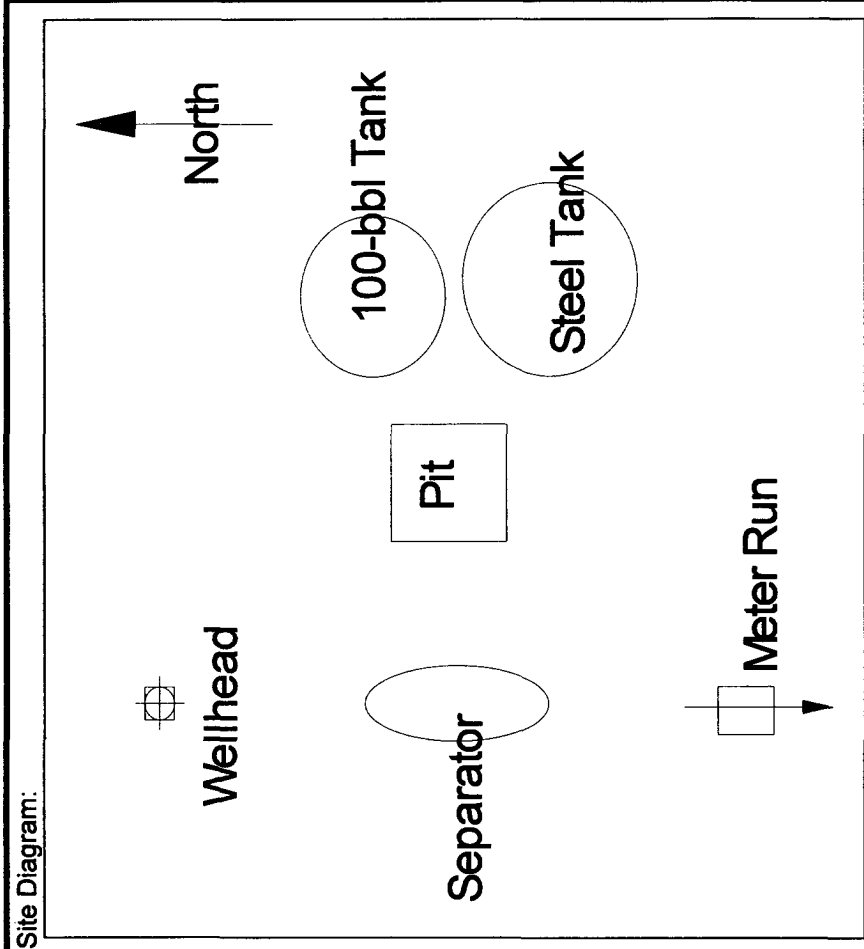
## Not to Scale

Final Pit: Sample location Soil sample collected from center of pit with hand probe

Sample depth 3-feet below pit bottom

Comments:  
Soil is brown sandy/clayey loam. Slight H-C odor and staining.
