Pit, Below-Grade Tank, or
Proposed Alternative Method Permit or Closure Plan Application

1.	Operator: <u>Burlington Resources</u> OGRID #: <u>14538</u> Address: <u>PO BOX 4289, Farmington, NM 87499</u> Facility or well name: <u>Hagood 30</u> API Number: <u>30-045-20979</u> OCD Permit Number: _____ U/L or Qtr/Qtr <u>A (NENE)</u> Section <u>34</u> Township <u>29N</u> Range <u>13W</u> County: <u>San Juan</u> Center of Proposed Design: Latitude <u>36.68822</u> °N Longitude <u>-108.18736</u> °W NAD: <input type="checkbox"/> 1927 <input checked="" type="checkbox"/> 1983 Surface Owner: <input type="checkbox"/> Federal <input type="checkbox"/> State <input checked="" type="checkbox"/> Private <input type="checkbox"/> Tribal Trust or Indian Allotment

Burlington Resources Oil Gas Company, LP
San Juan Basin
Below Grade Tank Closure Report

Lease Name: HAGOOD 30
API No.: 30-045-20979

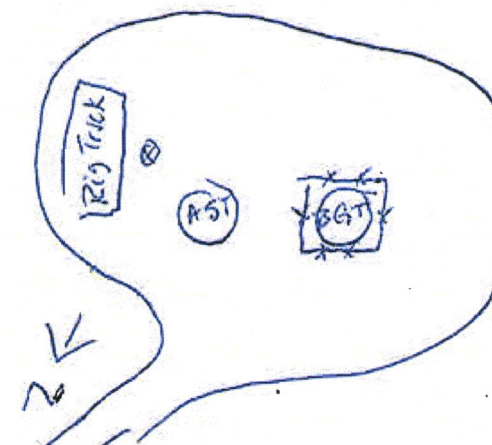
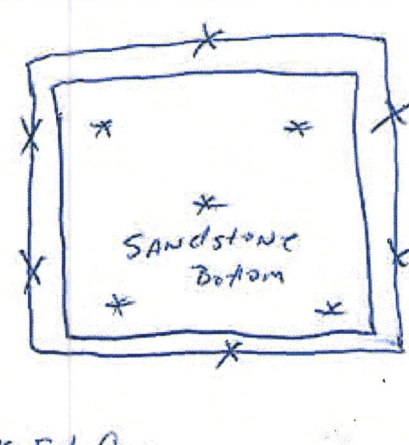
PROFILE

FIELD CHLORIDES RESULTS

<table border="1" style="width:100%; border-collapse: collapse;"> <thead> <tr> <th>SAMPLE ID</th> <th>READING</th> <th>CALC. (mg/kg)</th> </tr> </thead> <tbody> <tr> <td><u>Spl. Comp</u></td> <td><u>4.4</u></td> <td><u>189</u></td> </tr> <tr><td> </td><td> </td><td> </td></tr> <tr><td> </td><td> </td><td> </td></tr> <tr><td> </td><td> </td><td> </td></tr> <tr><td> </td><td> </td><td> </td></tr> <tr><td> </td><td> </td><td> </td></tr> <tr><td> </td><td> </td><td> </td></tr> </tbody> </table>	SAMPLE ID	READING	CALC. (mg/kg)	<u>Spl. Comp</u>	<u>4.4</u>	<u>189</u>

SAMPLE ID	READING	CALC. (mg/kg)																								
<u>Spl. Comp</u>	<u>4.4</u>	<u>189</u>																								
PID RESULTS																										
<table border="1" style="width:100%; border-collapse: collapse;"> <thead> <tr> <th>SAMPLE ID</th> <th>RESULTS (mg/kg)</th> </tr> </thead> <tbody> <tr> <td><u>Spl. Comp</u></td> <td><u>0.3</u></td> </tr> <tr><td> </td><td> </td></tr> <tr><td> </td><td> </td></tr> <tr><td> </td><td> </td></tr> <tr><td> </td><td> </td></tr> <tr><td> </td><td> </td></tr> </tbody> </table>			SAMPLE ID	RESULTS (mg/kg)	<u>Spl. Comp</u>	<u>0.3</u>
