Burlington Resources Oil & Gas Company, LP San Juan Basin Below Grade Tank Closure Report

Lease Name: San Juan 27-5 Unit 92R

API No.: 30-039-26527

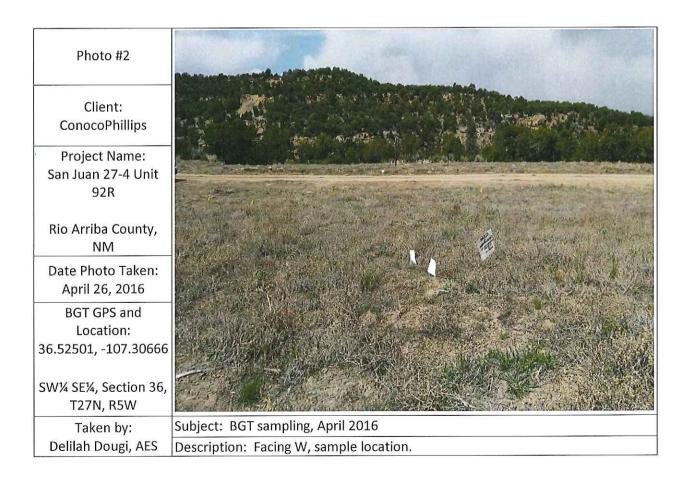
Photo #1 Client: ConocoPhillips Project Name: San Juan 27-5 Unit 92R Rio Arriba County, NM Date Photo Taken: April 26, 2016 **BGT GPS and** Location: 36.52501, -107.30666 SW¼ SE¼, Section 36, T27N, R5W Subject: BGT sampling, April 2016 Taken by: Delilah Dougi, AES Description: Facing E, well monument and half of location.
