XTO Energy Inc. San Juan Basin Below Grade Tank Closure Report

Lease Name: La Plata 7 #1 API No.: 30-045-29920

Description: Unit P, Section 7, Township 31N, Range 13W, San Juan County

XTO Energy, Inc. La Plata 7 #1 Section 7, Township 31N, Range 13W Closure Date: 2/21/2011

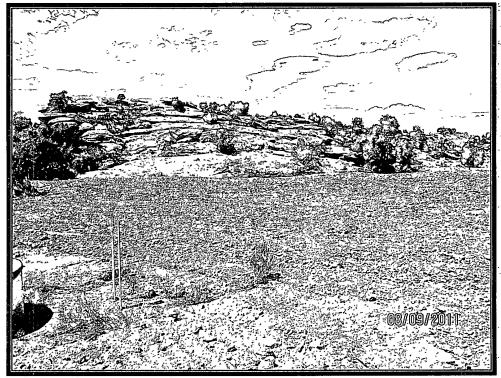
Photo 1: La Plata 7 #1 after Reclamation (View 1)

The location has been recontoured to match the above specifications.

The location has been reclaimed pursuant to the BLM MOU.

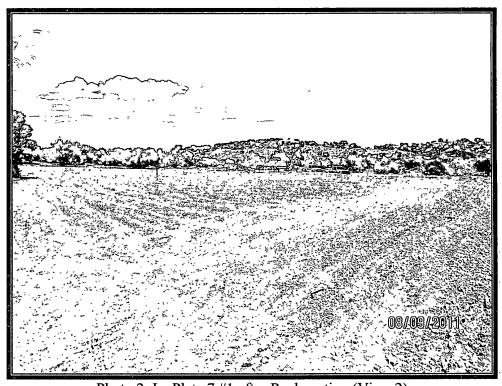
Photo 2: La Plata 7 #1 after Reclamation (View 2)
