Pit, Closed-Loop System, Below-Grade Tank, or Proposed Alternative Method Permit or Closure Plan Application

| Operator Burlington Resources Oil & Gas Company, LP OGRID#: 14538 |
|--|
| Facility or well name BLANCO COM A 6B |

Burlington Resources Oil Gas Company, LP San Juan Basin Closure Report

Lease Name: BLANCO COM A 6B

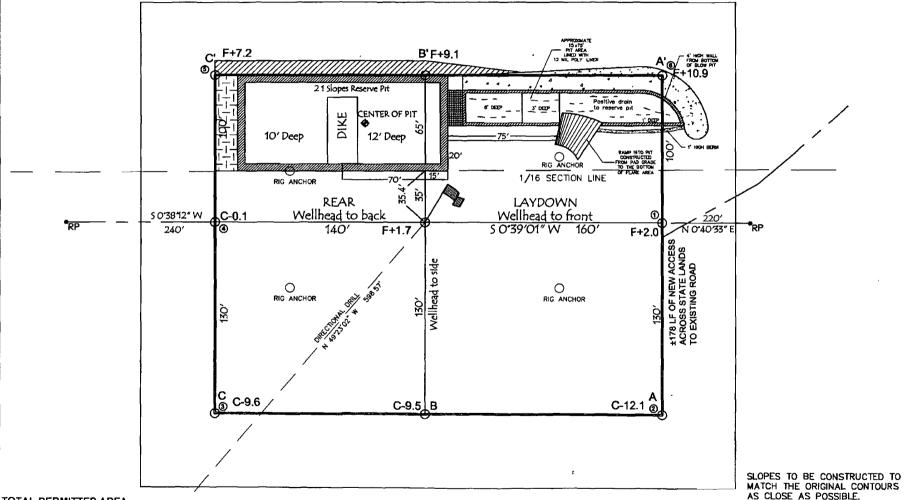
CENTER OF PIT

FINISHED PAD ELEVATION. 6065.7', NAVD 88

TOTAL PERMITTED AREA 330' x 400' = 3.03 ACRES
