**Release Notification and Corrective Action**

Name of Company	Williams Midstream	Contact	Aaron Dailey
Address	188 County Road 4900	Telephone No.	(505) 632-4708
Facility Name	Riddle 001 Well Site	Facility Type	Pipeline

Type of Release	Fire-no injury	Volume of Release:	N/A	Volume Recovered:	N/A
Source of Release:	Field Dehydrator and 45 BBL Tank	Date and Hour of Occurrence	5.5.11 @ 06:00 hours (est)	Date and Hour of Discovery	5.5.11 @ 06:00 hours
Was Immediate Notice Given?	<input checked="" type="checkbox"/> Yes <input type="checkbox"/> No <input type="checkbox"/> Not Required	If YES, To Whom? Brandon Powell, Aztec District office			
By Whom?	Aaron Dailey	Date and Hour 5.6.11 @ 16:00 hours			
Was a Watercourse Reached?	<input type="checkbox"/> Yes <input checked="" type="checkbox"/> No	If YES, Volume Impacting the Watercourse.

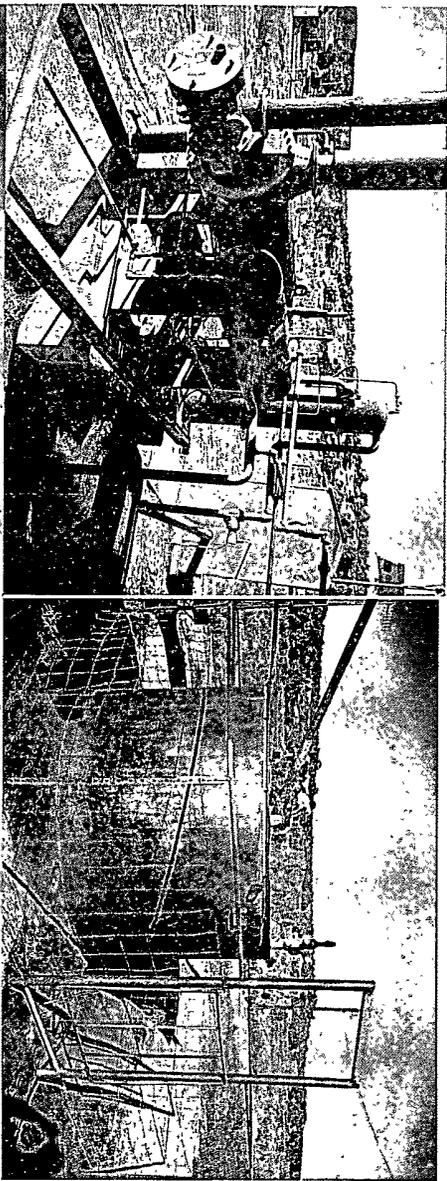
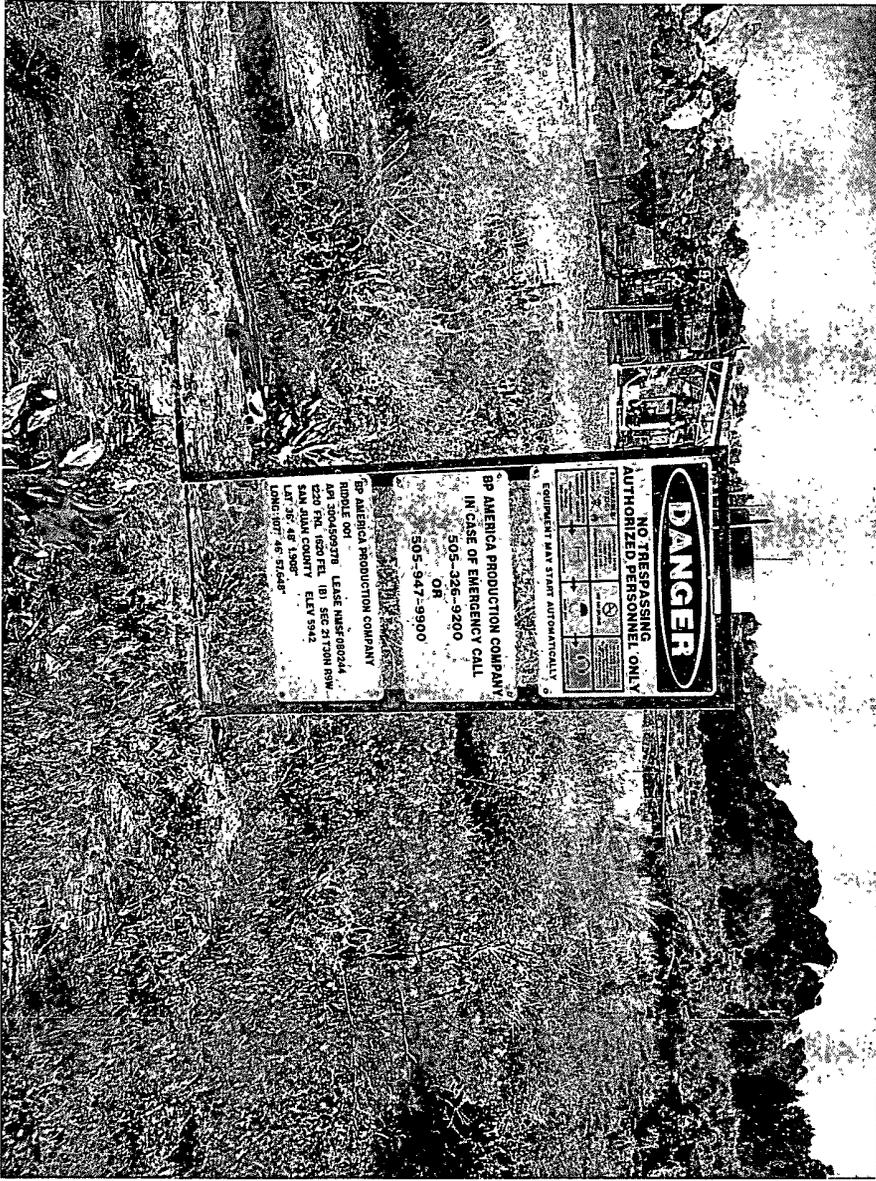
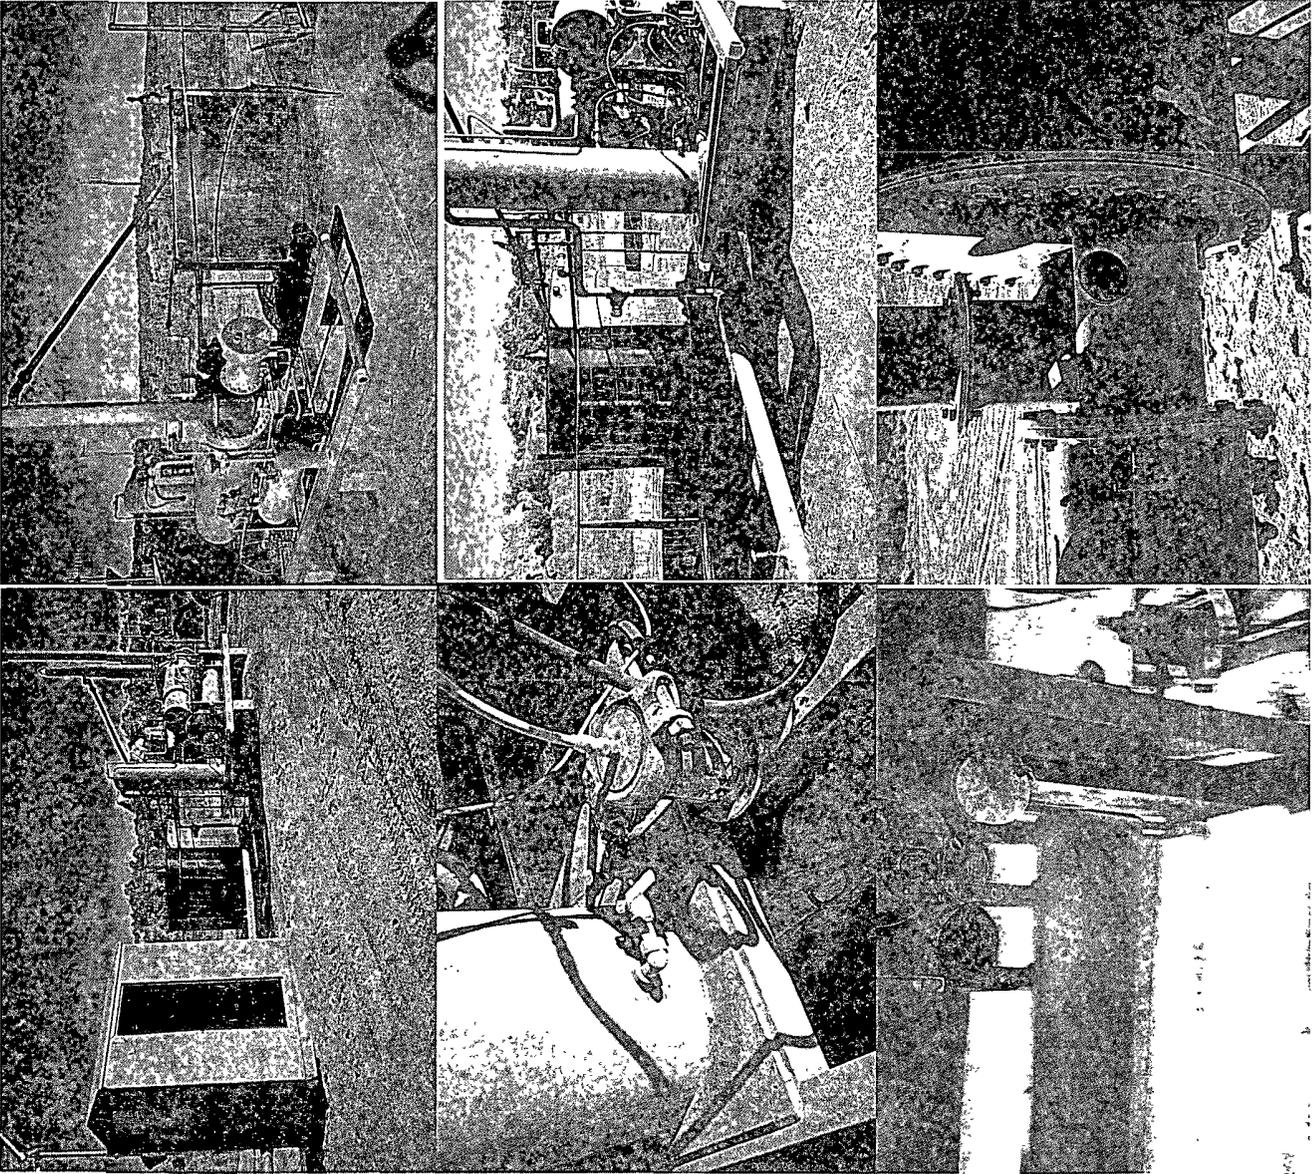
On Thursday 5/5/11 @ 6:00 am, the 45 bbl. Dehydrator pit/tank and dehy caught on fire on the Riddle-1 location. From Initial investigation it appears that flammable liquids in the tank ignited first and the heat and flames from that fire caused the dehy liquid level controller to also catch on fire. Investigation after the fire went out revealed that the 2" burner access plug had been removed and one of the liquid level cat-eyes had blow-out during the fire. The dehy's pump had been shut off and someone had inadvertently or maliciously removed the 2" burner access plug allowing flammable vapors from the liquid pit tank to find open access to the dehy's burners

Fire did not damage any vegetation. No impact to soil or groundwater. Photos attached to this report. In the photos, the area that appears dark in color is water as a result of the Center Point fire departments efforts in applying approximately 3 truck loads of water on the 45 BBL tank as a method of cooling the equipment.

The 45 bbl open top steel pit was damaged by the heat and fire. The pit tank will cost \$2000.00 to replace. The dehy has minimal damage. The liquid level controller will need replaced. Cost \$600 00
